Left Wing Gear Assembly

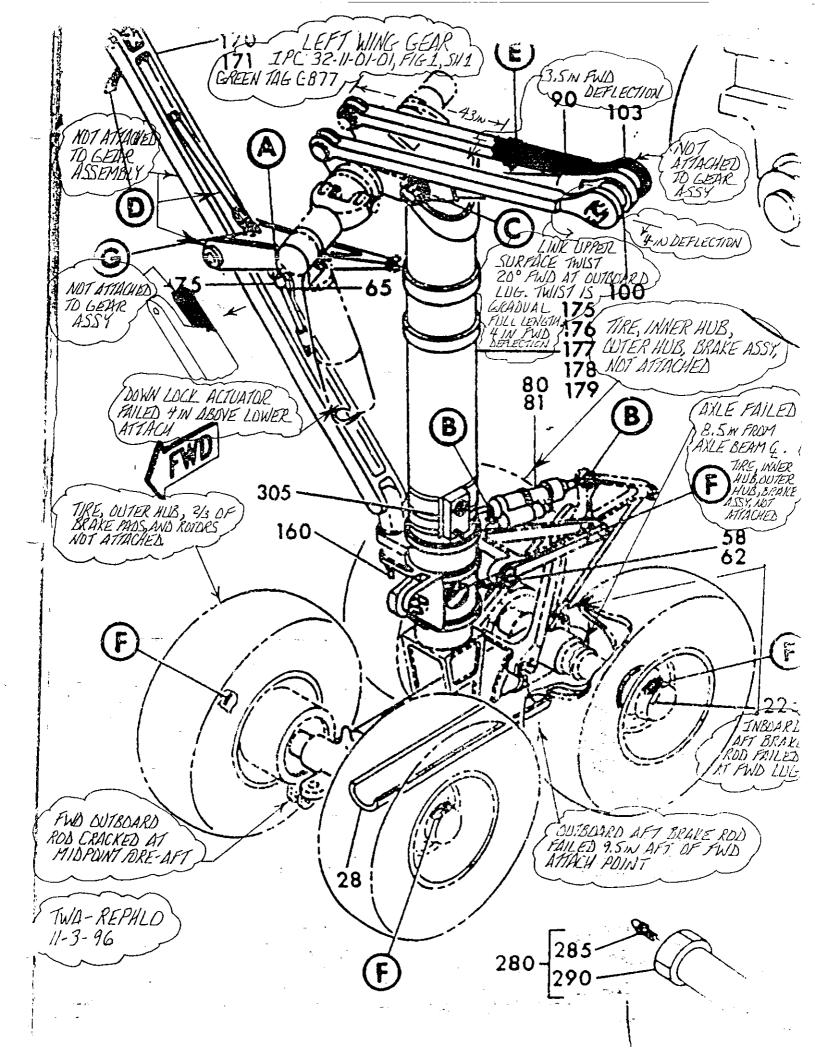
Log Number	LG2
Debris Field	Green
Target Number	C877
Coordinates:	
Latitude	
Longitude	
Left wing gear assembly	is not attached to trunnion fittings.
Some hydraulic lines rem	nain attached.
Some wiring remains atta	ached.
Downlock bungee is not	attached to gear assembly.
Inboard jury strut link is link is attached to outer c	unattached to side strut and unattached to outboard jury strut. Outboard jury strut ylinder.
All brake rods failed as si	hown on illustration.
Aft outboard axle failed 8	3.5 inches from gear beam centerline.
Retract stabilizing arms vunattached to gear assem	were bent as shown on illustration. Aft stabilizing arm outboard section is bly. See illustration.
	ub, outer hub, brake assembly, and outer portion of axle not attached to gear 5 inches from gear beam centerline.
Forward outboard tire ha	s cuts.
Inboard forward tire, innegear assembly.	er hub, outer hub, and outer two-thirds of brake pads and rotors not attached to

Inboard aft tire, inner hul	o, outer hub, and brake assembly not attached to gear assembly.
	gh paint layer only. No visible signs of soot.
TWA-REPHLO DYRYALS 11-26) <i>-9</i> 6
11-25-46 Stephen F. 1 R Suchtly 12.6. D. Att. BOUT	96 JAM
