Left Body Gear Assembly

Log Number LG3
Debris Field Green
Target Number C104
Coordinates:
 Latitude _____
 Longitude _____

LEFT BODY GEAR ASSY
IPC 32-13-01-01, FIG 1, SHEET 1
GREEN TAG C-104

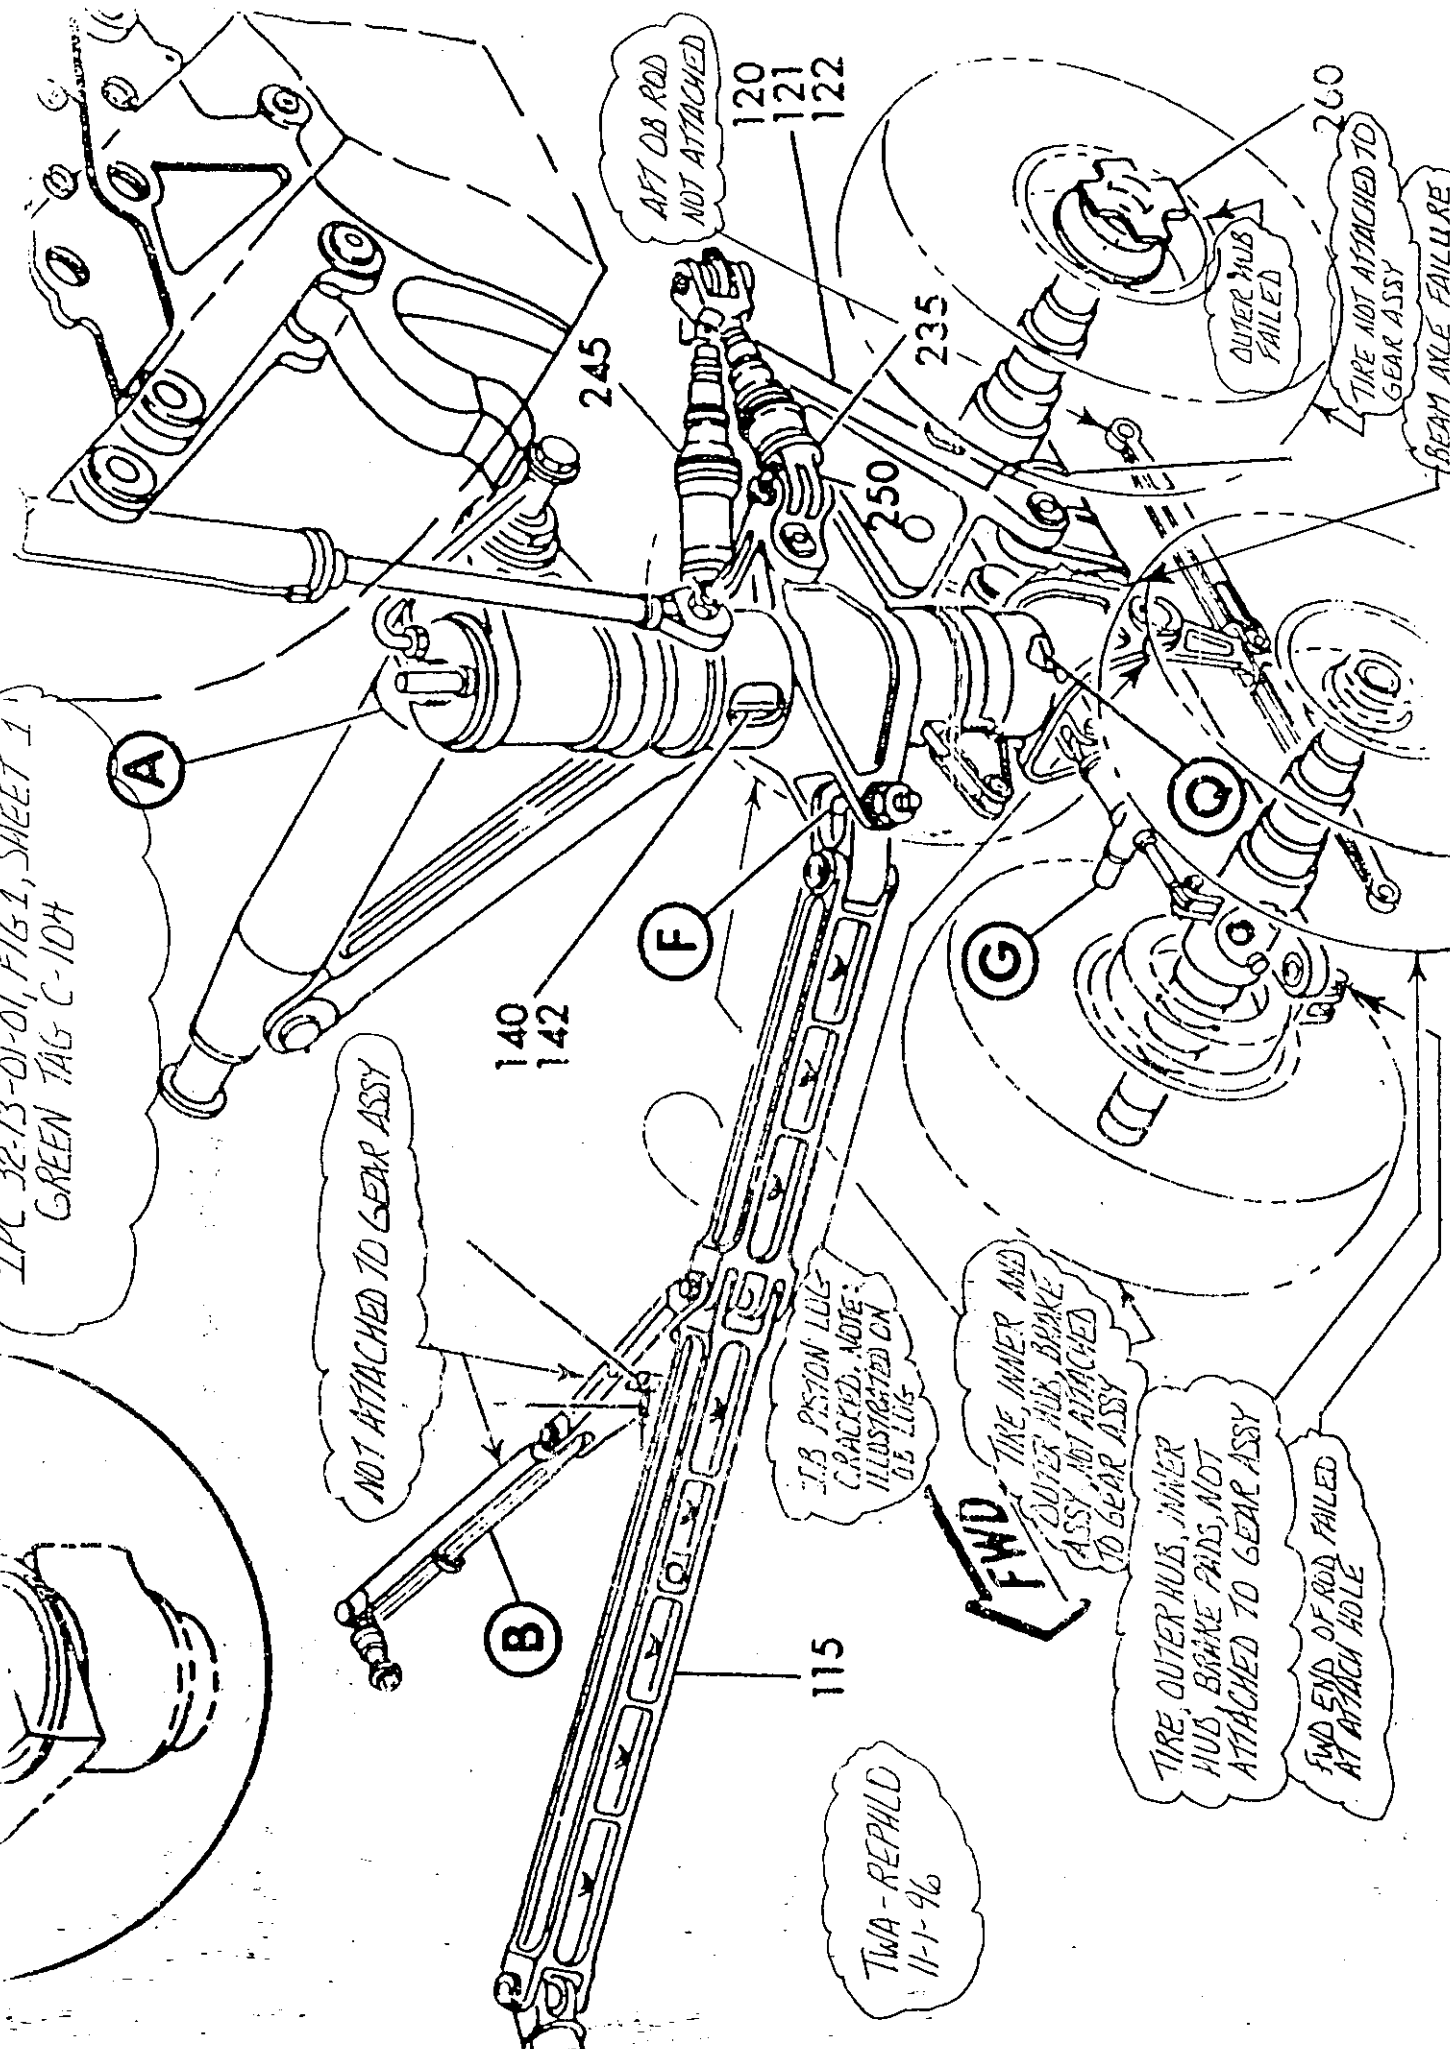
Left body gear assembly is attached to trunnion fittings. Trunnion fittings tore from fuselage structure. See LF-92. for description of attaching fuselage structure.

Jury strut separated from lower drag link as shown on illustration.

Outer cylinder gland nut became unattached allowing piston to separate from the outer cylinder.

Axle beam and connecting rods failed as shown on illustration.

A large portion of hydraulic lines remain attached.

Retract piston pulled aircraft structure attach fitting out of aircraft structure.

Both inboard tires, inner hubs, outer hubs, and brake assembly are not attached to the gear assembly. Forward outboard tire, inner hub, outer hub, and brake pads not attached to gear assembly. Aft outboard outer hub failed allowing tire to depart gear assembly.

General scratching through paint layer only. No visible signs of soot

AFT OB ROD
NOT ATTACHED

OUTER HUB
FAILED

TIRE NOT ATTACHED TO
GEAR ASSY

BEAM AXLE FAILURE

NOT ATTACHED TO GEAR ASSY

I.B. PISTON LUG
CRACKED. NOTE:
ILLUSTRATED ON
O.E. LUG

FWD TIRE, INNER AND
OUTER HUB, BRAKE
ASSY, NOT ATTACHED
TO GEAR ASSY

TIRE, OUTER HUB, INNER
HUB, BRAKE PADS, NOT
ATTACHED TO GEAR ASSY

FWD END OF ROD FAILED
AT ATTACH HOLE
