Right Body Gear Assembly

Log Number LG4
Debris Field Green
Target Number C105
Coordinates:
 Latitude _____
 Longitude _____

RIGHT BODY GEAR ASSY

GREEN TAG C-105

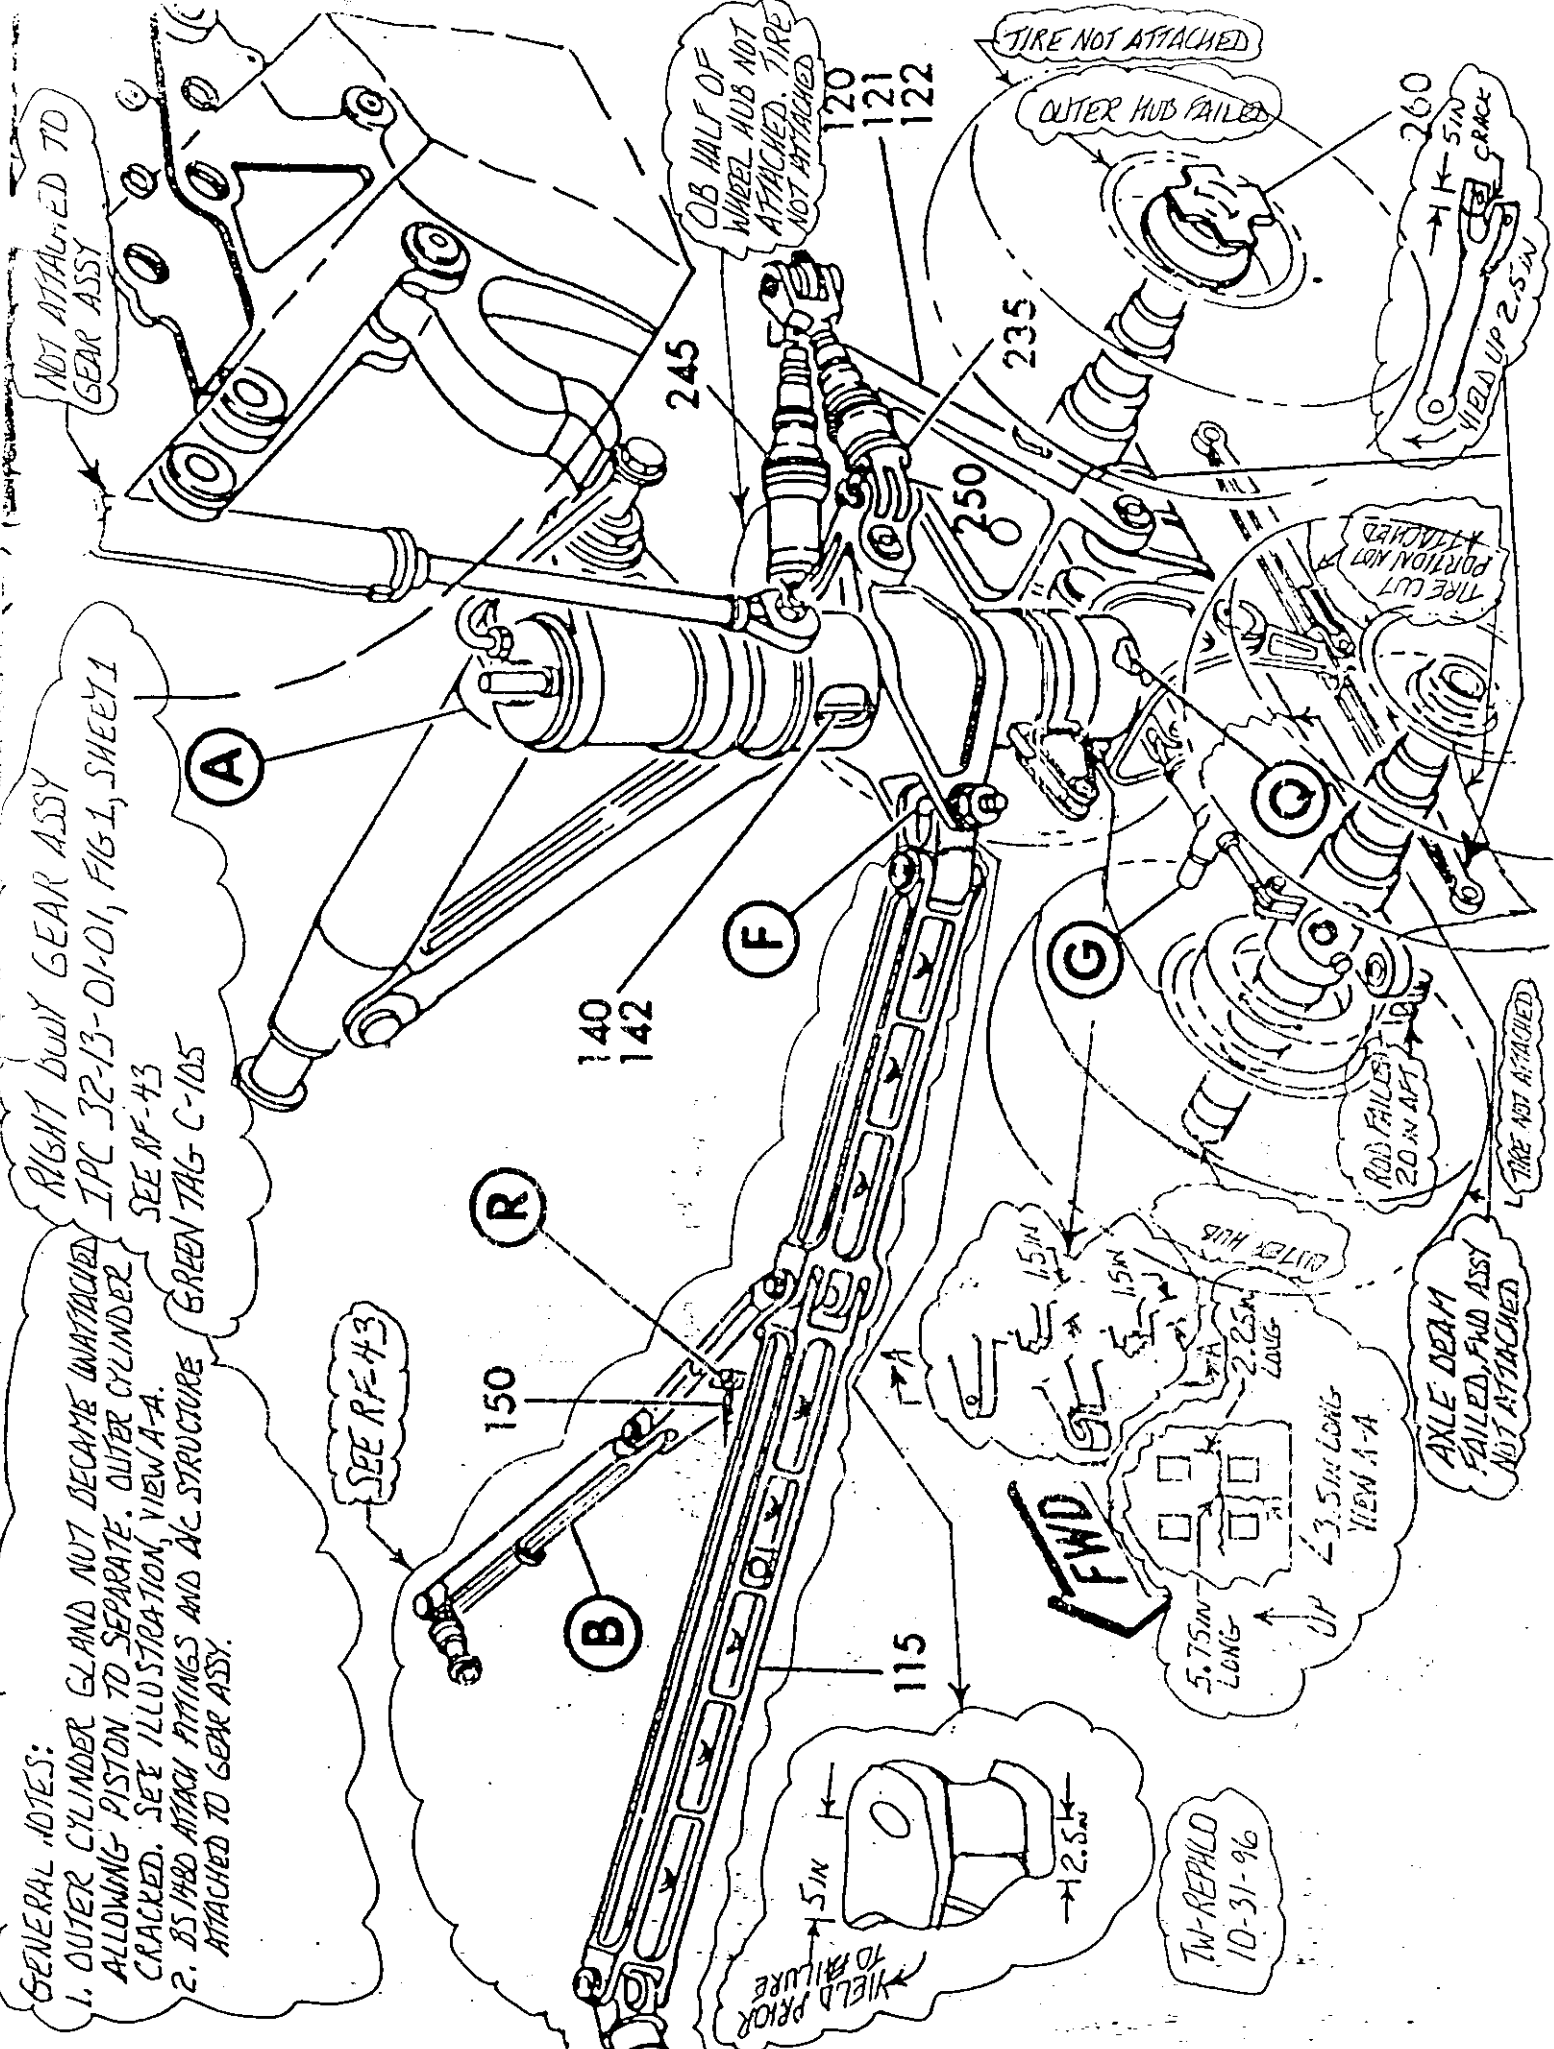
Right body gear assembly is attached to trunnion fittings. Trunnion fittings tore from fuselage structure. See RF-119 for description of attaching fuselage structure.

Outer cylinder to lower drag strut severed as shown on illustration. See RF-43 for additional description of lower drag strut, jury strut, and upper drag strut assemblies.

Outer cylinder gland nut became unattached allowing piston to separate from the outer cylinder. Outer cylinder cracked vertically in the thread area allowing gland nut to move away from outer cylinder.

Axle beam and connecting rods failed as shown on illustration.

Retract piston not attached to gear assembly.

Both outboard tires and the aft inboard tire are not attached. The outer hubs failed allowing tires to depart gear assembly. Outboard forward tire was sheared as shown on illustration.

General scratching through paint layer only. No visible signs of soot.

1. OUTER CYLINDER GLAND NOT BECAME UNATTACHED ALLOWING PISTON TO SEPARATE. OUTER CYLINDER CRACKED. SEE ILLUSTRATION, VIEW A-A.
2. B51480 ATTACH FITTINGS AND A/C STRUCTURE ATTACHED TO GEAR ASSY.

NOT ATTACHED TO GEAR ASSY

OB HALF OF WHEEL HUB NOT ATTACHED. TIRE NOT ATTACHED

OUTER HUB FAILED

YIELD UP 2.5 IN CRACK

AXLE DEAM FAILED, FWD ASSY NOT ATTACHED

TIRE CUT PORTION NOT ATTACHED

ROD FAILED 20 IN AFT

YIELD PRIOR TO FAILURE
