NOSE GEAR DOORS L&G

NOSE LANDING GEAR DOOR

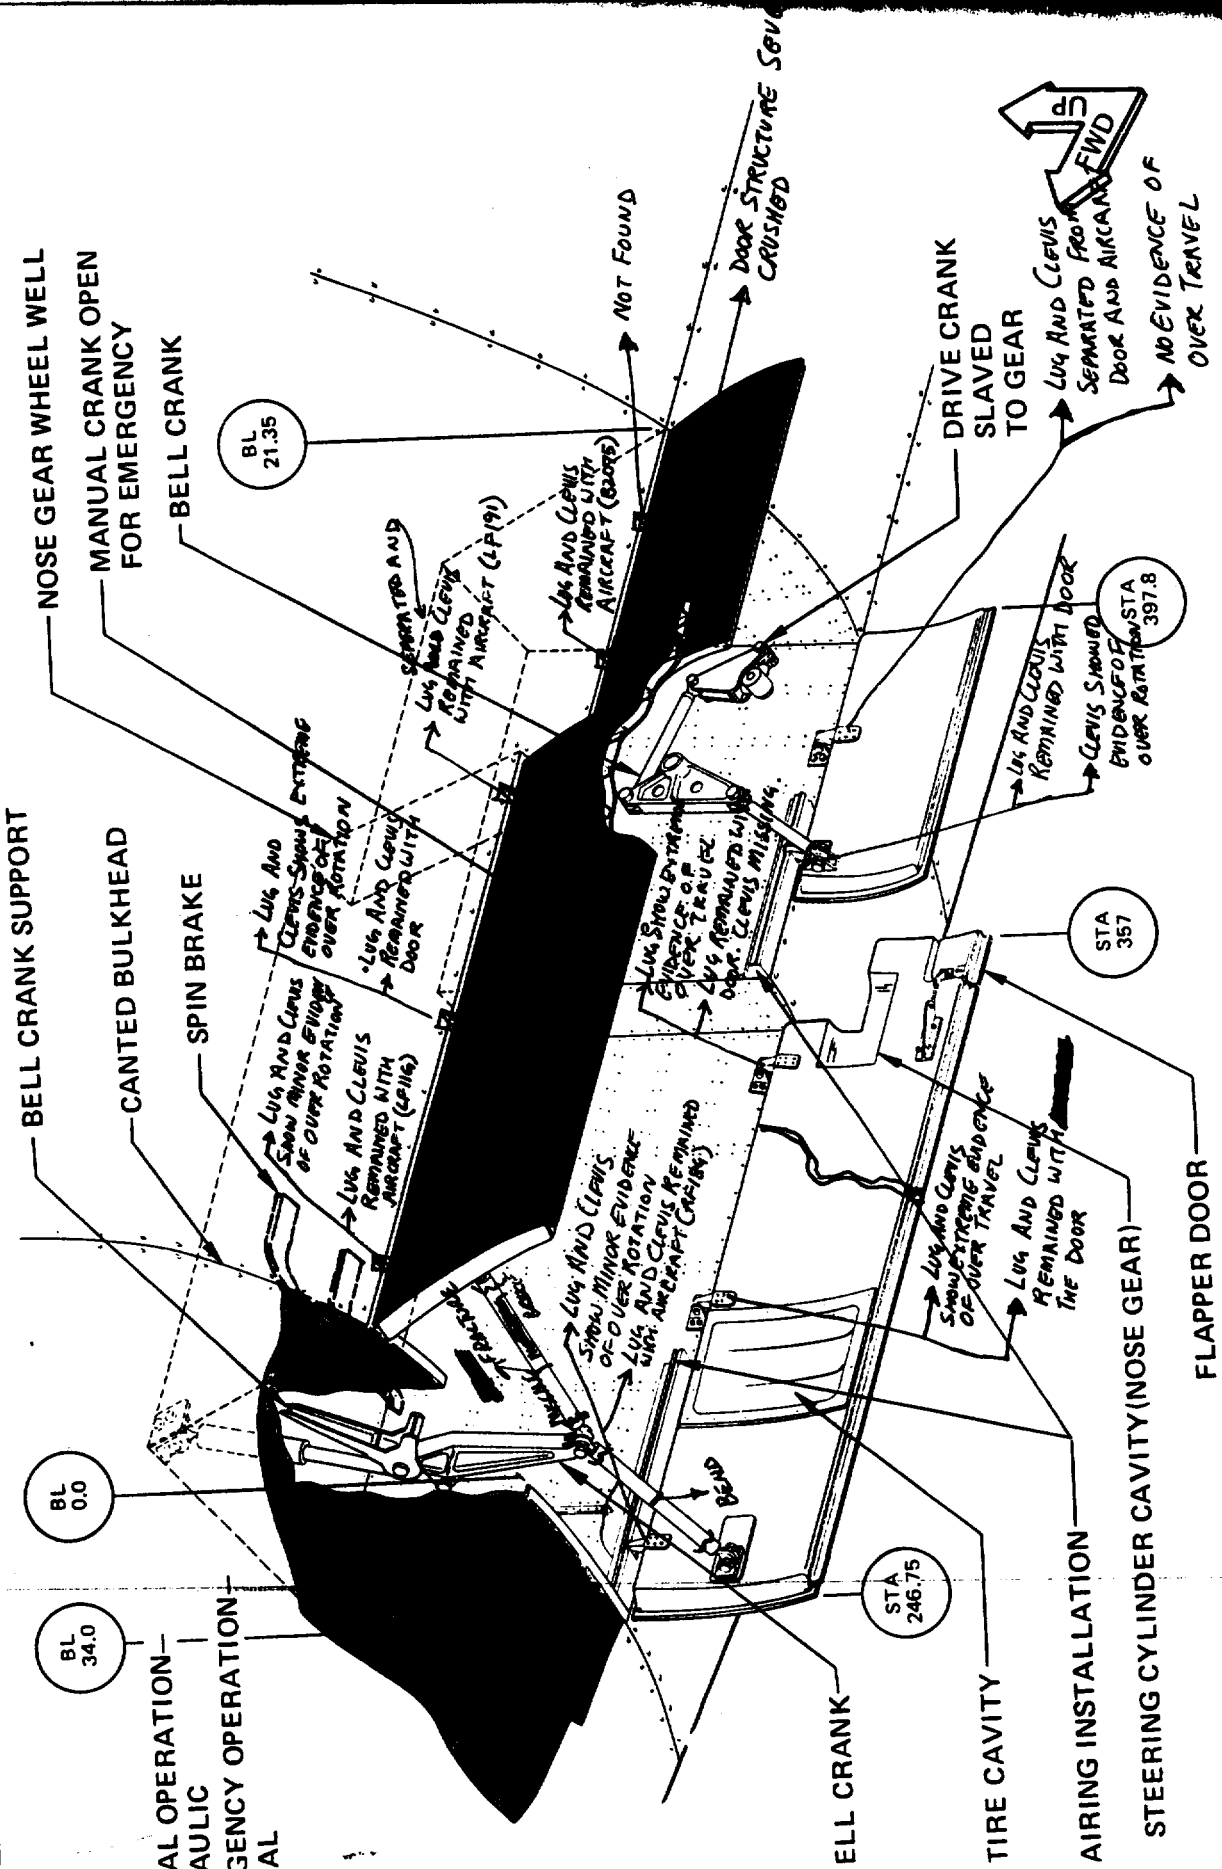
NLG FWD DOOR. (OUTER SURFACE)
VIEW LOOKING-UP

LUG AND CLEVIS SHOW MINOR EVIDENCE OF OVER ROTATION
 LUG AND CLEVIS REMAINED WITH AIRCRAFT (SP16)

LUG AND CLEVIS REMAINED WITH AIRCRAFT (SP19)
 LUG AND CLEVIS REMAINED WITH AIRCRAFT (BOOPS)

LUG SHOWS EXTENSIVE EVIDENCE OF OVER TRAVEL
 LUG REMAINED WITH AIRCRAFT (SP16)

DOOR STRUCTURE SEVERELY CRUSHED

LUG AND CLEVIS SEPARATED FROM DOOR AND AIRCRAFT
 NO EVIDENCE OF OVER TRAVEL

LUG AND CLEVIS REMAINED WITH DOOR
 CLEVIS SHOWS EVIDENCE OF OVER ROTATION

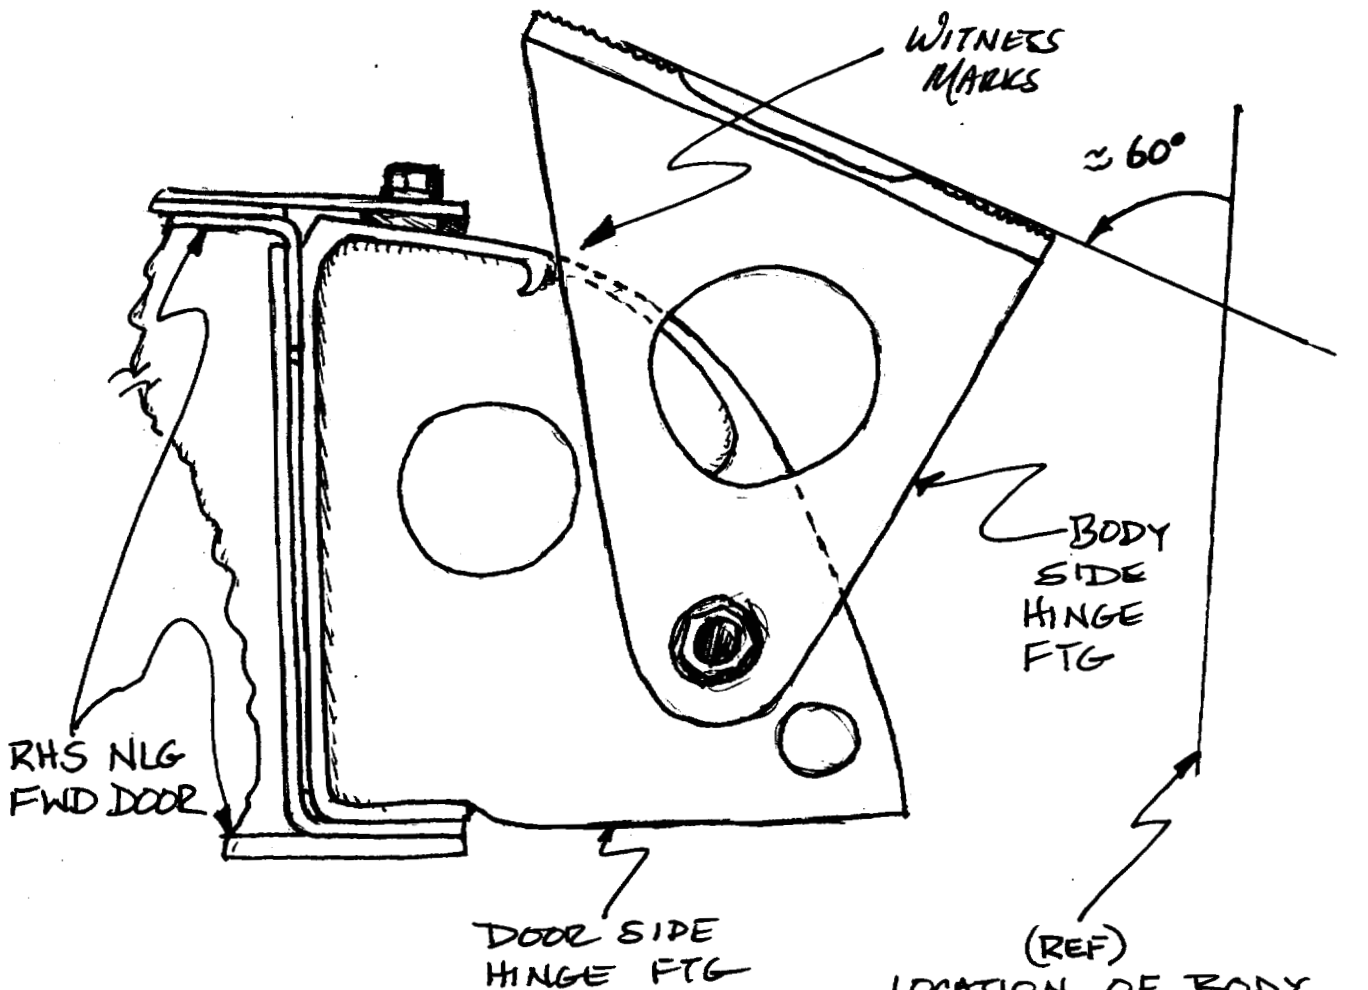
NLG RHS FWD DOOR - MID HINGE

(REF)
LOCATION OF BODY
SIDE HINGE FTG
RELATIVE TO DOOR
SIDE HINGE FTG
WITH DOOR IN
CLOSED POSITION.

THE WITNESS MARKS ON THE NLG FWD DOOR HINGE ASSEMBLIES ARE CONSISTENT WITH RELATIVE ROTATION APPROXIMATELY 60° BEYOND THE CLOSED POSITION.

THE ROTATION IS CONSISTENT WITH THE DOORS MOVING IN AN UPWARD DIRECTION.

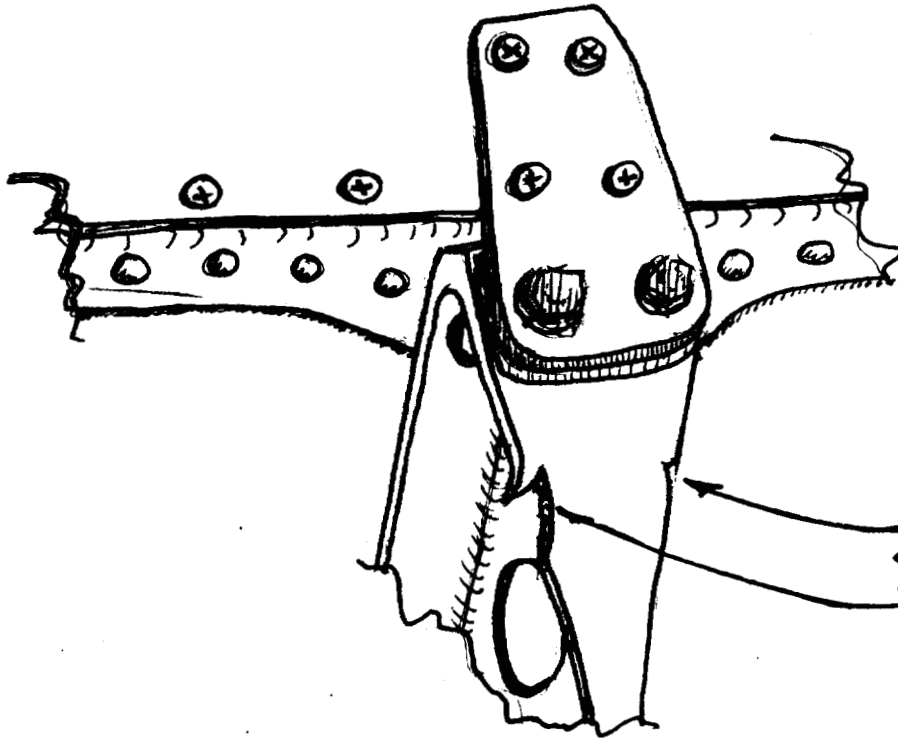
NLG RHS FWD DOOR - MID HINGE

WITNESS
MARKS ON
NLG DOOR
SIDE HINGE
FITTING

(IMPACT WITH BODY
SIDE HINGE FTG
CLEVIS)

THE RHS MID HINGE SHOWN SHOWS THE MOST OBVIOUS MARKS DUE TO IMPACT WITH BODY SIDE HINGE FITTING CLEVIS. MARKS COMMON TO THE DOOR SIDE FITTINGS AT THE OTHER HINGE LOCATIONS SHOW SIMILAR AMOUNTS OF RELATIVE ROTATION (EXCEPT AT THE RHS FWD DOOR AFT HINGE).
