## Left Body Gear Doors

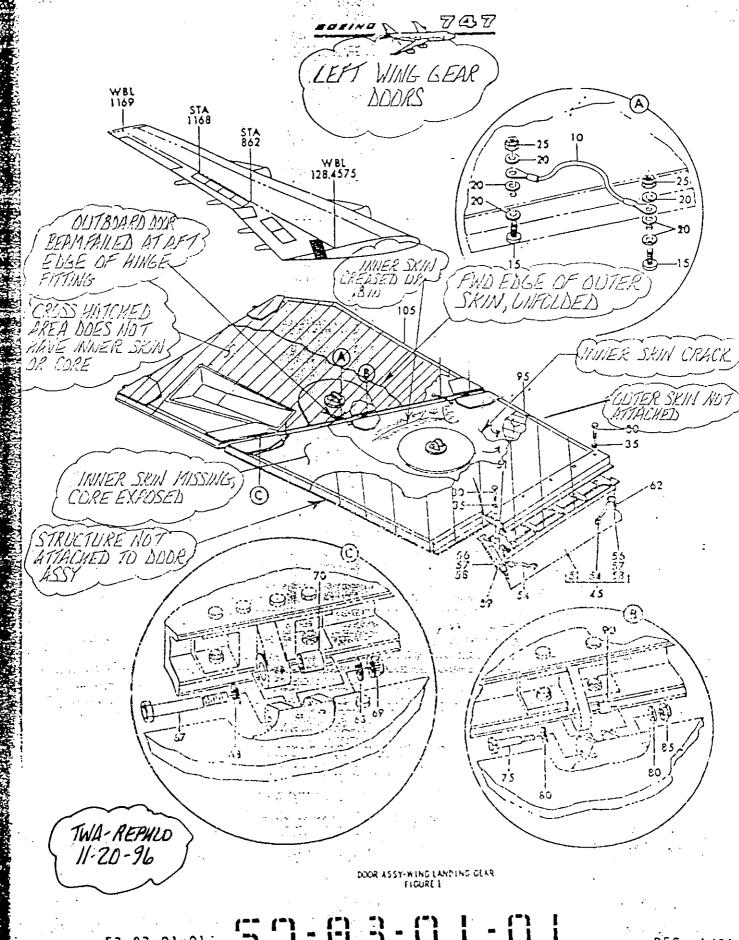
Log Number Debris Field Target Numbers Coordinates:	LG8 Green C849, Z3071, Z3269, Z3273 Latitude Longitude	
Outboard Forward Door	(Z3071)	
Outboard hinges failed.		
Inner skin has punctures,	cracks, and flapping as shown on illustration.	
Rod failed at door fitting.		
Structure has minor surface	ces abrasions. No visible indication of soot.	
Inboard Forward Door (2	Z3673)	
Inboard frame has failed a	at hinge locations. Hinges tore from door assembly.	
Outboard hinges failed.		
Leading edge door seal no	ot attached to door assembly.	
Rod not attached.		
Forward transverse inner	skin stiffener outboard 24 inches of vertical flange not attached.	
Inboard Aft Door (Z3269)	)	
Forward segment of door	exists. Aft segment is not attached and not identified.	
Forward segment separate	ed approximately forty-one inches aft of leading edge.	
Fuselage hinge failed at fo	orward hinge location.	
The second door hinge aft	; failed.

Structure has minor surface	ce abrasions. No visible indication of soot.	
Outboard Aft Door (C849	<i>)</i> )	
Outer skin dented as show	on illustration and torn downward from top approximately twelve inches	i.
Hinges are failed.		
Approximately three inche	es of rod are attached.	
Seal retainer has areas of c	cracking and deflection as shown on illustration.	
	the abrasions. No visible indication of soot.	
Stephen F. Klapack SN	- 2-96 TWA R. Swelith IAM 12-6-96.	ALPA O1-20-97
