Right Body Gear Doors

LG9 Log Number **Debris** Field Green Z3328, Z2746, Z3064, Z3355 Target Numbers Coordinates: Latitude Longitude

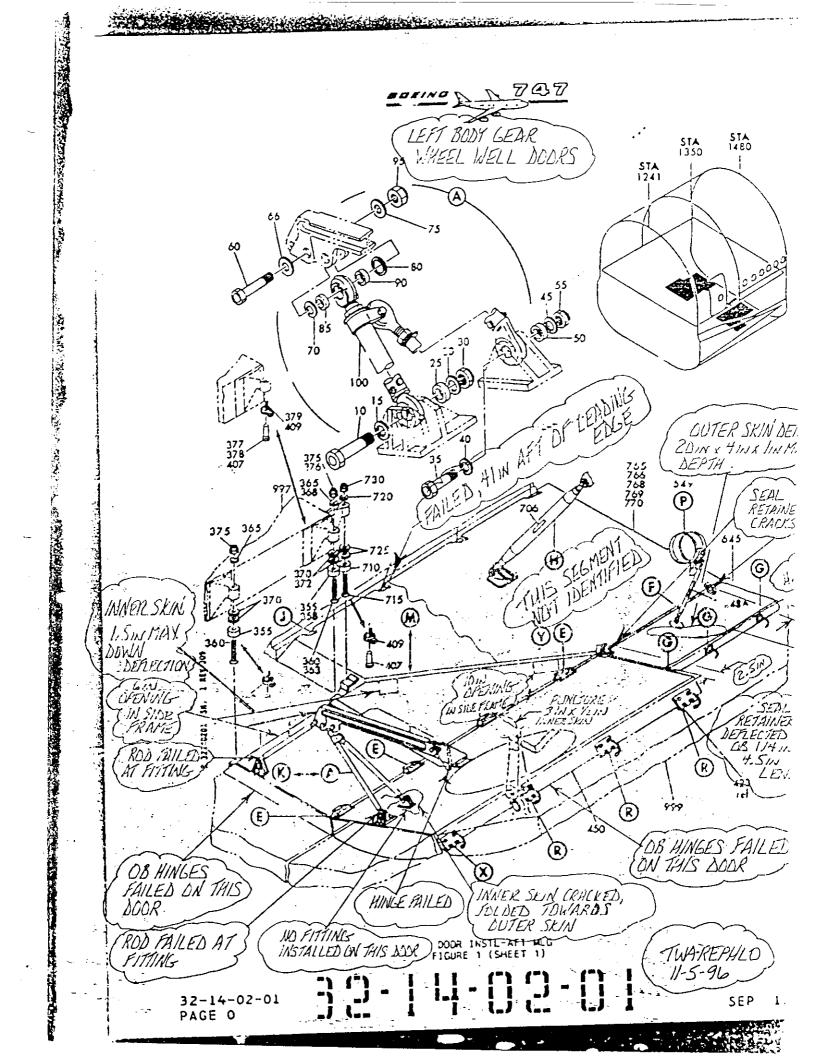
Outboard Forward Door (Z3328)

Outboard hinges attached to fuselage structure which is approximately 17 inches circumferentially x 130 inches fore-aft.

Outer skin dented and cracked along leading edge of dent adjacent to second rib aft of leading edge.

Rod failed 1.5 inches from door fitting.

Structure has minor surface abrasions. No visible indication of soot.

Inboard Forward Door (Z2746)

Inner skin has cracking and a dent as shown on illustration.

Outboard hinges failed.

Inboard and outboard sections of leading edge door seals not attached.

Rod not attached.

Structure has minor surface abrasions. No visible signs of soot.

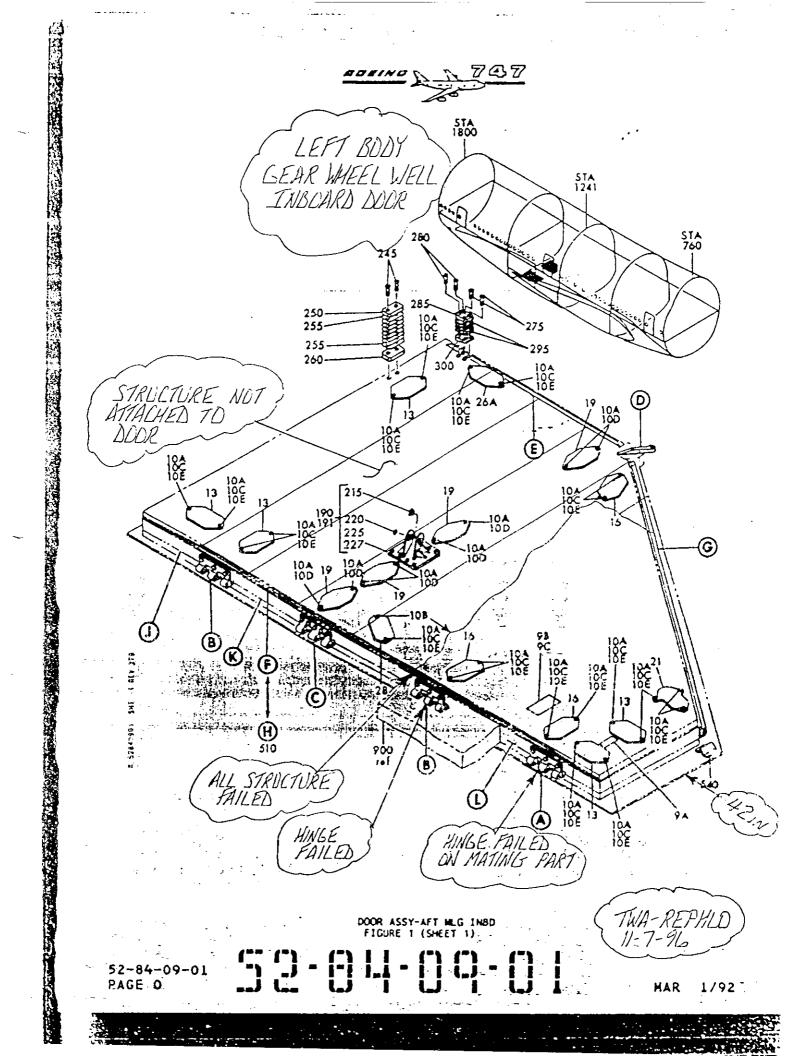
Inboard Aft Door (aft segment Z3064, forward segment Z3355)

Numerous punctures, cracks, and skin flapping exists. See illustration.

Aft hinge location has fuselage fitting attached.

Second hinge forward failed.

Third hinge forward is attached to outer skin.

Aft segment of door is separate from forward segment.

A mangled segment of forward edge approximately eleven inches by four inches is not attached.

Structure has minor surface abrasions. No visible indication of soot.
