LW12
C-886 Green Tag
Left Wing Lower Surface

LW-12 R.T. STETTNER 11-17-96

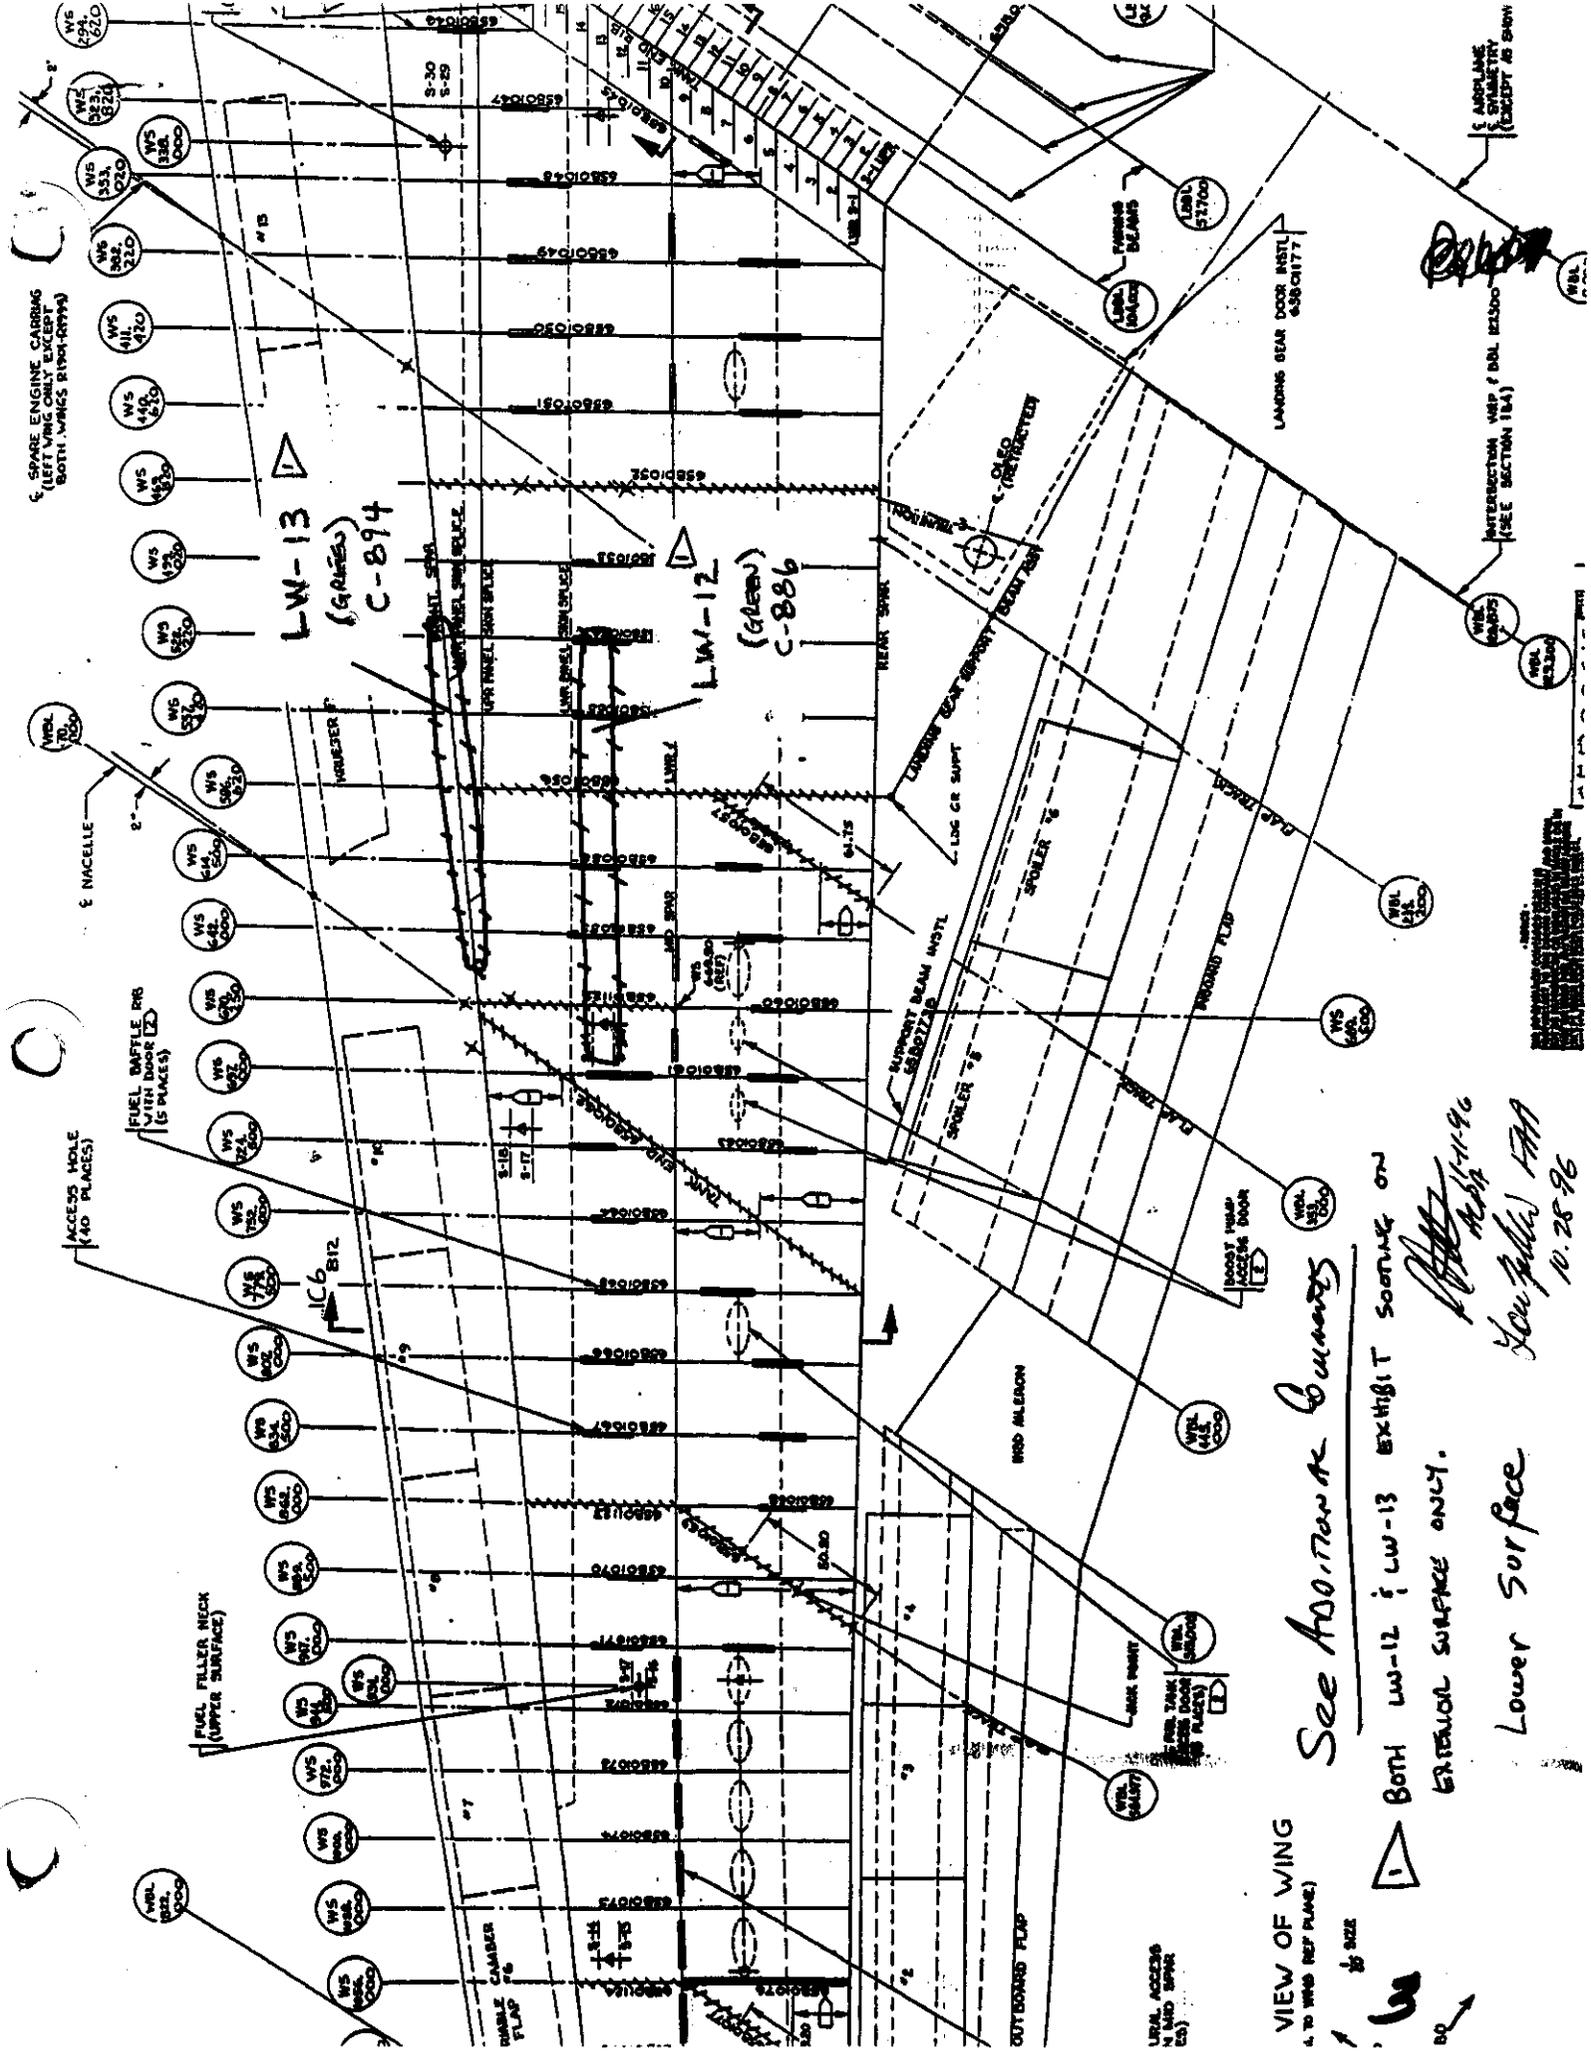
LW-12 (GREEN) C-886

Soot on exterior surface.

Skin panel piece has some curvature and twist, but not nearly as extreme as many of the other skin panels.

Stringer 13 fractured along most of fastener line. In 3-foot region where fastener line deviated from fastener line, holes are round and clean.

Stringer 14 has approx 30% of fasteners missing with no hole elongation (round and clean). Remaining skin holes are filled with fasteners, with fractures flush to inside skin surface.

Stringer 15 completely missing, and no fasteners at all remain in skin. Hole elongation exists over length, with elongation in the fore-aft direction +/- 30 degrees.

- 1) ~~STRINGER 13 IS NOT PRESENT AS A MATTER OF FACT~~
NO STRINGERS ATTACHED TO LW-12
- 2) PANEL IS BASICALLY FRACTURED ALONG FASTENER HOLES OF STRINGER 13
- 3) LAST STATEMENT SHOULD READ FASTENER HOLE ELONGATION VARIES FROM FORE AND AFT TO SPANWISE ELONGATION.

BOTH LW-12 & LW-13 EXHIBIT SORTING ON EXTENSION SURFACE ONLY.
