LW 18  
 Green Area C203Z  
 Received 8-19-96 Lot B

Wing Skin Segment  
 Lower Left Panel

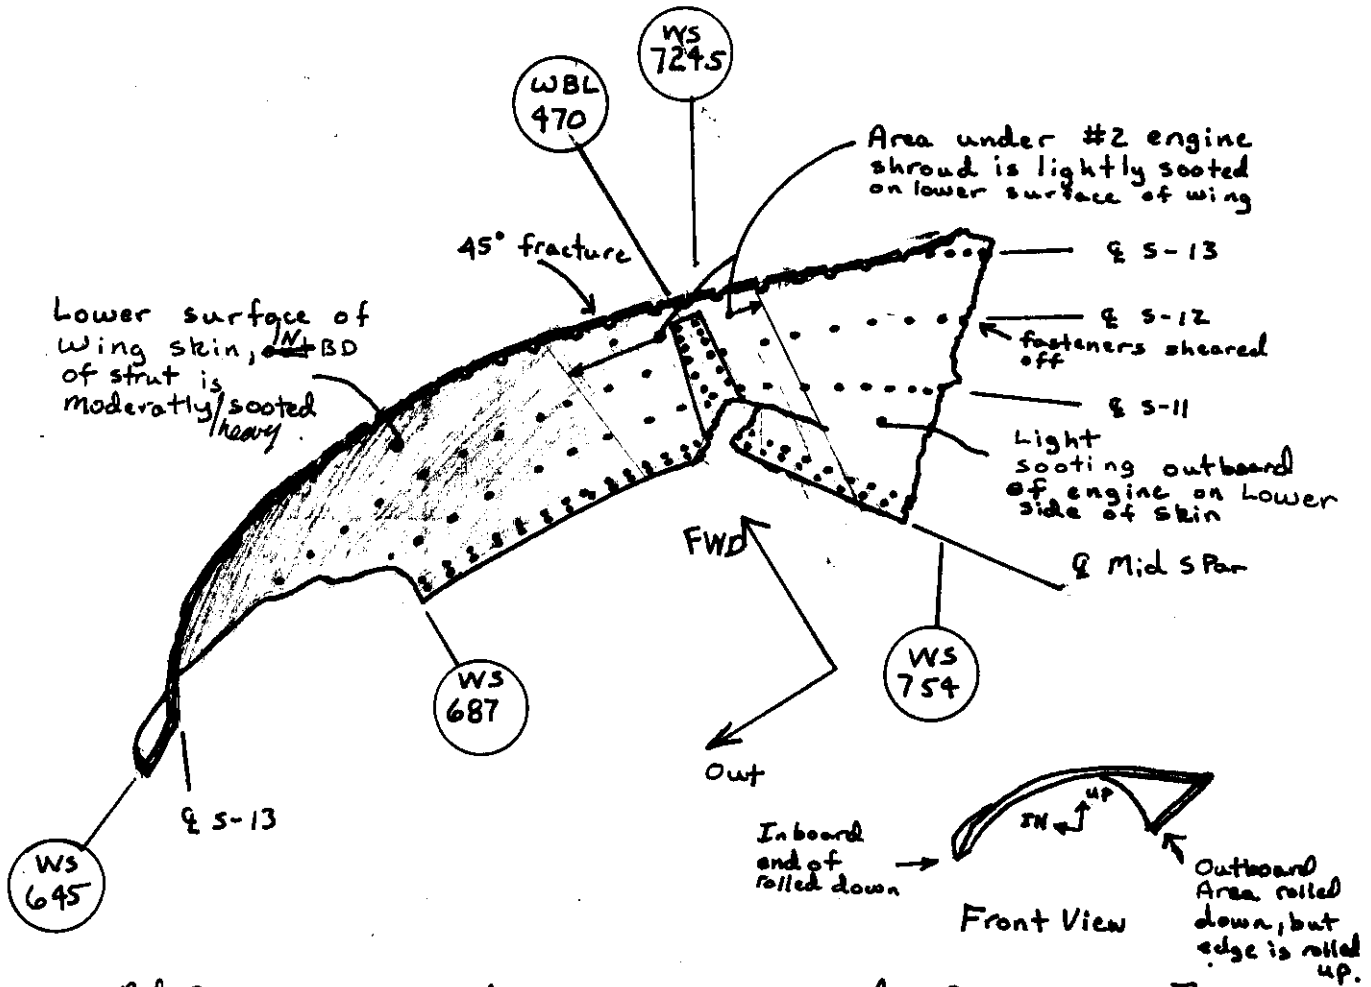
- Mid Spar splice chord is missing inboard of WS 701. The remaining chord has no vertical flange
- Fracture surfaces are not sooted
- No evidence of fatigue failure
- Strut fitting is not attached
