LOG # 121

TARGET # 008

### #4 FLAP TRACK ASSY.

DEBRIS FIELD GREEN COOB

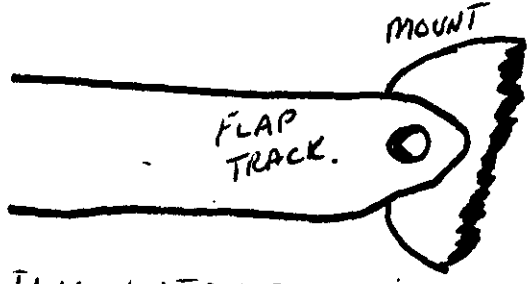
LEFT SIDE INBOARD FLAP TRACK AND CARRIAGE ASSY #4 FLAP POSITION. THE FRONT FLAP TRACK MOUNT SEPERATED FROM THE WING UNDER SIDE (MOUNT IS FRACTURED)

CARRIAGE IS MOSTLY INTACT WITH THE EXCEPTION OF THE CONNECTING RODS AND LINKAGE. WHICH ARE BROKEN AND OR FRACTURED.

THE MID FLAP. IS PARTIALLY CONNECTED AND THE UPPER SURFACE INBOARD SIDE IS DELAMINATED ~~AT~~ AT THE TRAILING EDGE OF THIS SECTION. THE FLAP IS SEVERED AT THE INBOARD & OUTBOARD LOCATIONS (EDGES) THIS ASSY MEASURES APPROX 16 FT. LONG WITH NO SIGNS OF SOOTING.

THE TRAILING EDGE FLAP IS STILL CONNECTED TO THE ~~THE~~ MID FLAP. BY THE FLAP CONNECTORS. THE TRAILING EDGE FLAP IS CONNECTED AT 2 POINTS AND HAS A BREAK-SEPERATION IN THE CENTER MAILING IT 2 PIECES

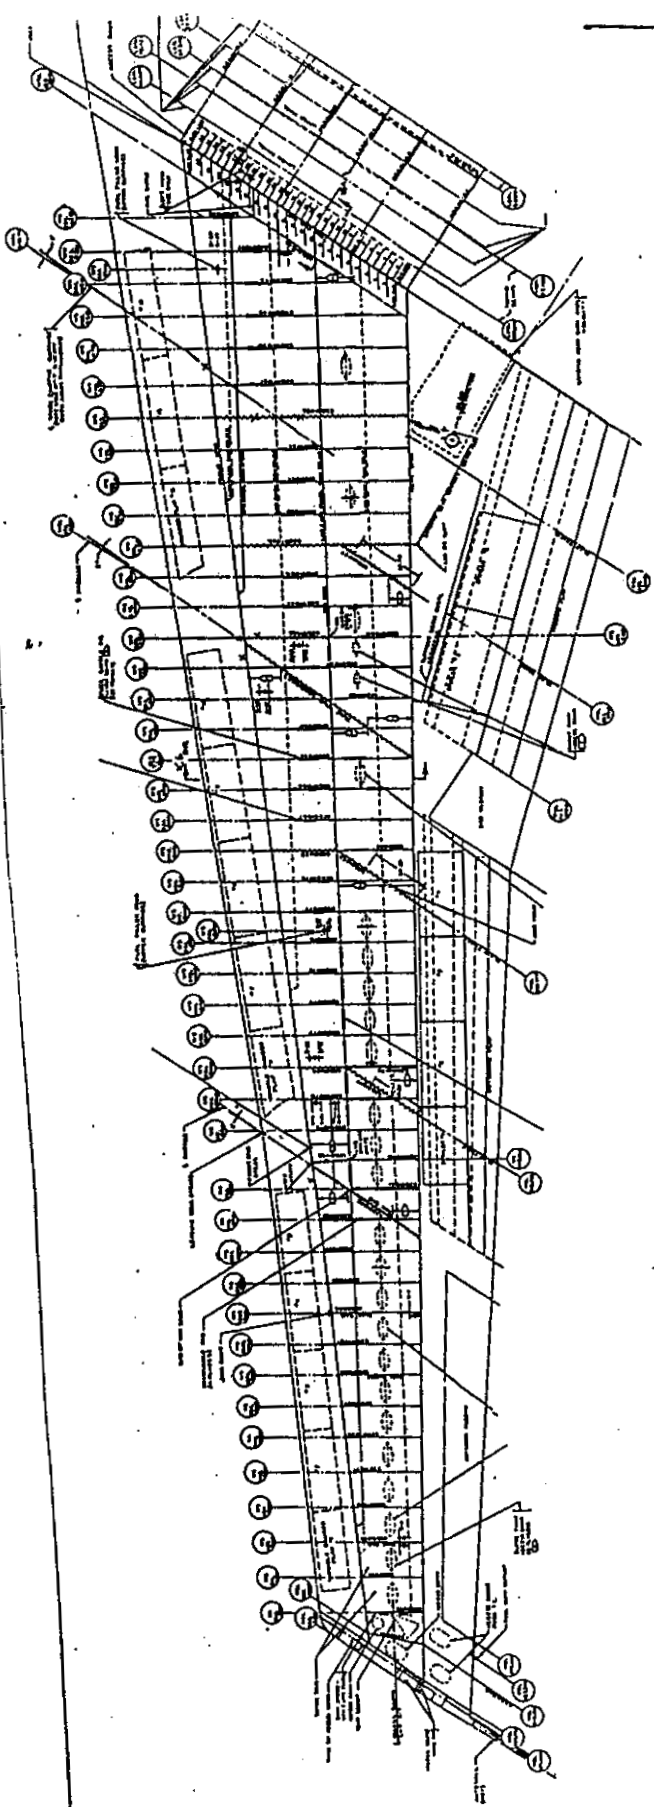
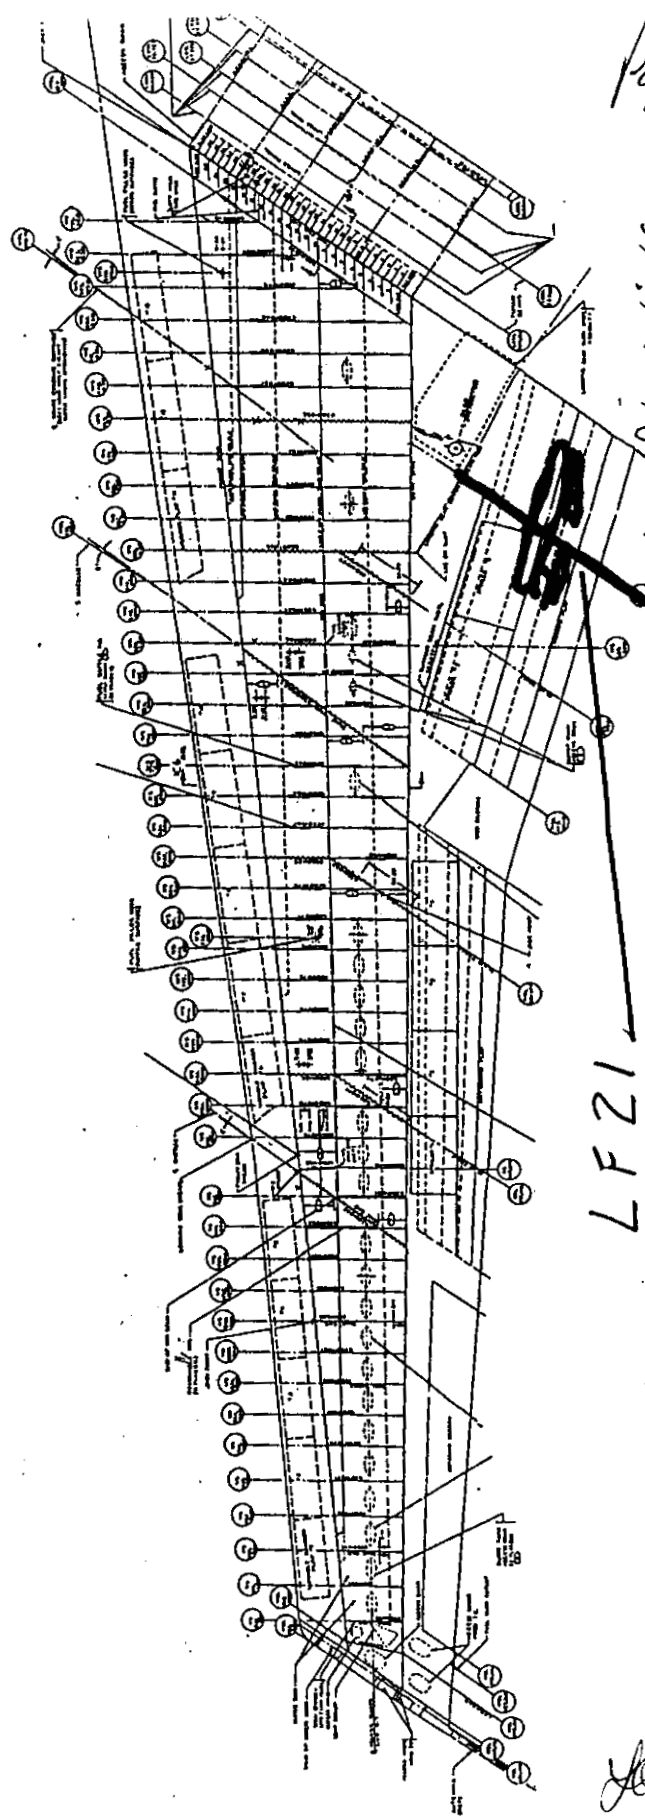
LFZ1  
(GREEN)  
TARGET #008.

Left Wing  
#4 FLAP/TRACK ASSY.
