LOG # LW-22

DEBRIS FIELD GREEN (C887)

Left Wing #3 Flap Track Assy

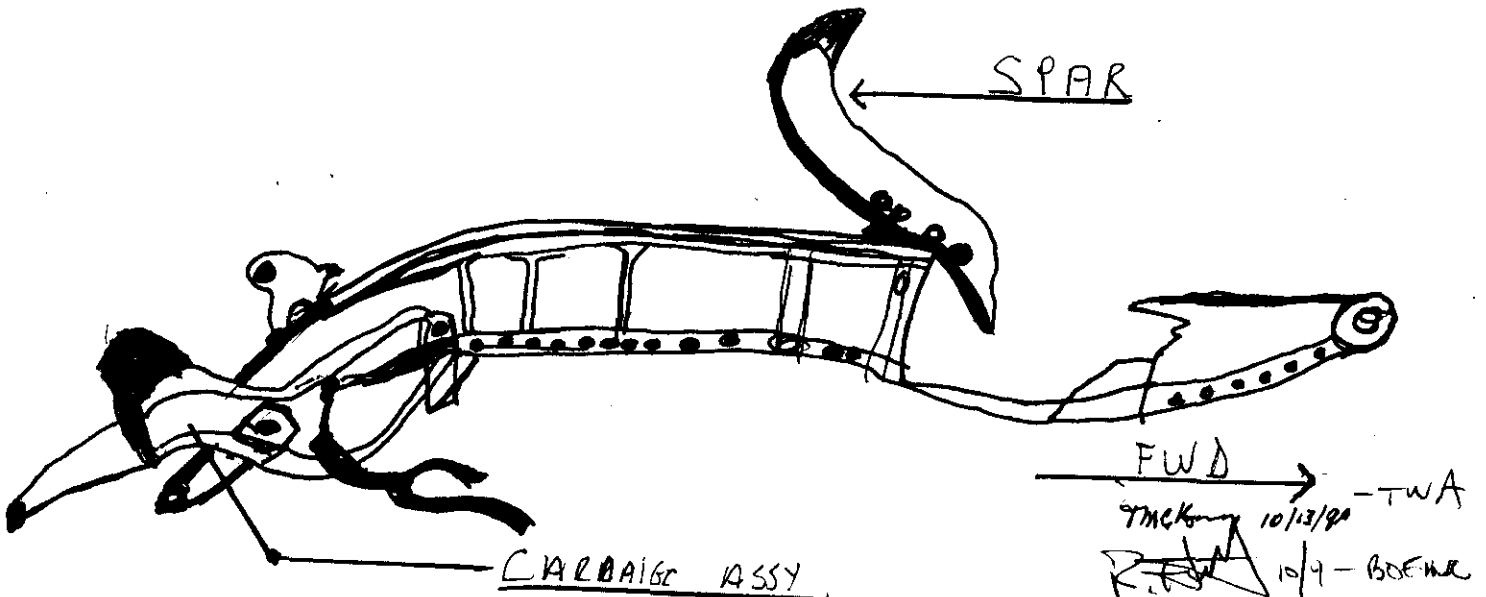
CARRIAGE ASSY

#3 Left Hand FLAP TRACK AND CARRIAGE ASSY. Fwd section has a approx. 2 foot piece missing. Mid section TOP has a section of SPAR ATTACHED (4 bolts) 3' FT Long 6" wing. Slightly curled. AFT section carriage assy is fractured AT FLAP MOUNT AREA. All mounts appear to be fractured. No burning or sooting indications

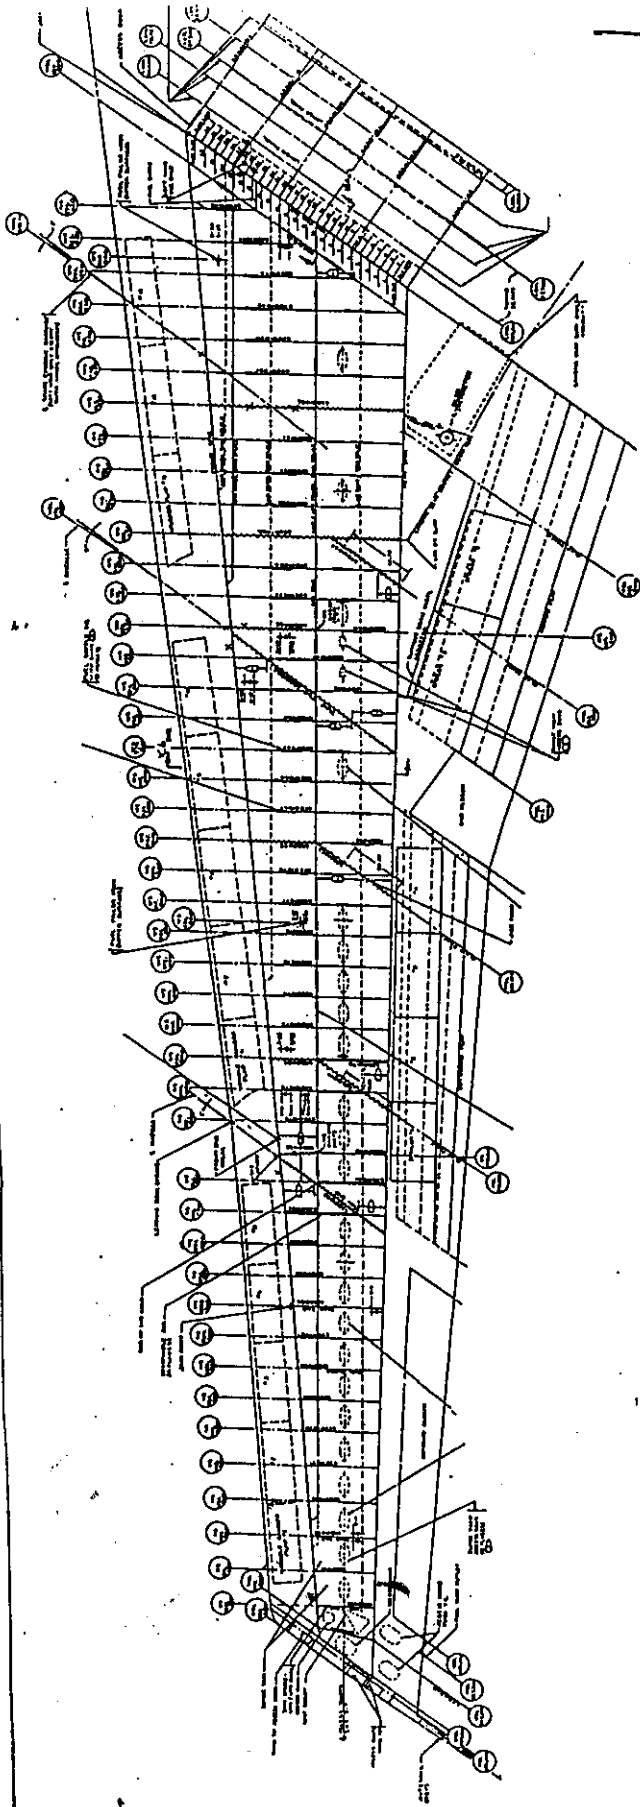
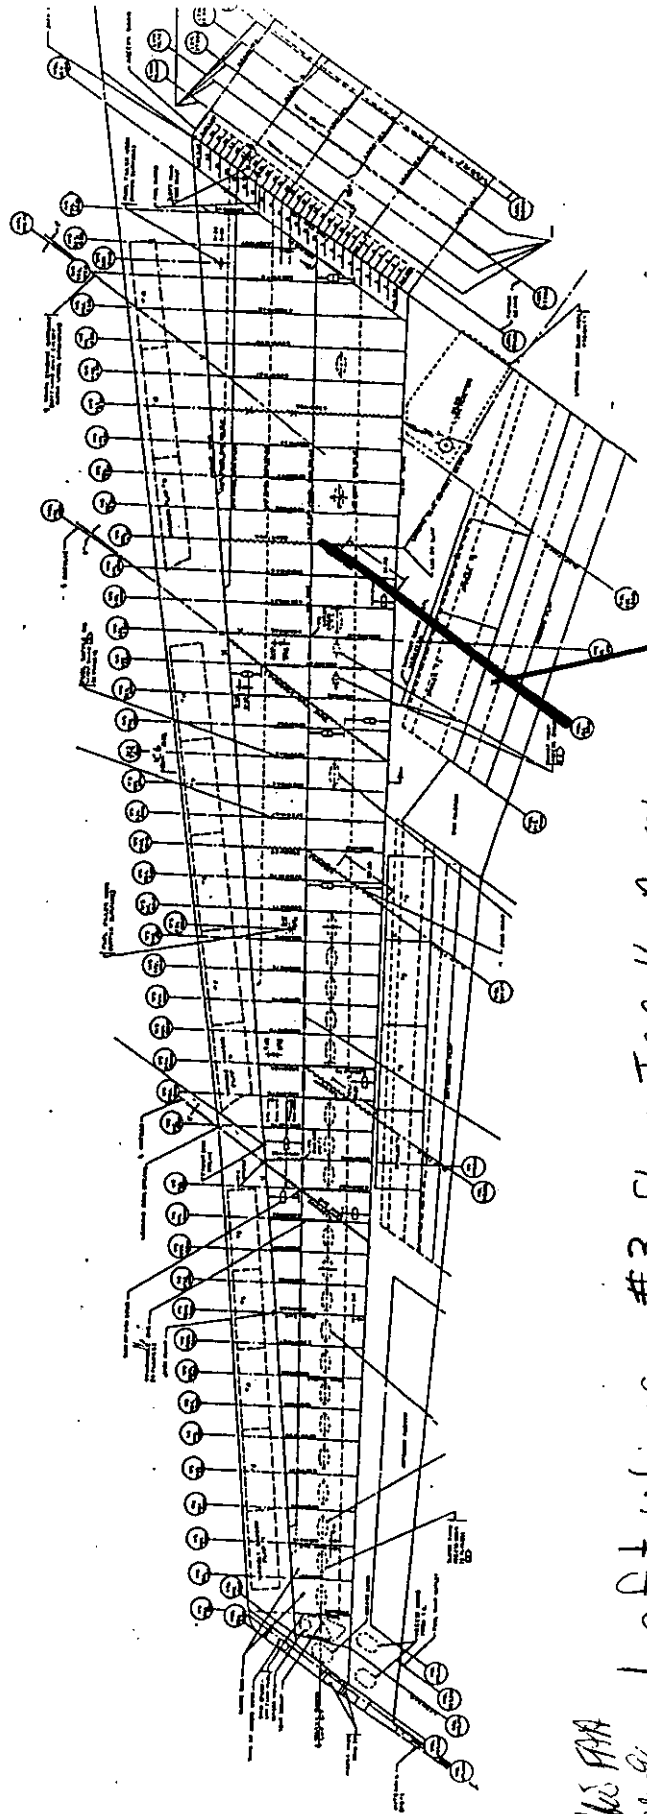
- 1) THERE ARE SOOTING INDICATIONS AT THE REAR SPAR ATTACH AREA - BOTH VERTICAL SIDES AND THE TOP.
