LOG# L	w-23	A
TARGET#_	906	1963
COORD: LAT		·

FLAP. TRACK # 1 POSITION DERRI

DEBRIS FIELD Green (906

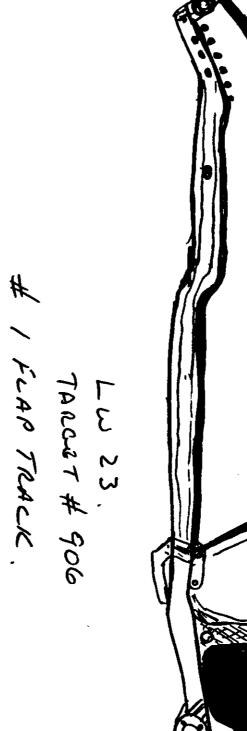
FLAP TRACK IS INTACT WITH THE EXCEPTION OF
THE YOKE ASSY. THE FLAP. GEAR BOX IS STILL ATTACHED
AN CONJECTED BY 2 STUDS AND NUTS. THE 3RD MOUNT IS
FRACTURED. THE WORE GEAR IS BROKEN OF F AT AROUT
3 to 4 INCHES FROM THE CONNECTING POINT. 3 to 4 INCHES
OF WORM GEAR IS STILL VISABLE. THE FRONT WINE
MOUNT IS STILL ATTACHED. BUT THE FSTUDS ARE STILL
ATTACHED, BUT THE NUTS HAVE SEPERATED.
APPEARS TO HAVE NO FIRE DAMAGE OR SUTTING
THE TRACK HAS A KARGE HOLE ON THE FWO-INBO
SIDE. THERE IS NO FLAP OR FLIGHT CONTROL
COMPONENT ATTACHED.

REFER FIRE AND EXPLOSION GROUP NOTES FOR FIRE DAMAGE

1) THE IS LIGHT TO MODERATE SOUTHING ON ALL SIDES OF FLANTRACK BETWEEN FURWARD MOUNT AND REAL SPAR MOUNT

2) THER IS ALSO SUDTING AT THE TRAILING & DCK BUTTON 810C
