LW-3 C-108 Green Tag Lat 40.39.47 / Long 72.37.28 Lower surface, left wing skin panel, extending from Side-Of-Body rib to WS 670, Fwd Half of Wing Skin.

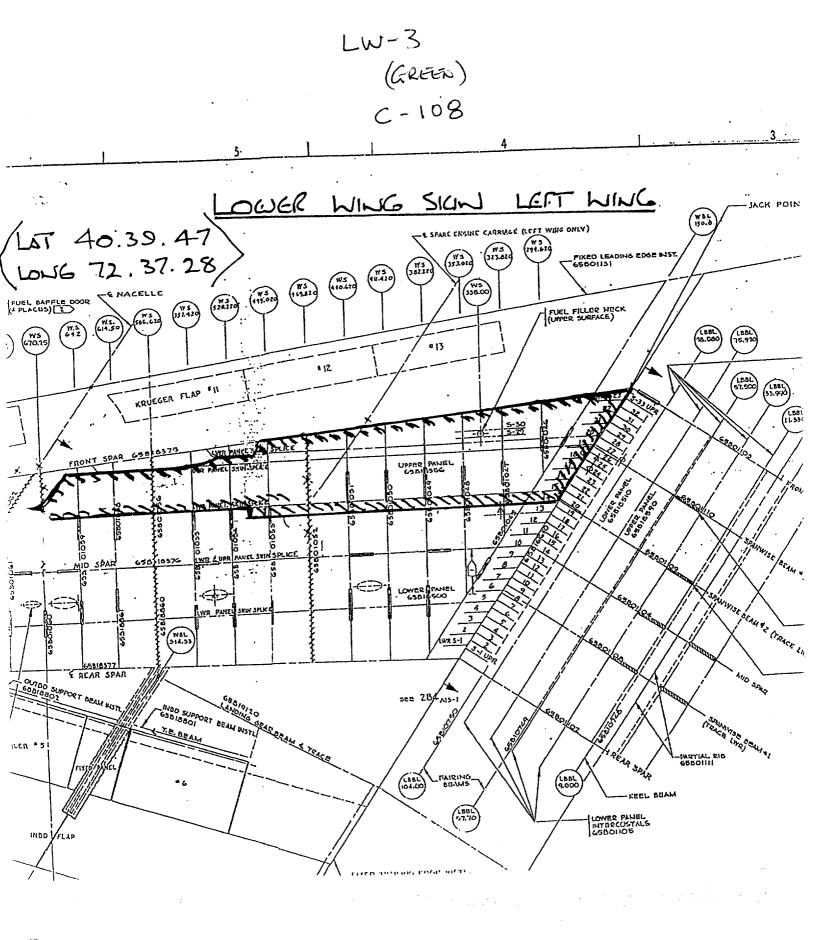
The panel includes exterior skin, some of stringers 15 to 23, and some associated clips/strap pieces attached to the stringer caps. The end fittings for stringers 15 to 23 are still attached to the skin. Some of the stringers are fractured off of the skin within the first 2 feet of the SOB rib. Two of the stringers are attached to the skin over the majority of the panel length, and are fractured at high skin curvature locations. The two remaining stringers are attached at the end fitting at the inboard end, and not attached anywhere else. These stringers extend off the panel in convoluted shapes.

The panel itself is extremely deformed: It is bent roughly 60 to 90 degrees at two locations, with the axis of curvature perpendicular to the stringer direction. The bends are such that the skin is on the inside of the radius, and the stringers are on the outside.

75% of the fasteners used to attach the stringers to the skin panels are pulled out of the skin, leaving holes that are still round, with no significant deformation. Of the fasteners that failed, and still remain, many have fractures that are flush with the skin or stringer flange surface, where others have fractures that are angled across the width of the fastener shanks. Some fastener hole elongation was identified in the wing skin at the front spar interface.

Sooting was identified on the exterior surface of the panel. The darkness of the soot residue is most extreme at the interface along the side of body, as well as from wing station WS 470 to 670. In the region outboard of the SOB, the exterior surface has a blotch texture, where paint is removed in random shapes. Remaining surface is rough.

STR NGER Panel SIDE I/B 12 Ft. DEFORMED -CURRENT RDEING REFER FIRE AND EXPLOSION GROUP NOTES FOR FIRE DAMAGE 10/ stres luftfil - M-S 10/28/96 jou gulier - FAA
