15-879

TAC # 2863

UPPER WING SKIN

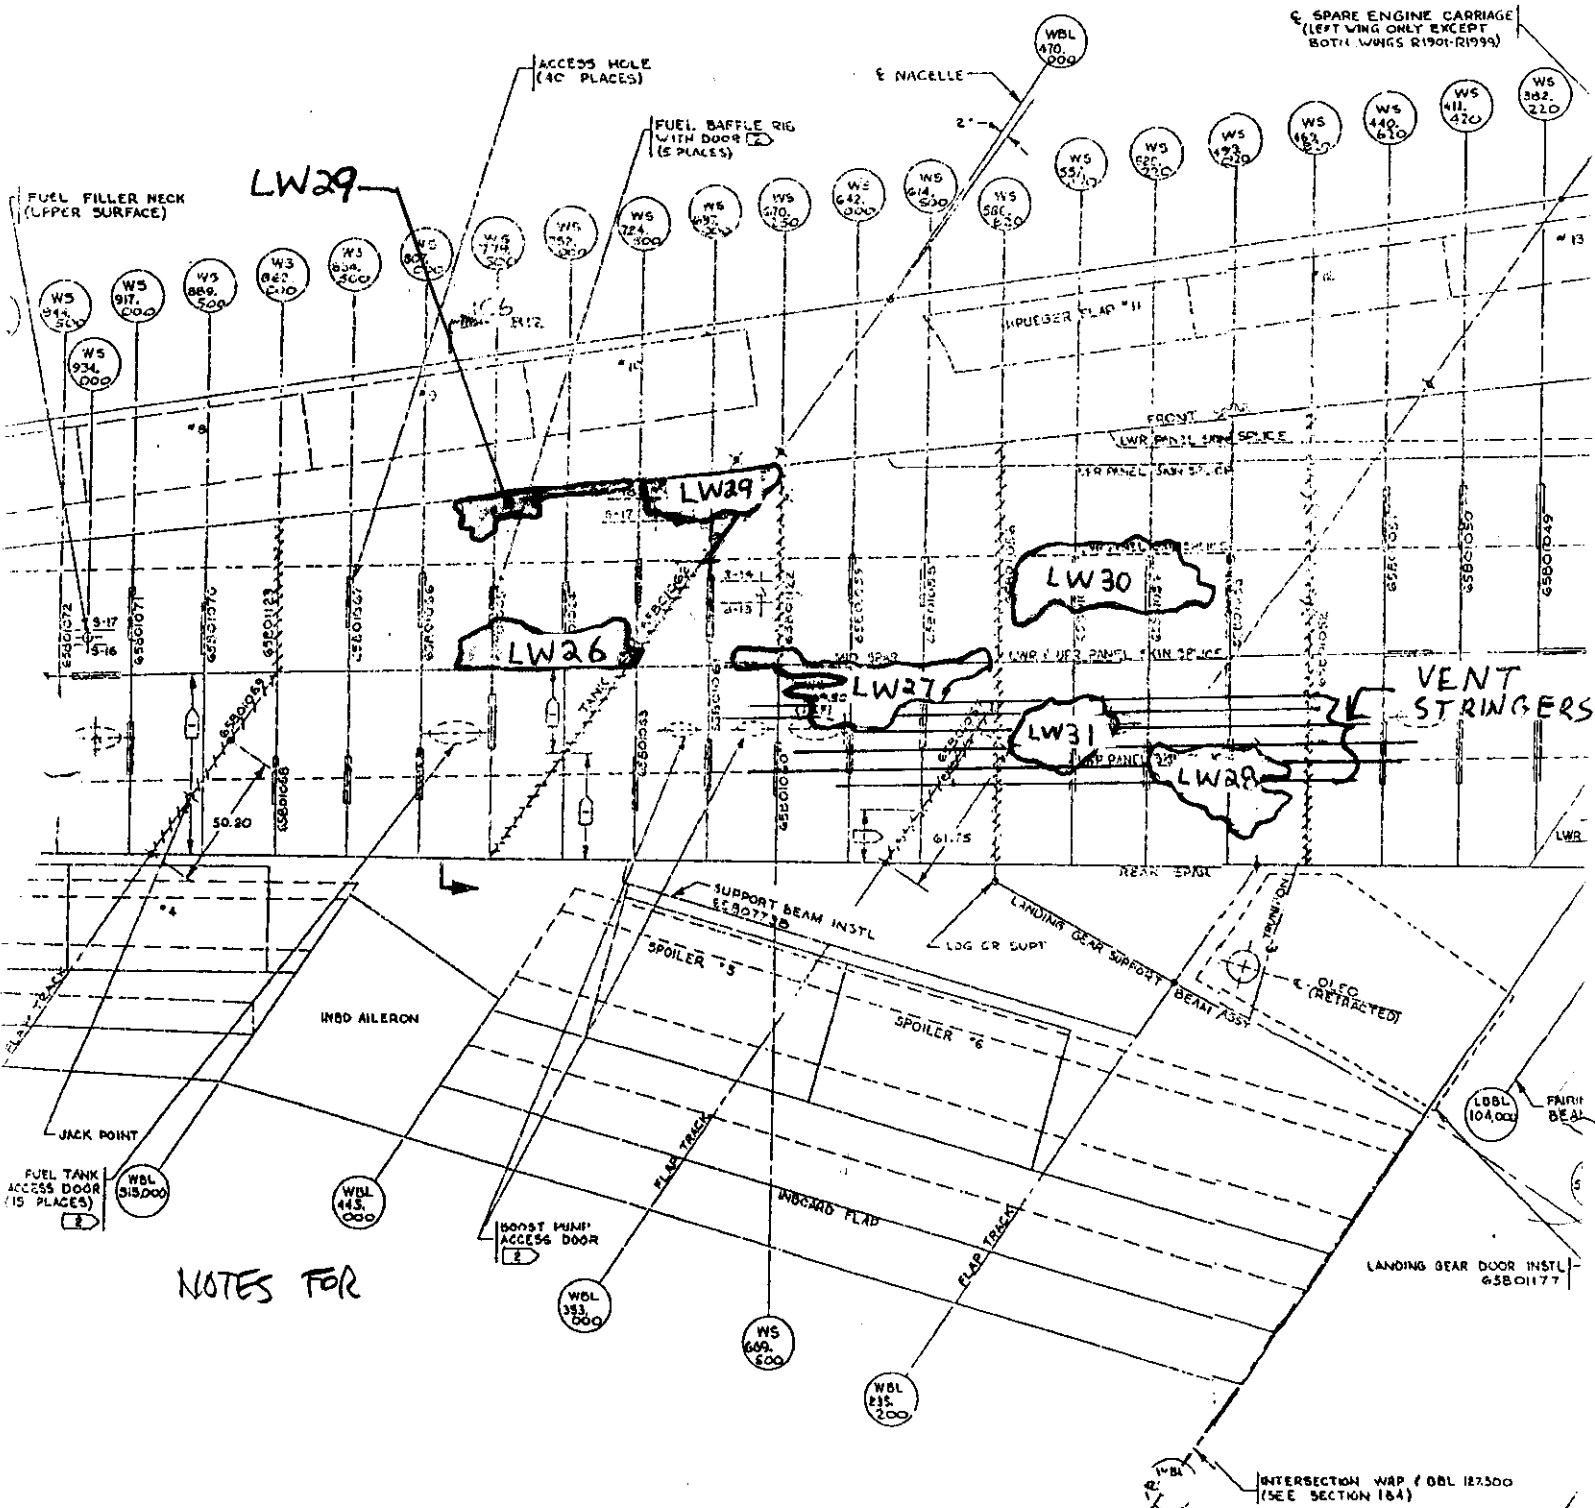
LW31

ALL ON PART OF ALL THREE.
VENT STRINGERS WERE ON THIS PANEL.
NO SMOKE OR FIRE DAMAGE.

* LOCATION OF THIS PANEL IS BEST POSSIBLE AT THIS TIME.

- A) UPPER WING SKIN FROM W.S. 554' to WS 580 AND FROM STR 7 to STR 10.*
 PANEL HAS NO STRINGERS ATTACHED AND IS BOWED 6" OVER LENGTH OF PART. VENT STRINGER AREAS BETWEEN STRINGER 6+7, 8+9, 9+10 ARE CLEAN WITH NO SIGNS OF SOOT OR FIRE
- B) SMALL PIECE OF UPPER WING SKIN ≈ 8" X 15". PIECE IS FLAT WITH NO STRINGERS ATTACHED. NO SOOT OR FIRE DAMAGE.
