LW 39
TAG # Z 2661

UPPER WING SURFACE

LW 39
 UPPER WING PANEL
 TAG# Z2661

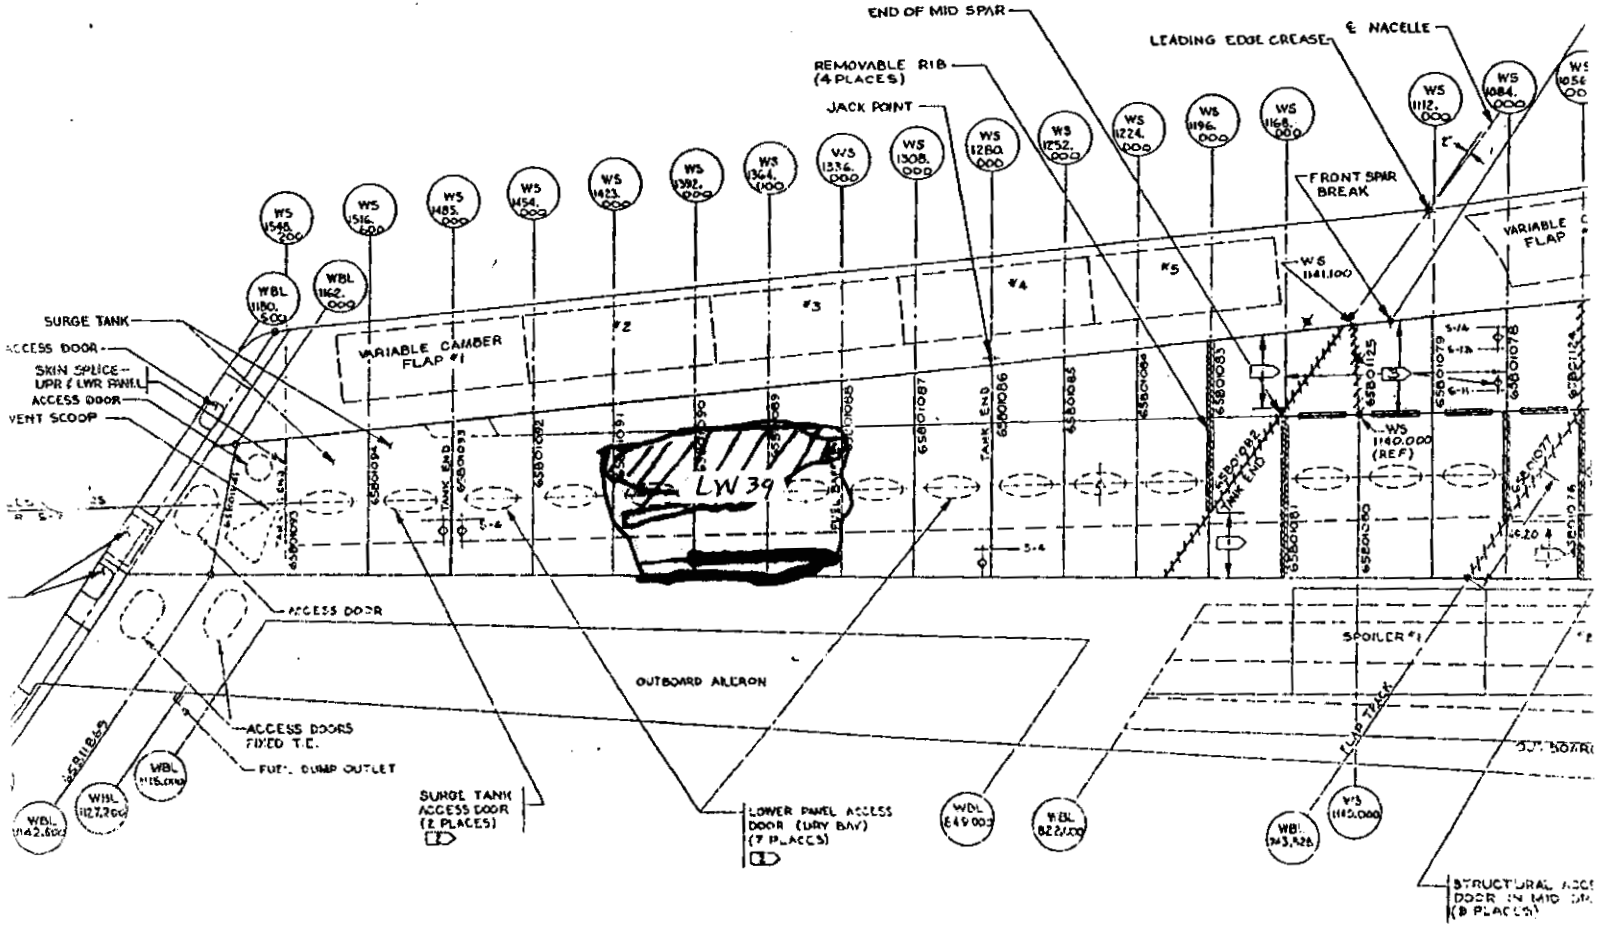
PLAN VIEW
(NORMAL TO WP10)

REFER FIRE AND EXPLOSION GROUP NOTES FOR FIRE DAMAGE

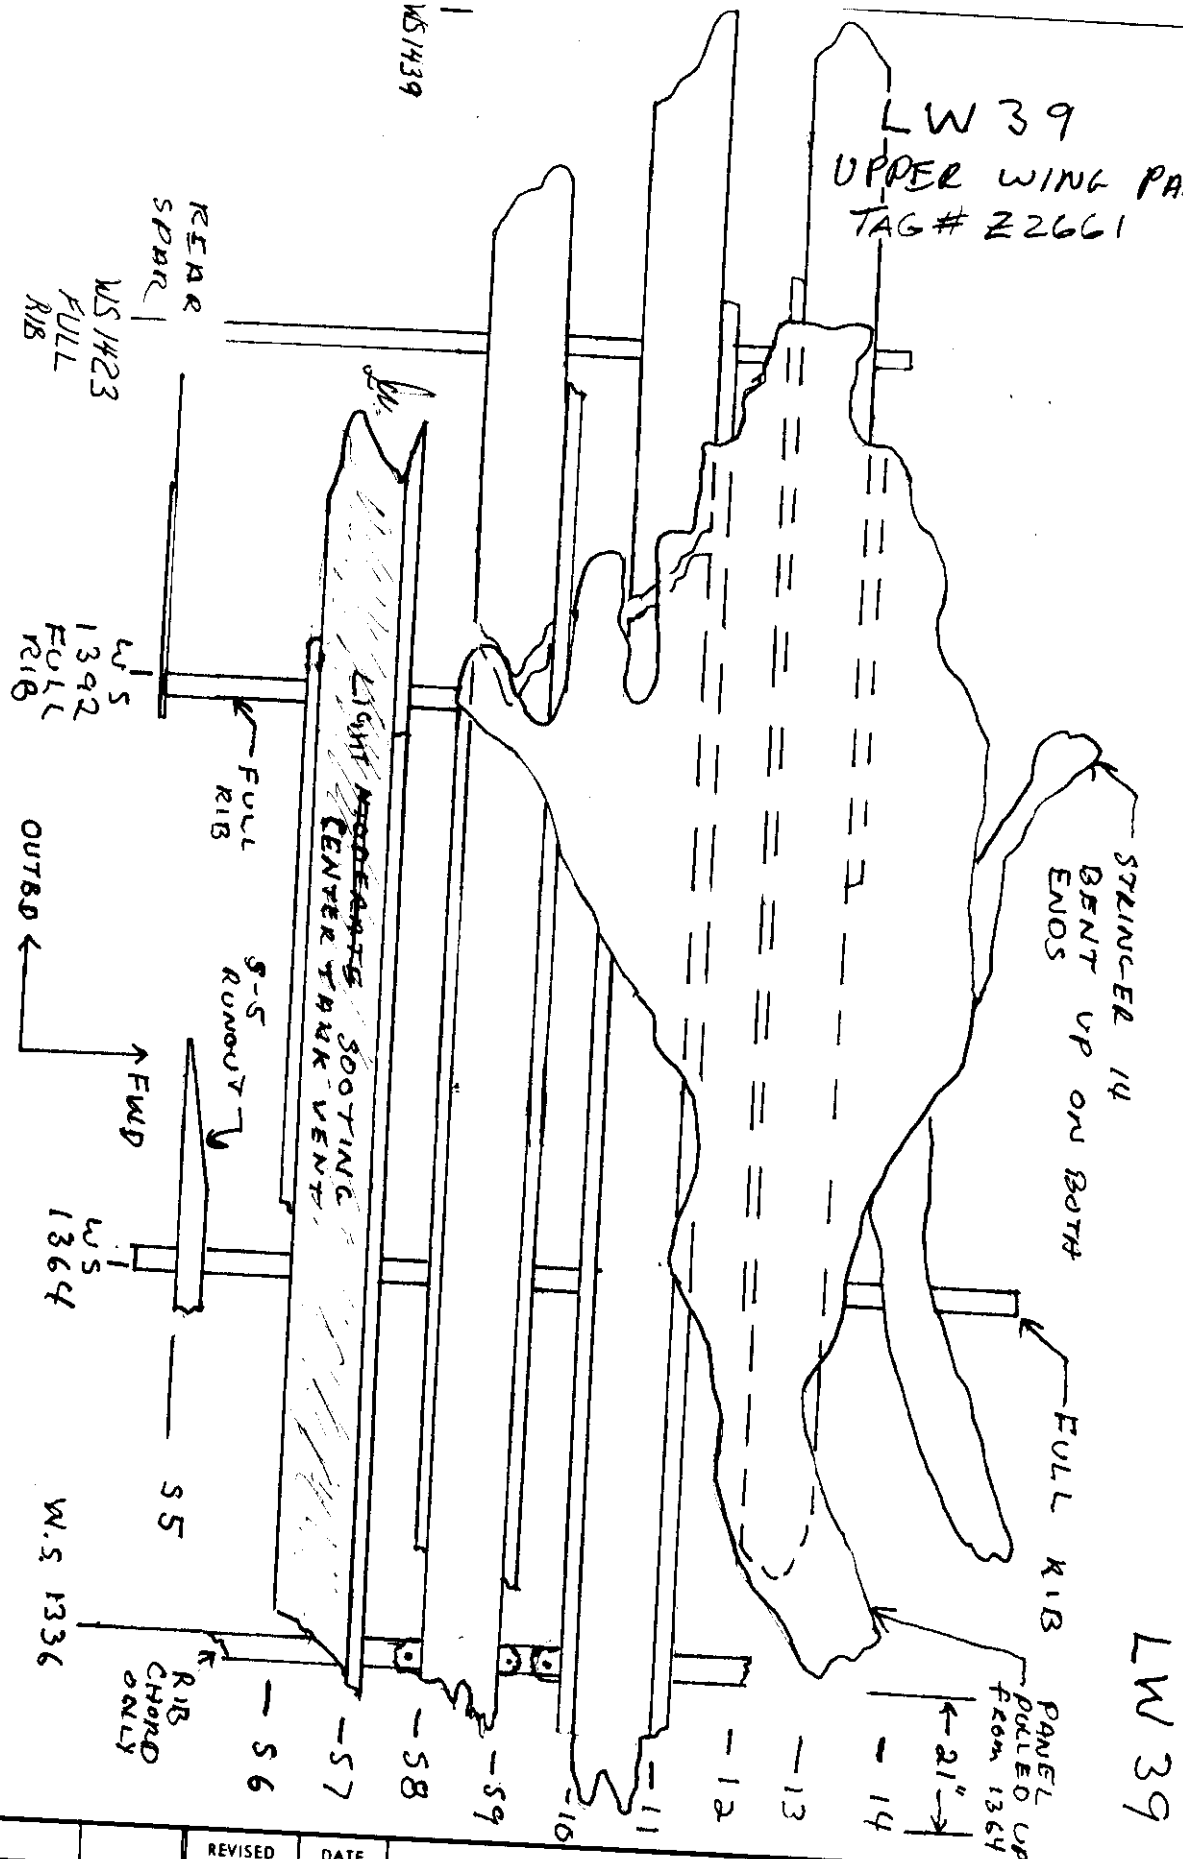
VIEW LOOKING DOWN

SKIN AND STRINGERS FROM OUTBOARD LEFT WING, PANEL GOES FROM WS 1336 TO WS 1423 AND FROM STR 5 TO STR 14.

PANEL IS GENERALLY FLAT EXCEPT FOR PIECE BETWEEN WS 1364 + 1336 WHICH IS BENT UP.

THE RIBS AT WS 1364 AND 1392 ARE COMPLETE.

LOWER PANEL IS MISSING

VENT STRINGER BETWEEN STRINGERS 6 AND 7 HAS MODERATE SOOTING, THIS IS THE VENT FOR WING CENTER TANK. THE REST OF THIS SECTION HAS NO SOOTING OR FIRE DAMAGE.
