LW-4

C-2293 Green Tag

Left wing lower surface, extending from SOB to WS 670, Aft End of Wing Skin.

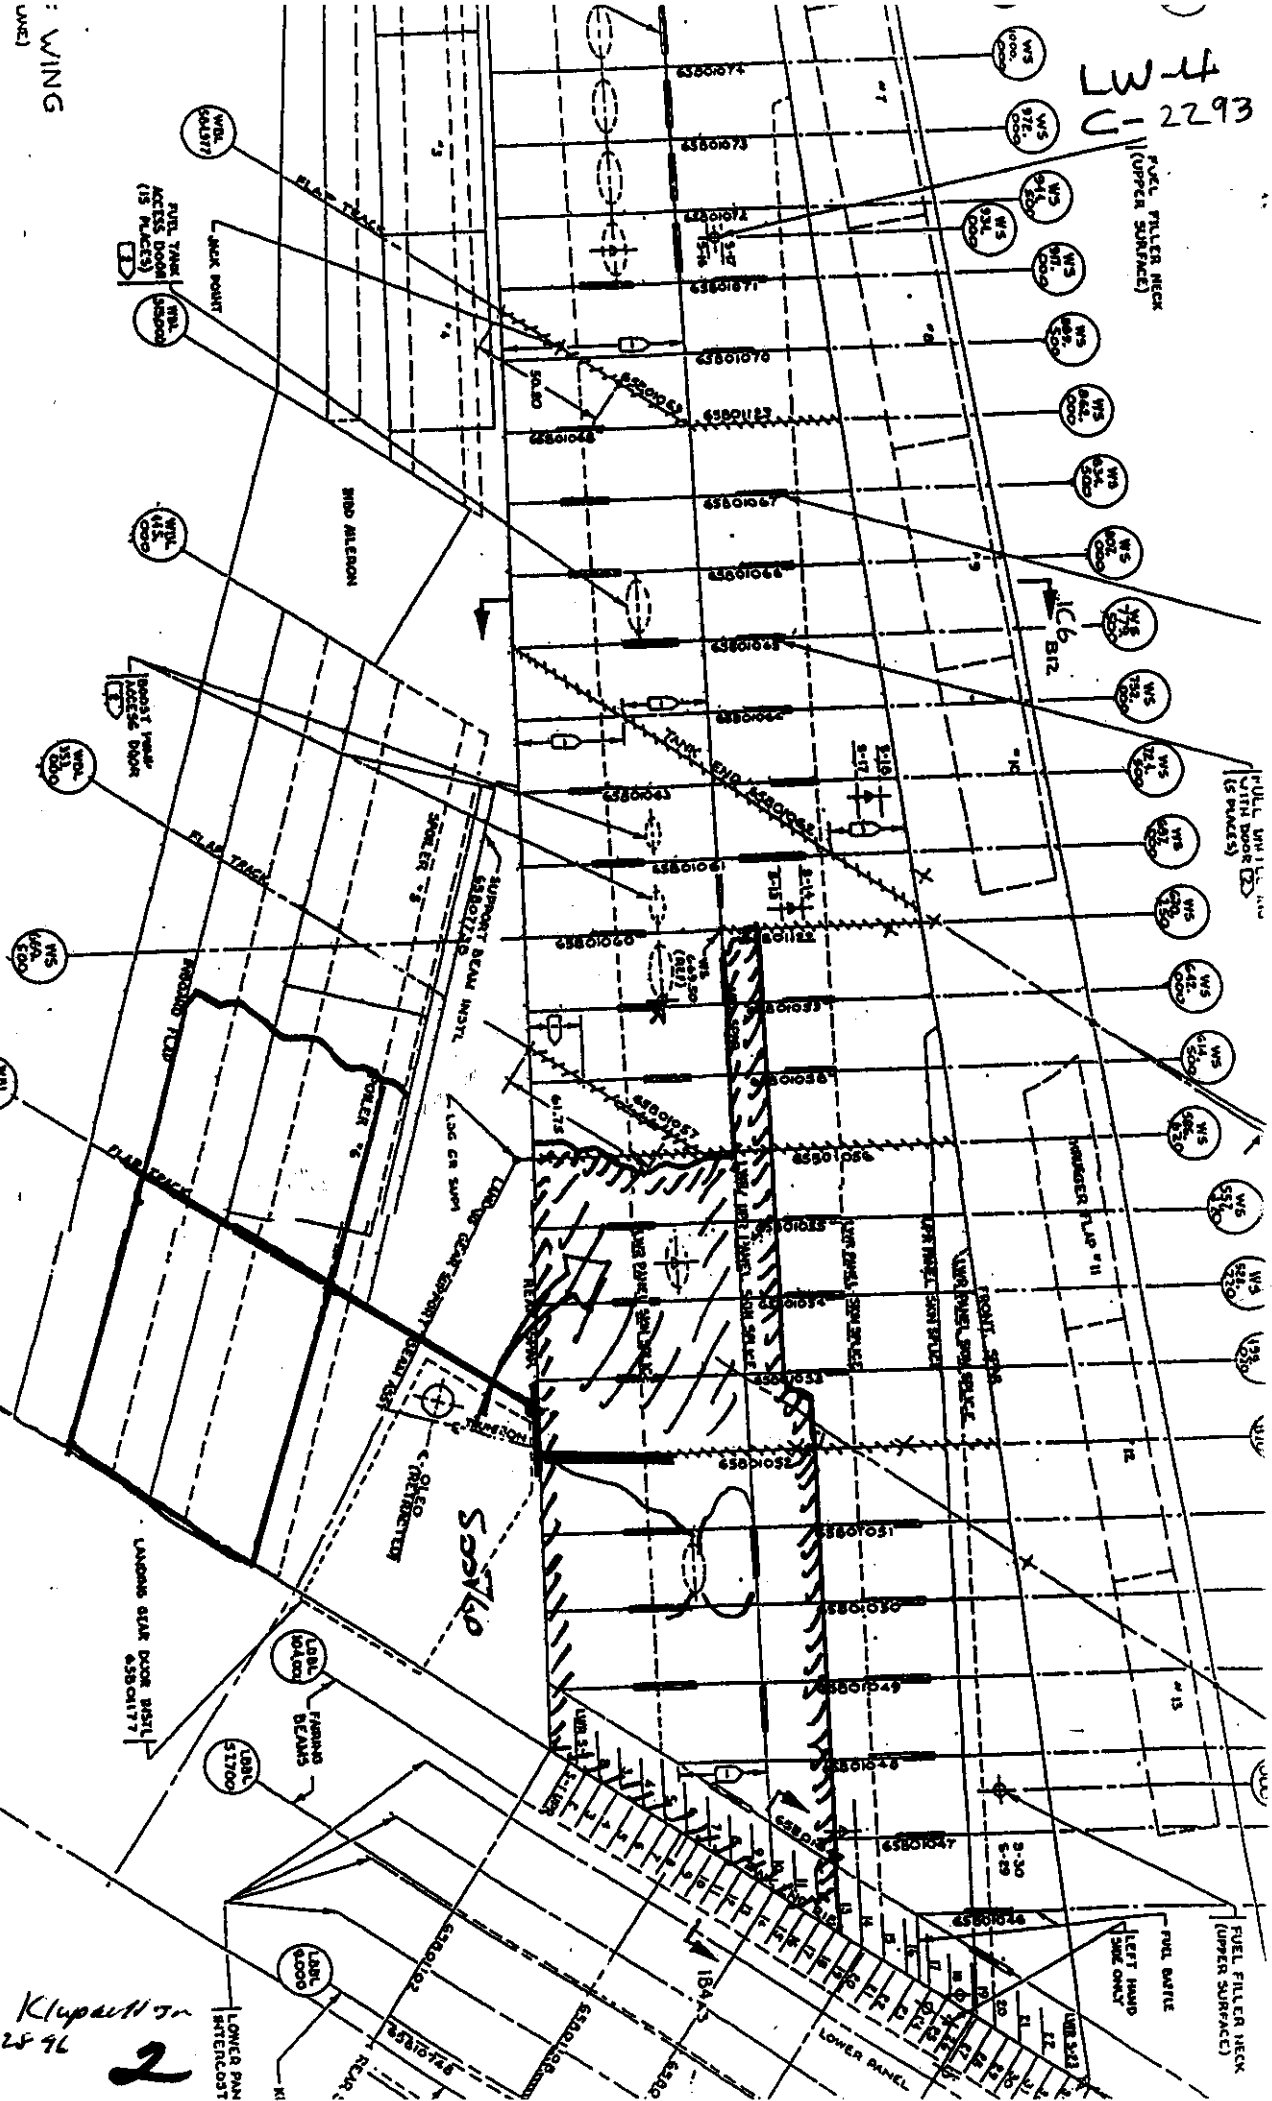
LW 4
C-2293

The panel includes exterior skin, some of stringers 1 to 14, and some associated clips/strap pieces attached to the stringer caps. The end fittings are still attached to the skin. Stringers 1,2, 10, 11, 12, 13, 14 are fractured off of the skin near the side-of-body. Two of the stringers are attached to the skin over the majority of the panel length, and are fractured at high skin curvature locations. The two remaining stringers are attached at the end fitting at the inboard end, and not attached anywhere else. These stringers extend off the panel in convoluted shapes.

The panel itself is extremely deformed: It is bent more than 90 at two locations, with the axis of curvature perpendicular to the stringer direction. The bends are such that the skin is on the inside of the radius, and the stringers are on the outside. A portion of the skin (outboard 95" of panel, front spar-to-stringer 4) is bent close to 180 (back on itself).

Many fasteners used to attach the stringers to the skin panels are pulled out of the skin, leaving holes that are still round, with no significant deformation. Of the fasteners that failed, and still remain, many have fractures that are flush with the skin or stringer flange surface, where others have fractures that are angled across the width of the fastener shanks. Some fastener hole elongation was identified in the wing skin at the front spar interface.

Sooting was identified on the exterior surface of the panel. The darkness of the soot residue is most extreme at the interface along the side of body, as well as from wing station WS 470 to 670. A portion of the exterior surface at the inboard few feet of this panel, between stringers 1 and 4, exhibit a rough / blotched surface texture. In the blotched regions, the skin has been removed.

The access door, located closest to the SOB is ^(print?) gone, with the frame in place. A portion of the interior face sheet of the panel is still in place, and covers roughly 25% of the opening. The other inspection panel and frame are missing entirely.
