LW-46 Z3123

(9-10-96-4) GREEN TAG

LEFT WING LOWER SURFACE

WS 670 TO 557, MID SPAR TO STRINGER 8.

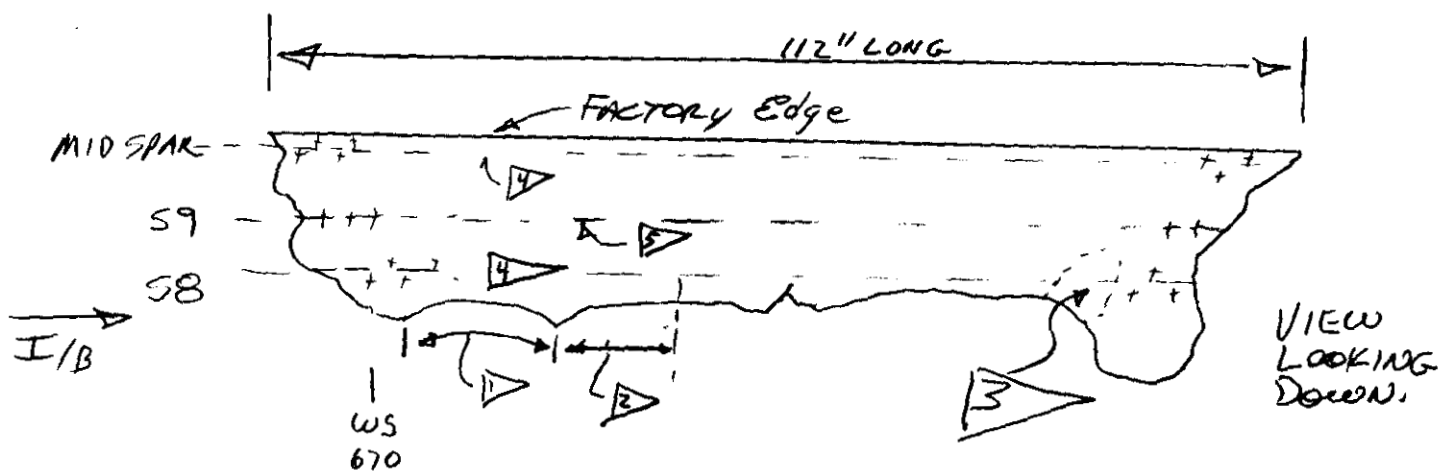
EXTERIOR OF PART HEAVILY SOOTED EXCEPT IN REGION 3

FRACTURE SURFACES VARY BETWEEN JAGGED, AND ANGLED.

FRACTURE SURFACES DARKENED. VISUAL INSPECTIONS NOT CONCLUSIVE OF SOOT

- 1 ▷ FACTORY Edge OF ACCESS PANEL CUT-OUT
- 2 ▷ UNIQUE FRACTURE FACES MATCH FRACTURES ON LW2
- 3 ▷ UN-SOOTED REGION CONSISTENT WITH FLAP UNDERWING FAIRING (EXTERIOR SIDE)

4 ▷ MID SPAN AND 58 MOSTLY MISSING, Hole Elongation SPANWISE DIRECTION $\pm 45^\circ$

5 ▷ FASTENERS MOSTLY IN PLACE, sheared off flush w/surface

- NFB
 SPANWISE KEYHOLE FRACTURE
 PAN 10 25-96

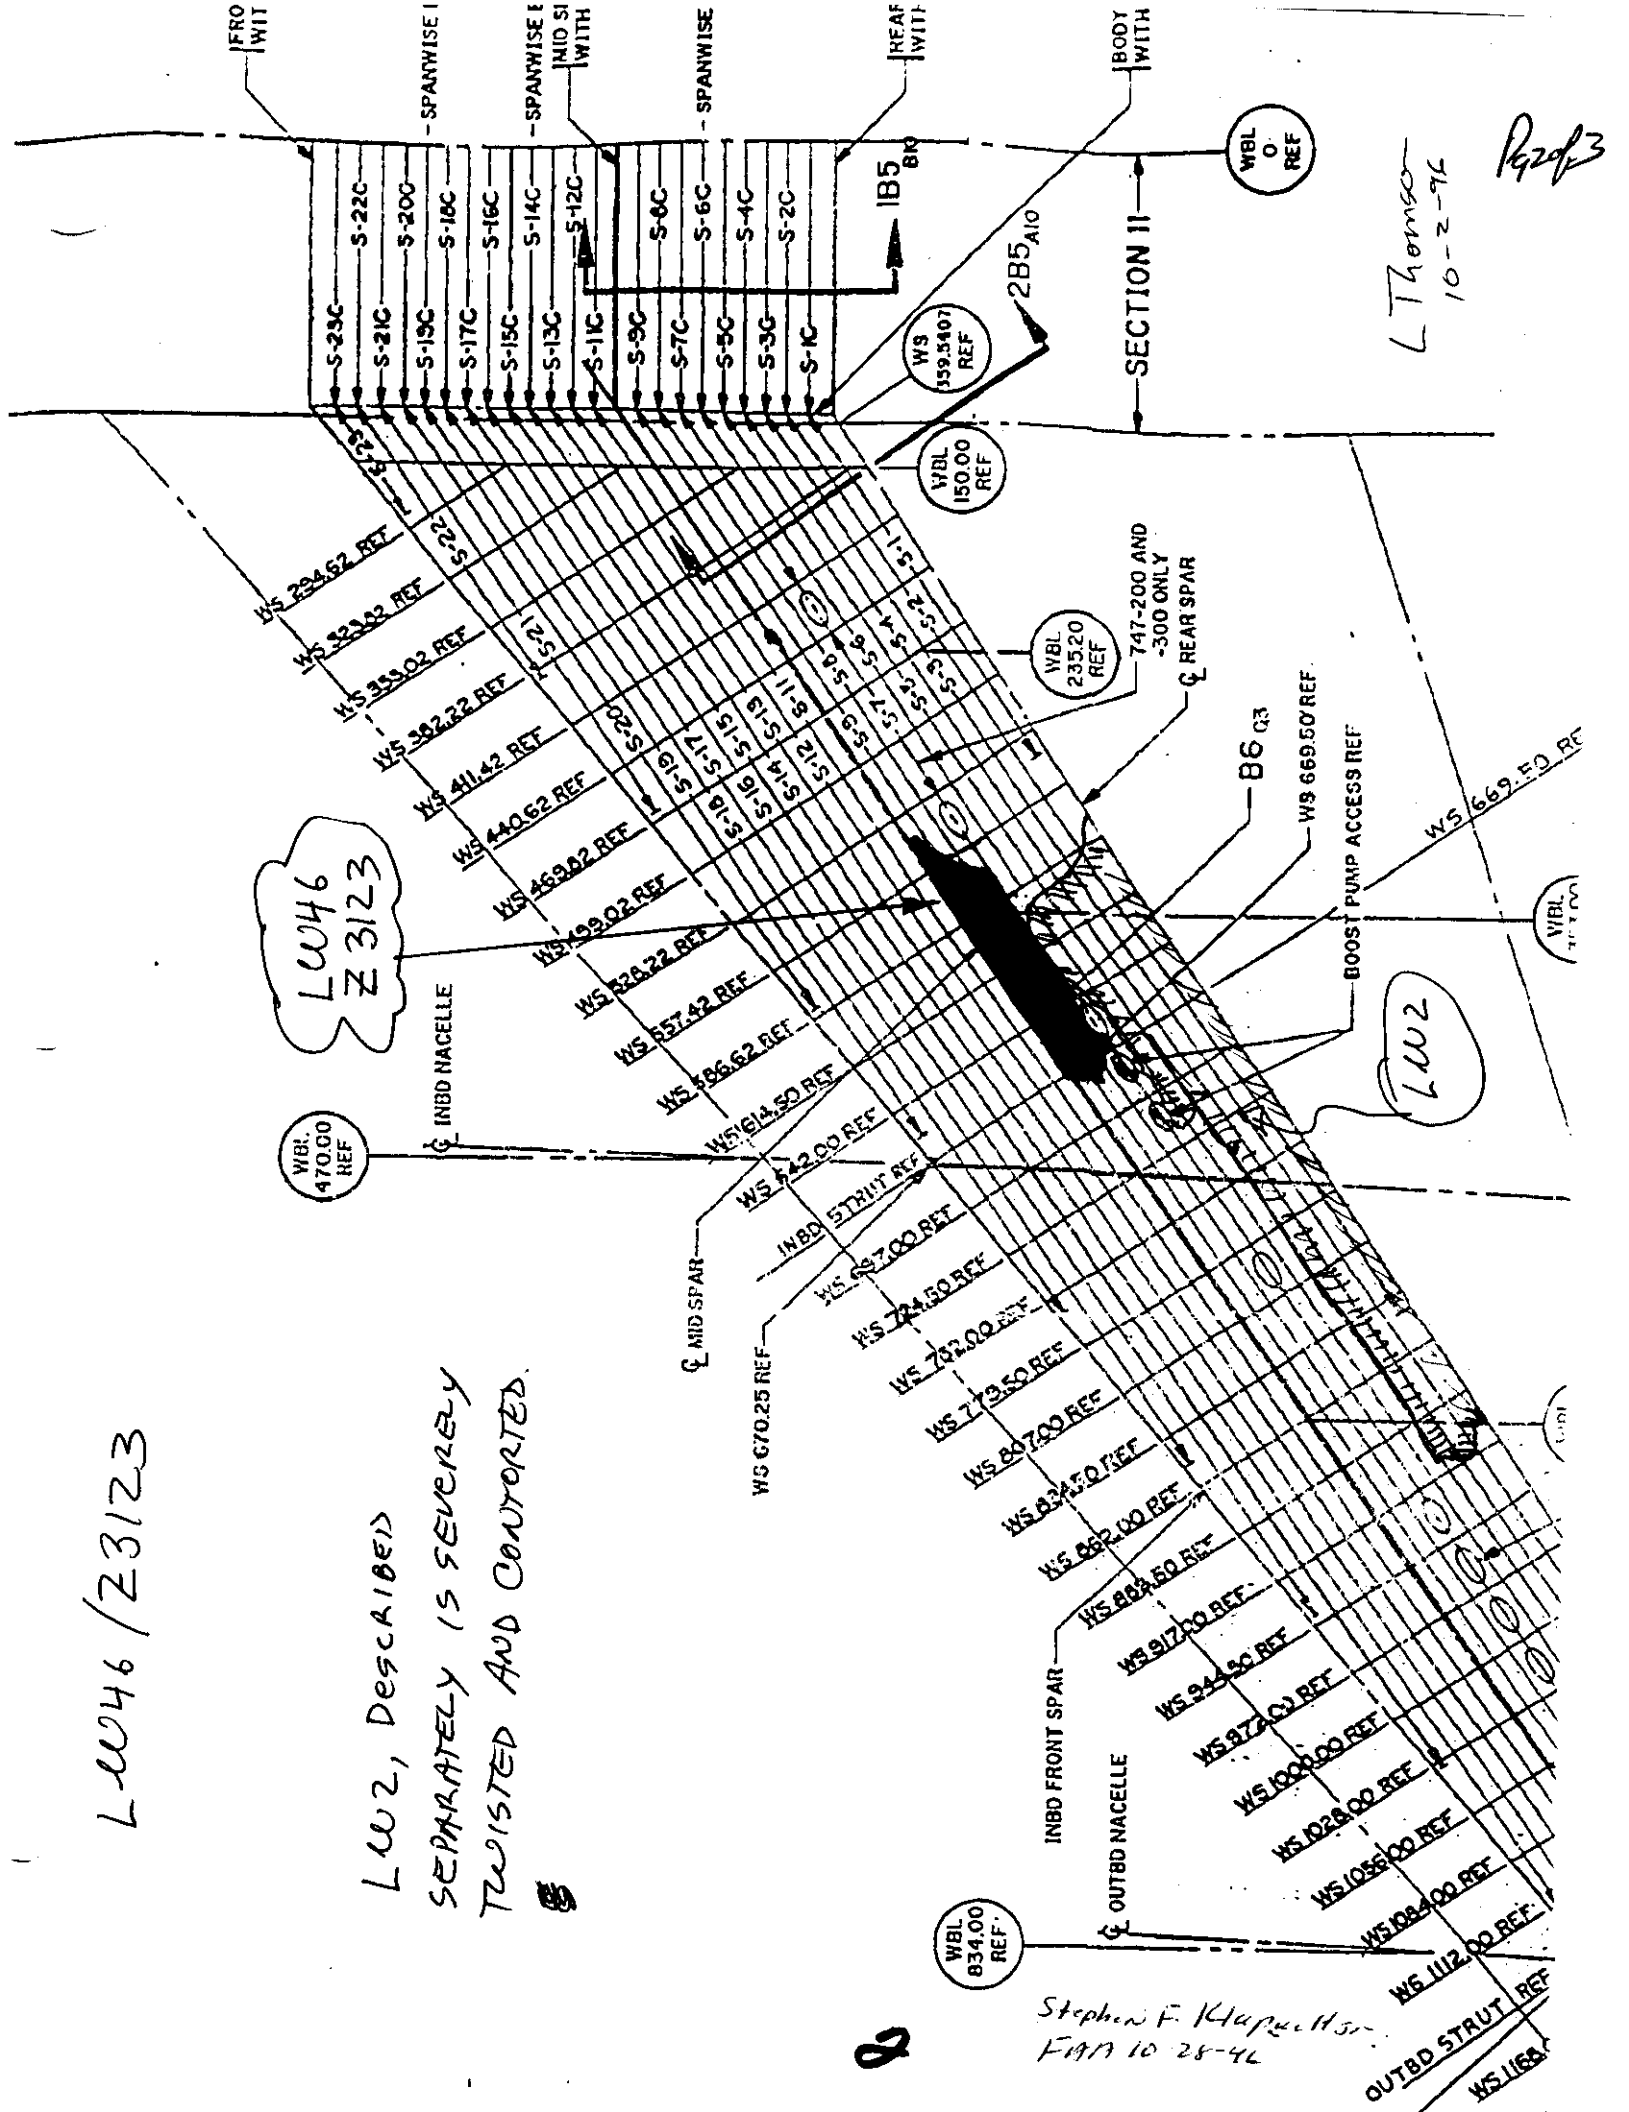
LW46
Z3123

LW2, DESCRIBED SEPARATELY IS SEVERELY TWISTED AND CONVORTED.

1. Chordwise shear tie bolts at approximately WS 600 remain in place. Shear ties are partially to mostly missing. Bolts exhibit no bending, ~~tho~~ ~~tension failure of shear tie attachment.~~
