LW-9  
C-876  
GREEN

LW9

P1315

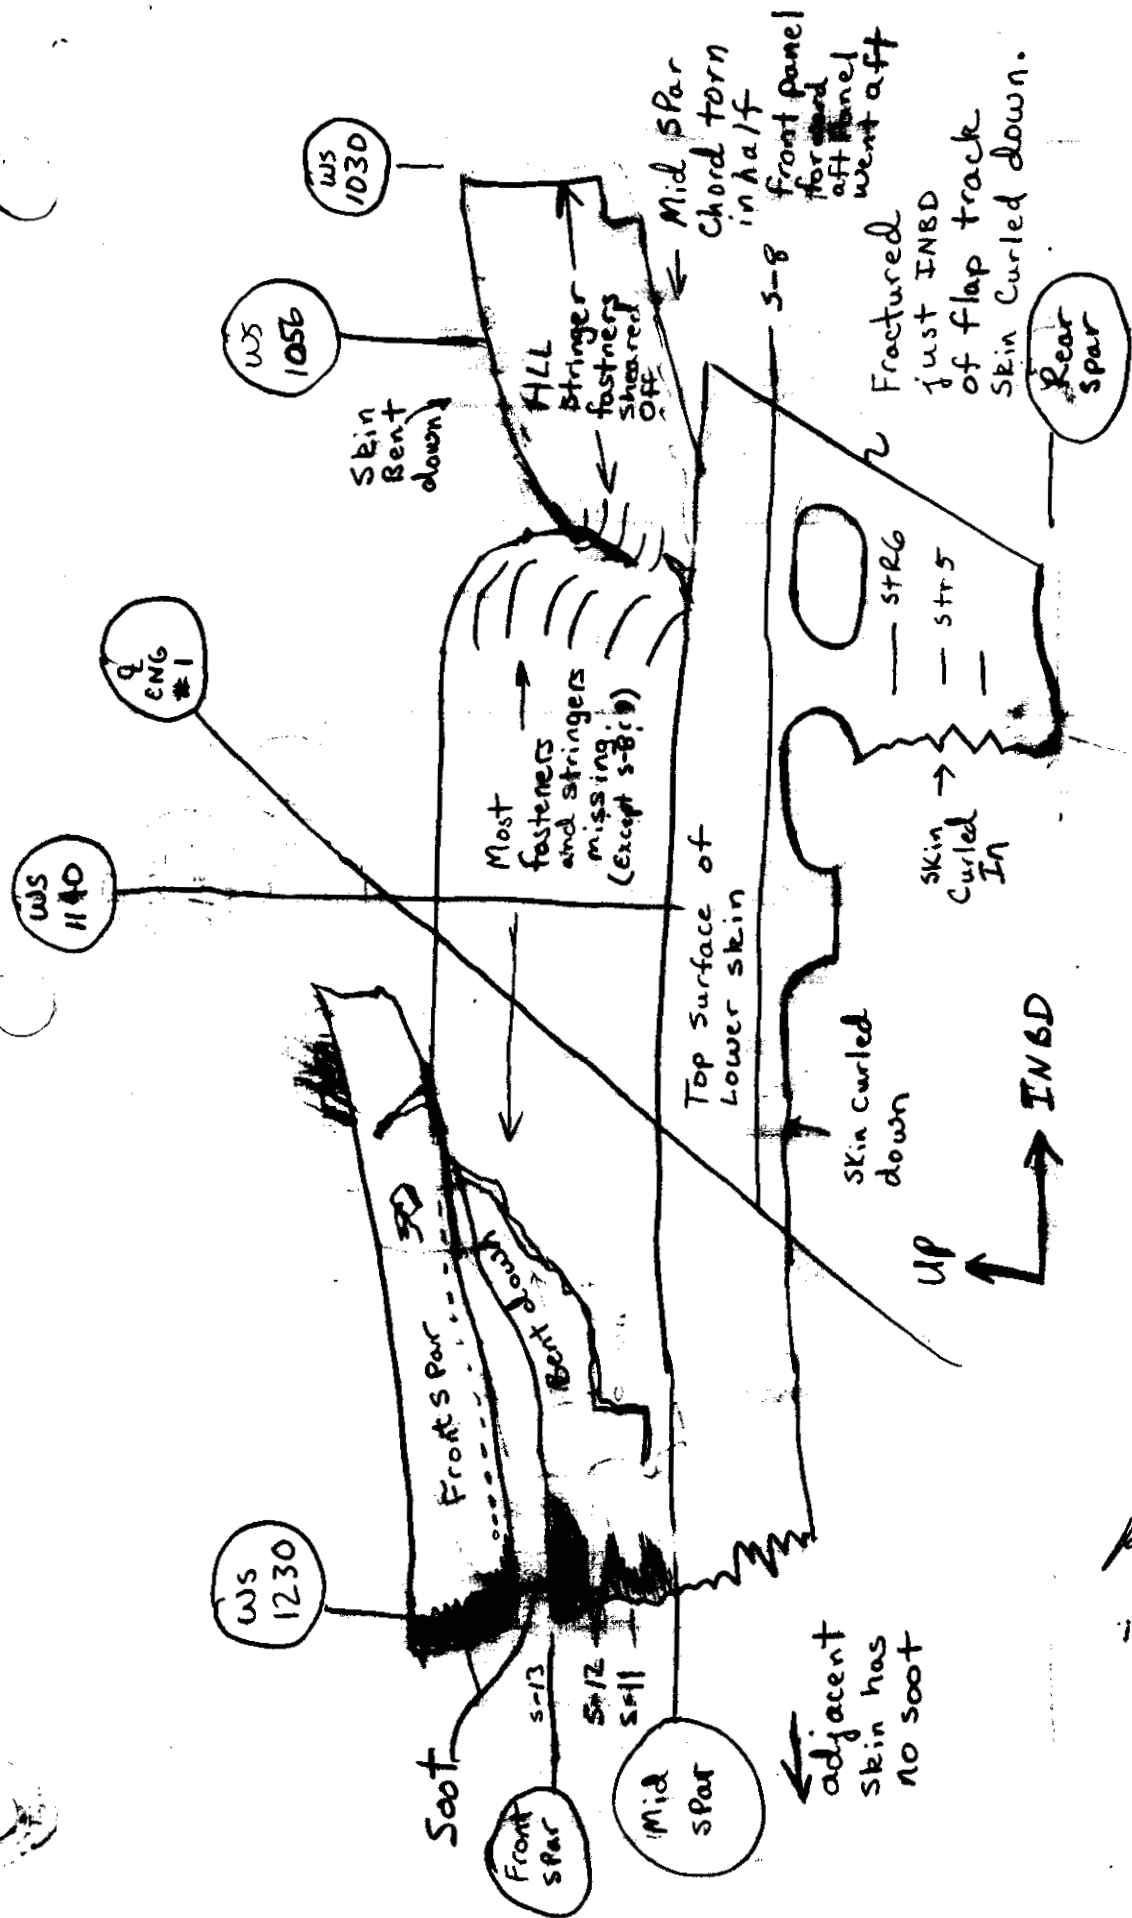
- 1) THERE IS A LIGHT COATING OF SOOT ON THE FRONT SPAR AT FSSO 1168 AND ON THE PYLON ATTACH FITTINGS -(OUTBOARD MID SPAR).
- 2) THE FOLLOWING PYLON ATTACH FITTINGS ARE HEAVILY SOOTED:
  - A) INBOARD UNDERWING FITTING
  - B) INBOARD MIDSPAR FITTING
  - C) THE AFT AND UNDERSIDE SURFACES ON THE OUTBOARD MID SPAR FITTING
  - D) MID SPAR SIDE LOAD FITTING
- 3) EXTENSIVE BURN DAMAGE ON ATTACHED INTERNAL PYLON SHEET METAL
- 4) THE FRACTURED SURFACES OF THE PYLON WITHIN THE MIDSPAR FITTINGS ARE HEAVILY SOOTED
- 5) THE OUTBOARD MIDSPAR PYLON FITTING HAS LEFT AN IMPRESSION AFT OF THE ATTACH PIN ON THE OUTBOARD UNDERWING FITTING
- 6) THE INBOARD MIDSPAR PYLON FITTING HAS LEFT AN IMPRESSION FORWARD OF THE ATTACH PIN ON THE INBOARD UNDERWING FITTING
- 7) UNDERWING ATTACH LUG FOR THE SIDE LOAD BRACE IS FRACTURED ~~LATERALLY~~ LATERALLY

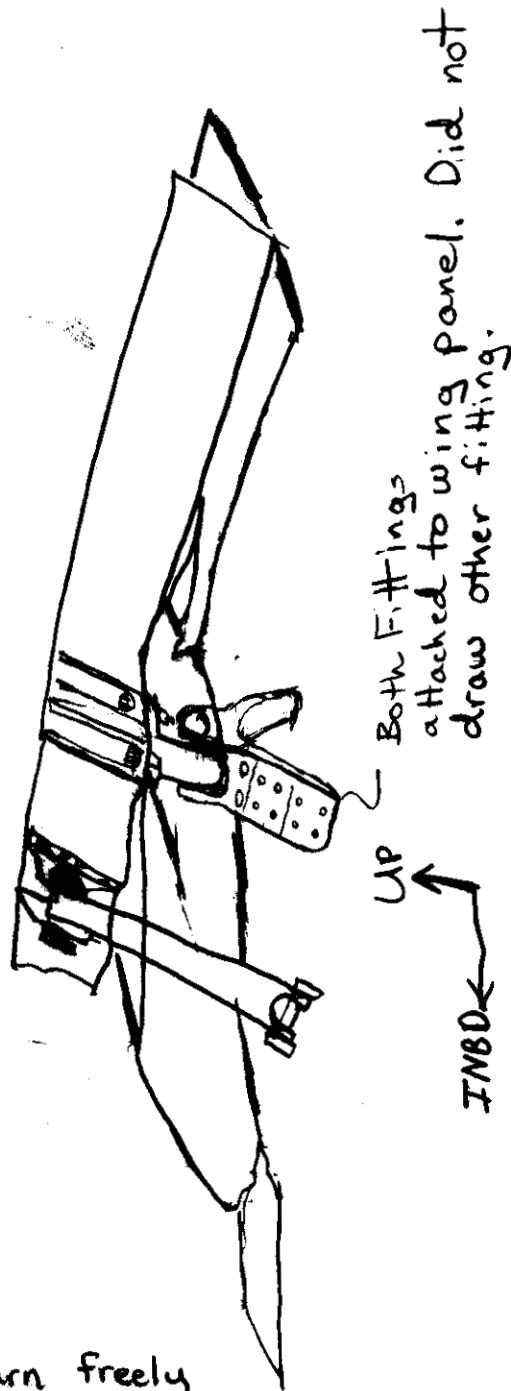
View looking aft  
at front spar

- Fuse Pins turn freely
- No soot on Front face of Front Spar
- Lower Surface of wing heavily sooted inboard of Nacelle fittings
- Small brackets between Nacelle fittings are burned
