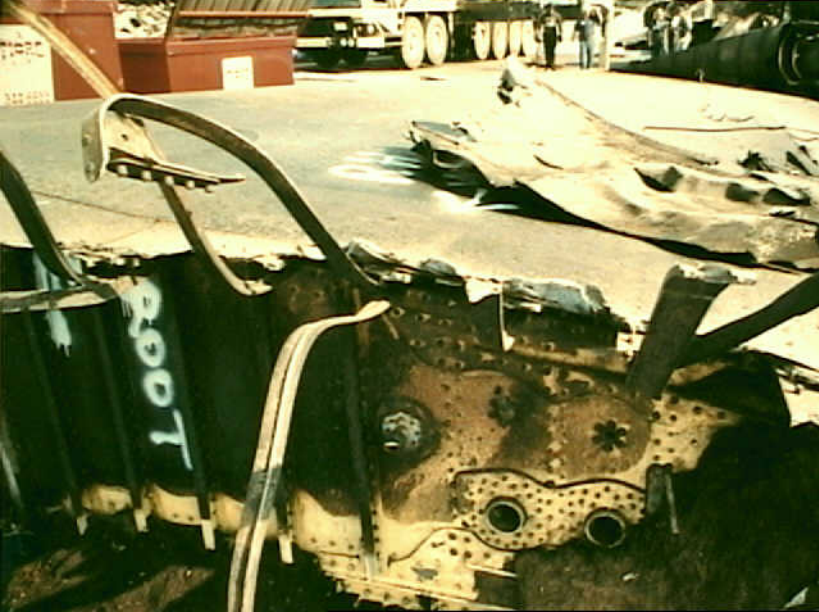
Structures 7 - Photo 10. Close-up view of right wing  
Note: fractured stringers bent upwards
