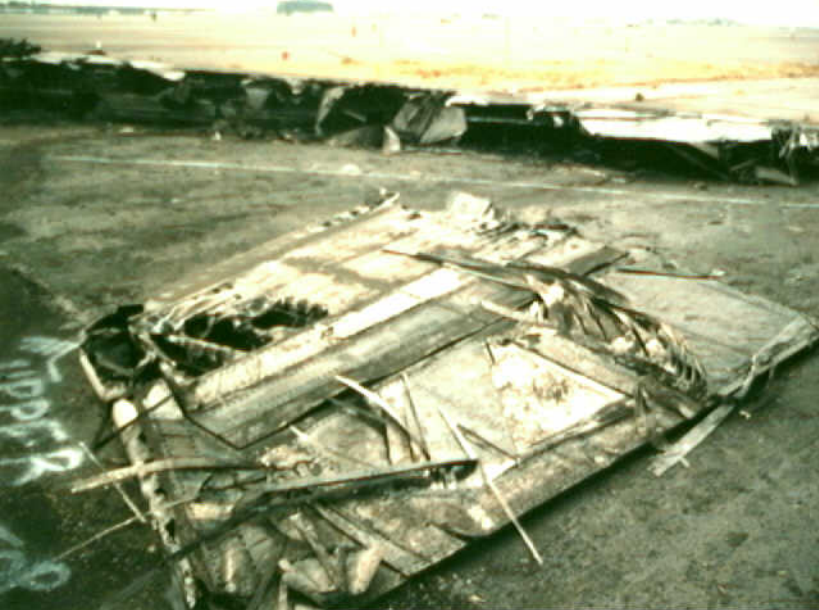
Structures 7 - Photo 14. View of burned outboard section of right horizontal stabilizer
