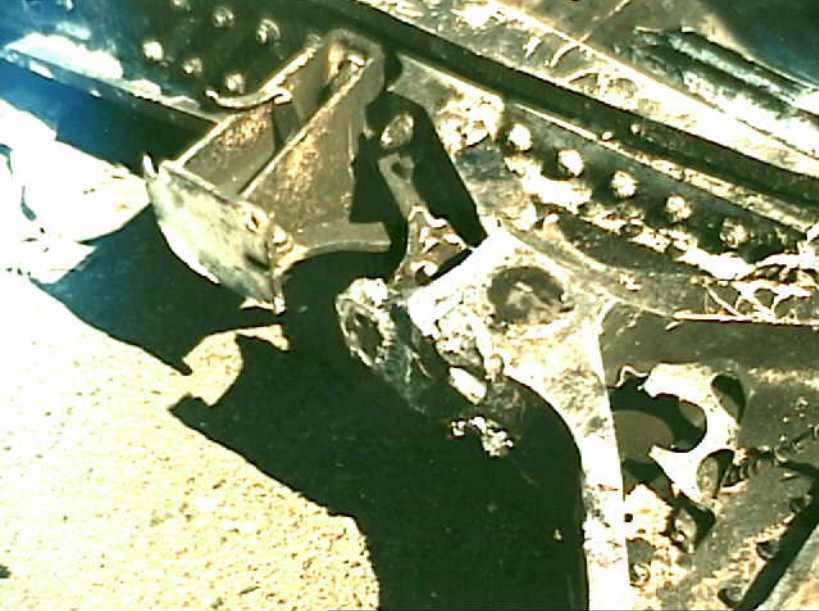
Structures 7 - Photo 19. View of fractured right landing gear trapezoidal panel
