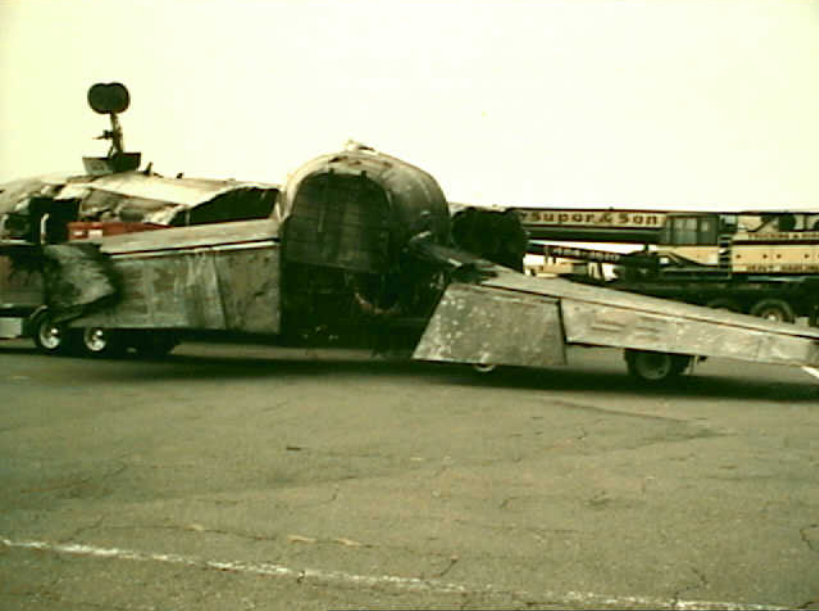
Structures 7 - Photo 4. View of the empennage and damaged outboard end of the left horizontal stabilizer
