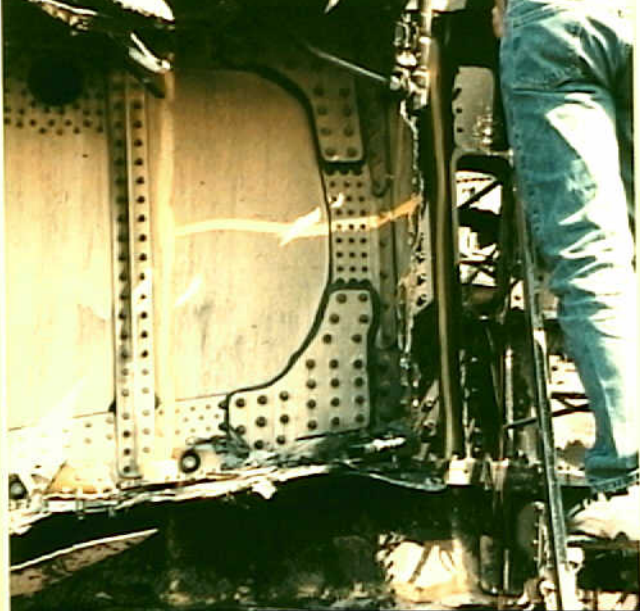
Structures 7 - Photo. 11 - View of fractured inboard right wing root at side of body.
