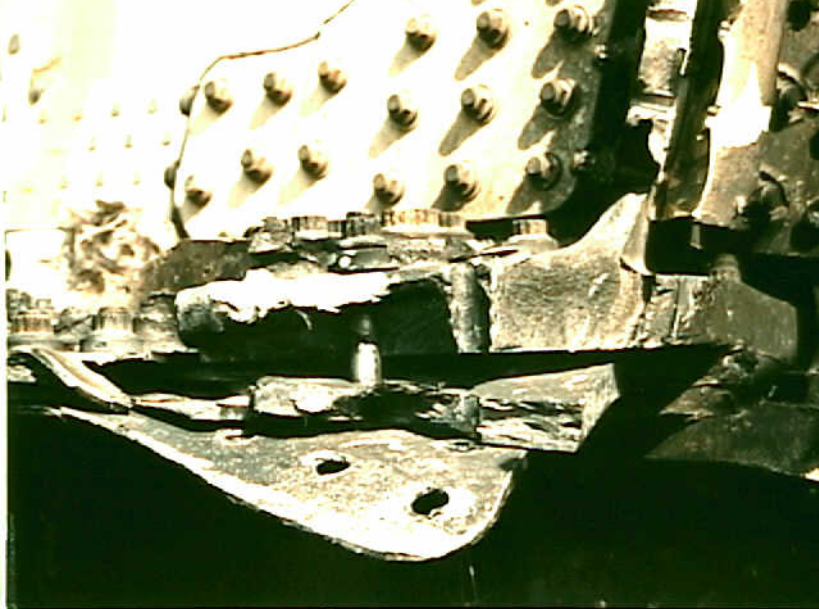
Structures 7 - Photo. 12 - View of upper rear spar cap fracture face at inboard right wing root side of body.
