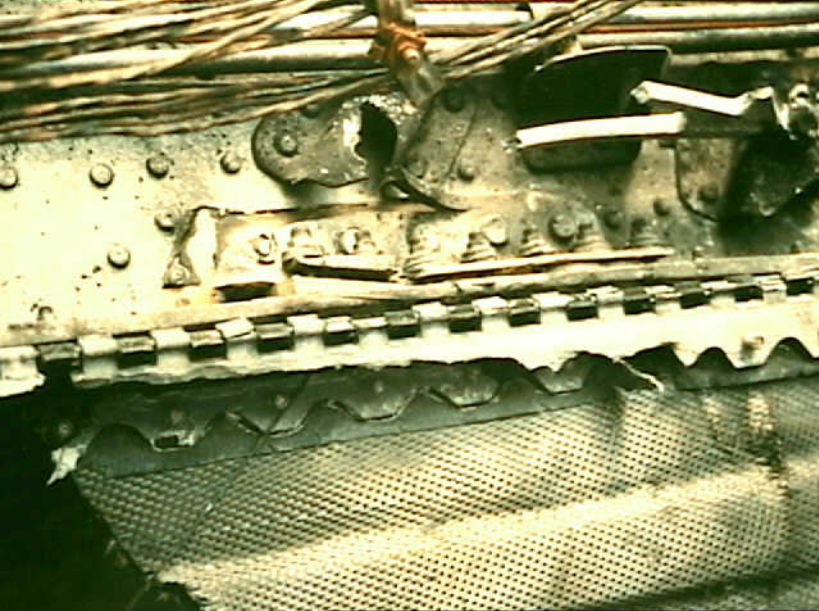
Structures 7 - Photo. 8 - View of the fractures flap hinge inboard side brace fitting.
