GREEN DEBRIS FIELD

TAG+ C 019

FBI = 8/9/96-37

R2 15 A SECTION OF THE UPPER RUDDER APPROX.

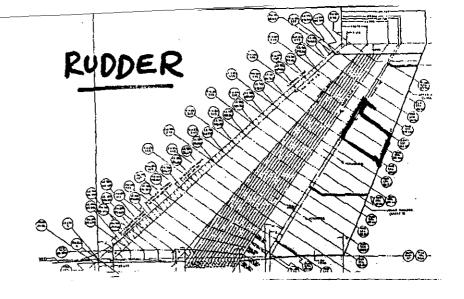
T' X 6'9" FROM RU. STA 257.5 TO 332.4

RUNNING FROM LEADING EDGE TO TRAILING EDGE.

THE LUS HONEY COMB SKIN PANEL IS MISSING

BETWEEN RU. STA 257 \$ 282. THE LEADING EDGE

BEAM HAS 3 SECTIONS OF COUNTER BALANCE WEIGHTS.

THE HINGE FITTING HAS NEGLIGIBLE DAHAGE, WITH BOLT

ATTACHED AT PINOT POINT. RIGHT SKIN PANEL OUTER

FACE SHEET IS MISSING FOR APPROXIMATELY 3" BY 24".

OUTER SKINS HAVE SOME MINOR PUNCTURES AND

SURFACE ABRASIONS. LEADING EDGE SEAL SHROUD

HAS IMPACT DAMAGE, THERE AKE NO OBVIOUS

SIGNS OF SOOT NOR FIRE DAMAGE, R2'S LEADING

EDGE MATES WITH RI AT RU. STA 332.

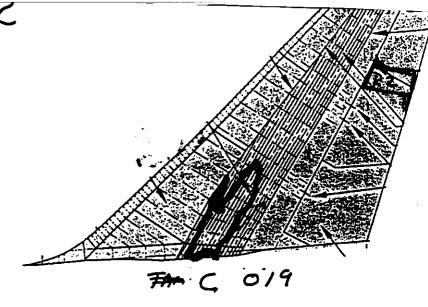
R2 upper Rudden Section Measures Approximately
6'x 6'9" Lower Section Above Ru-STA 282, 504 HAS
A Large Section of Honey Comb Missing UH Side
Piece Encompasses Ru Sta 3.3 21437-Sta 307, 472-Sta
282, 504 & SMAll Section of Ru Sta 257, 544.

TRAILINS Edge Beam HAS Three(3) Section of Adjustment weights

face sheet is MISSING for
