R3 RUDDER

FLOATER

BLUE TAG E2033

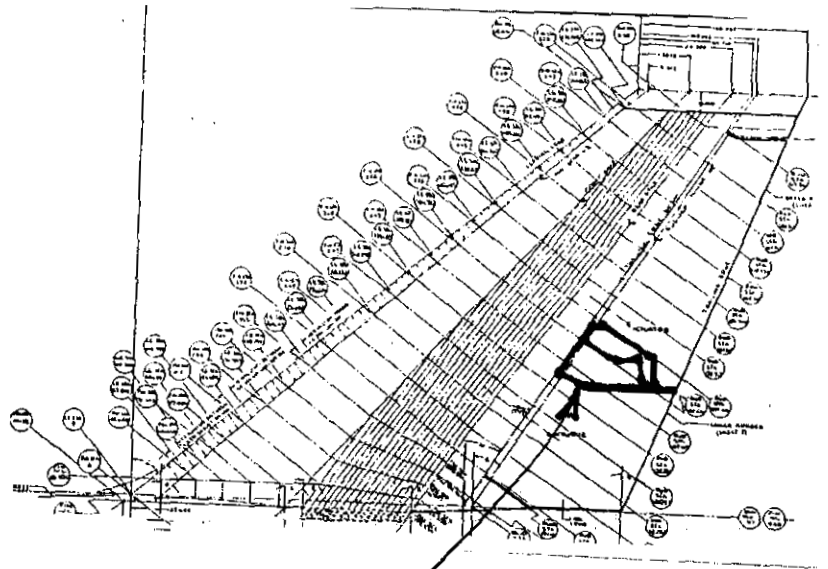
R3

UPPER RUDDER SECTION MEASURING APPROXIMATELY 55" x 6' FROM RUDDER STATION 147.7 TO 207.6 RUNNING FROM LEADING EDGE TO TRAILING EDGE.

THE LEFT HAND SIDE HAS TWO SECTIONS OF HONEY COMB MISSING, THE REST OF THE PANEL IS CRACKED - SEE SKETCH.

THE FRONT SPAR HAS NUMEROUS AREAS OF CRACKING AND IMPACT RELATED DAMAGE. AN AREA OF THE LHS SKIN PANEL IS NOT ATTACHED FROM RU. STA 182 TO 207, FROM FRONT SPAR TO REAR SPAR. THE HINGE FITTING HAS NEGLIGIBLE DAMAGE, BOLT REMAINS IN HINGE FITTING PIVOT POINT. THIS PART MATES WITH PART R5. SURFACE OF PART IS DIRTY AND GUTTER IS PRESENT. NO OBVIOUS SIGNS OF SOOT NOR FIRE DAMAGE. THE LEADING EDGE SEAL SHROUD HAD A LARGE AMOUNT OF IMPACT DAMAGE.

Upper rudder from rudder station 147.722 to 207.615 running from leading edge to trailing edge. Front spar has numerous areas of cracking and impact related damage. Leading edge seal shroud has a large amount of impact damage. An area of left skin panel is not attached from rudder station 182.651 to 207.615 from the front spar to rear spar. Skin panels have numerous areas of cracking. Hinge fitting and ~~rod fitting~~ have negligible damage. Bolt remains in hinge fitting. Bolt and rod remain in rod fitting. Outer skins have minor punctures and surface abrasions.

rod is damaged
