HORIZONTAL TAIL &

ELEVATORS

LOG# RE-1

NOMENCLATURE: RIGHT SIDE, INBOARD ELEVATOR PORTION.

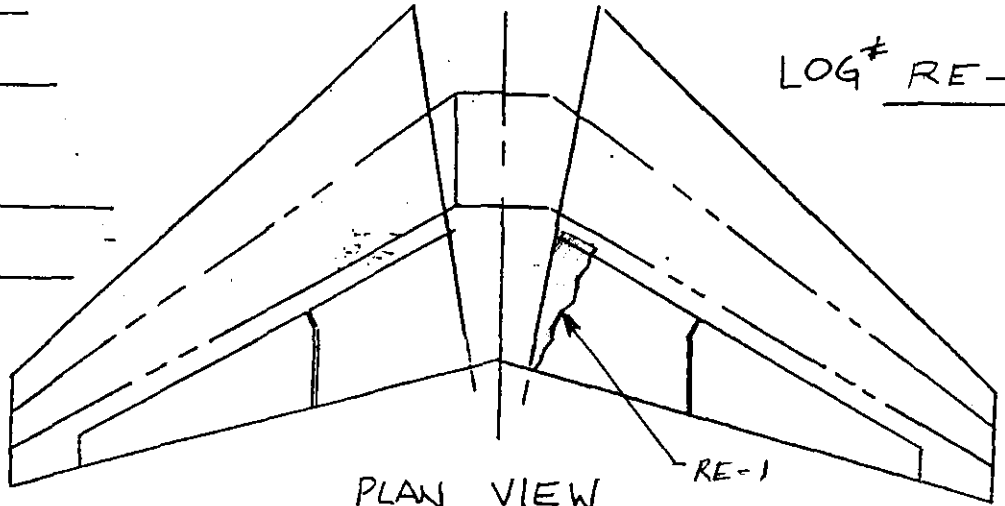
PLAN VIEW
LOOKING DOWN

DESCRIPTION: RIGHT SIDE, INBD. ELEV. PORTION, INBD CLOSURE RIB TRAILING EDGE TO FORWARD EDGE, OUTBD. ALONG FORWARD EDGE TO ELEVATOR STATION 81.000 TO TRAILING EDGE.

a) SOME BURN DAMAGE ALONG OUTBOARD EDGE.

b) SEVERAL SURFACE SKIN PUNCTURES, UPPER AND LOWER SURFACE.

c) DAMAGE ASSUMED ^{15 RE-1 12/11/96} ~~TO BE~~ AERODYNAMIC AND IMPACT RELATED.

Right inboard elevator inboard end to first outboard internal rib and from the leading edge to the trailing edge is designated RE1. Leading edge structure has impact damage. Front spar web has horizontal crack running inboard approximately twelve inches from outboard edge and located approximately ten inches down from upper chord. Front spar outboard upper area is down approximately half inch from original contour. Lower skin panel is missing from front spar aft approximately fifteen inches and from the inboard edge to the outboard edge of this section. The lower skin panel outer skin is missing around the forward skin panel fracture line. Outboard internal rib is not attached from the front spar running aft approximately 22 inches. ~~Outboard edges of~~ skin panels show indications of charring. A few minor skin punctures and internal rib punctures exist. The leading edge shroud hinge area was damaged.
