HORIZONTAL TAIL &

ELEVATORS

LOG # RE-2A, -2B, -2C, -2D, -2E, -2F

NOMENCLATURE: RIGHT SIDE, OUTBOARD ELEVATOR

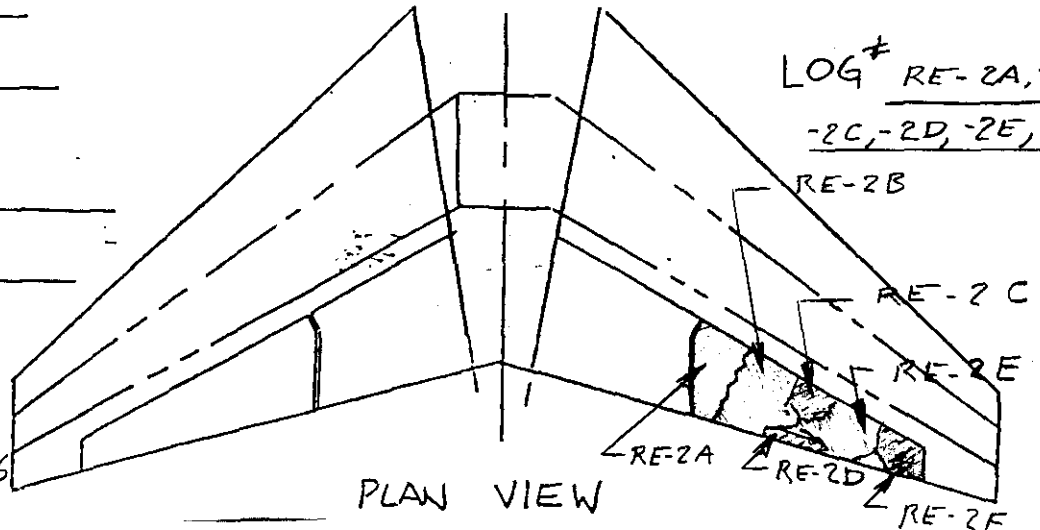
PLAN VIEW
LOOKING DOWN

DESCRIPTION: RIGHT SIDE, OUTBOARD ELEVATOR. ESTIMATE 90% OF ELEVATOR RECOVERED. ELEVATOR FRACTURED FORE AND AFT DIRECTION 4 LOCATIONS.

RE-2A - PORTION FROM INBD. CLOSURE RIB OUTBD TO 244 RH 12/11/96 TBC
ELEV. STA 238.000.

RE-2B - PORTION ALONG FORWARD EDGE FROM ELEV. STA. 244 RH 12/11/96 238.000 OUTBD TO ELEV. STA. 281.803, FROM ELEV. STA 281.803 AFT. DIRECTION RANDOM FRACTURE ELEV. STA. 281.803 TO ELEV. STA 294.000 TO ELEV. STA. 281.803, FROM FORWARD EDGE AT ELEV STA 238.00 AFT TO TRAILING EDGE.

RE-2C - DAGGER SHAPE PORTION, ALONG FORWARD EDGE 276 APPROX RH 12/11/96
ELEV. STA. 281.803 TO ELEV STA 306.794,
EXTENDING TO A POINT APPROXIMATELY 30 INCHES AFT OF ELEV. HINGE LINE.

RE-2D - TRAILING EDGE WEDGE, 12 INCHES FORE
AND AFT AND FROM ELEV. STA. 291.803
OUTBD TO ELEV. STA. 306.794.

RE-2E - BEGINNING FORWARD EDGE AT ELEV. STA. 306.794
RANDOM FRACTURE EXTENDING AFT ALONG ELEV.
STA. 306.794 TO ELEV. STA. 294 TO ELEV STA
306.794 AND BEGINNING FORWARD EDGE AT ELEV.
STA 356.777 RANDOM FRACTURE EXTENDING AFT
ALONG ELEV. STA 356.777 TO ELEV STA 331.756

RE-2F - OUTBD, PORTION OF OUTBD ELEV. BEGINNING
FORWARD EDGE AT ELEV STA 356.777 RANDOM
FRACTURE EXTENDING AFT FROM ELEV. STA
356.777 TO ELEV STA. 368.000.

- a) ~~NO BURN DAMAGE (PART DOES NOT HAVE TAG)~~ ^{RA 12/11/96}
- b) ELEVATOR SEPARATED FROM STABILIZER, SECOND
HINGE OUTBD. AND THREE OUTBD HINGES ATTACHED
TO STAB., ELEVATOR ATTACHED STRUCTURE FAILED. OTHER
TWO HINGES MISSING. ACTUATOR FITTING ATTACHED
TO STAB., ACTUATOR FLANGED FAILED.
- c) NUMEROUS SURFACE SKIN PUNCTURES, UPPER AND
LOWER SURFACE.
- d) DAMAGE ^{15 RA 12/11/96} ~~ASSUMED TO BE~~ AERODYNAMIC AND IMPACT
RELATED.

Right outboard elevator from inboard end to elevator station 244 and from the leading edge to the trailing edge is designated RE2A.

The upper skin panel has impact damage removing the outer skin and some core at local areas. The lower skin panel impact damage areas have various amounts of outer skin, core, and inner skin missing. The leading edge has some damage. The leading edge shroud is torn up and aft at the hinge and actuator locations.

Right outboard elevator from elevator station 244 to approximately elevator station 290 and from the leading edge to the trailing edge is designated RE2B. The lower skin panel outboard trailing edge area has approximately a fifteen inch by fifteen inch area of unattached skin panel assembly. The lower surface has normal hydraulic and grease streaking. The counter balance weight structure is bent upwards. Hinge at Elev Sta 256 remains attached.

Right outboard elevator from approximately elevator station 276 to elevator station 306 and from the leading edge aft approximately 30 inches is designated RE2C. The lower skin panel is not attached. The leading edge structure has impact damage.

Right outboard elevator trailing edge wedge from approximately elevator station 281 to 307 is designated RE2D. The upper inboard four inches of skin is not attached.

Right outboard elevator from approximately elevator station 306 to elevator station 356 is designated RE2E. Inboard edge of upper skin panel has zig zag fracture line with some light charring. Two large criss-cross fractures in the upper skin panel are each approximately twenty inches long. The lower skin panel has an area approximately twenty inch diameter of unattached skin panel at the outboard trailing edge. The leading edge has some damage.
THIS PART IS SCOTED ON UPR & LWR SURFACES.

Right outboard elevator from approximately elevator station 356 to the outboard edge and from the leading edge to the trailing edge is designated RE2F. The leading edge shroud is torn up and aft at the hinge locations. The inboard edge of upper skin panel has some impact damage and light charring. The upper skin panel outer skin has paint blistering. The counter balance weight structure is bent upwards.
