TAG # C2246

LOG # RF-11

FRAME SEGMENT  
STA 1420, STR 5R - 9R

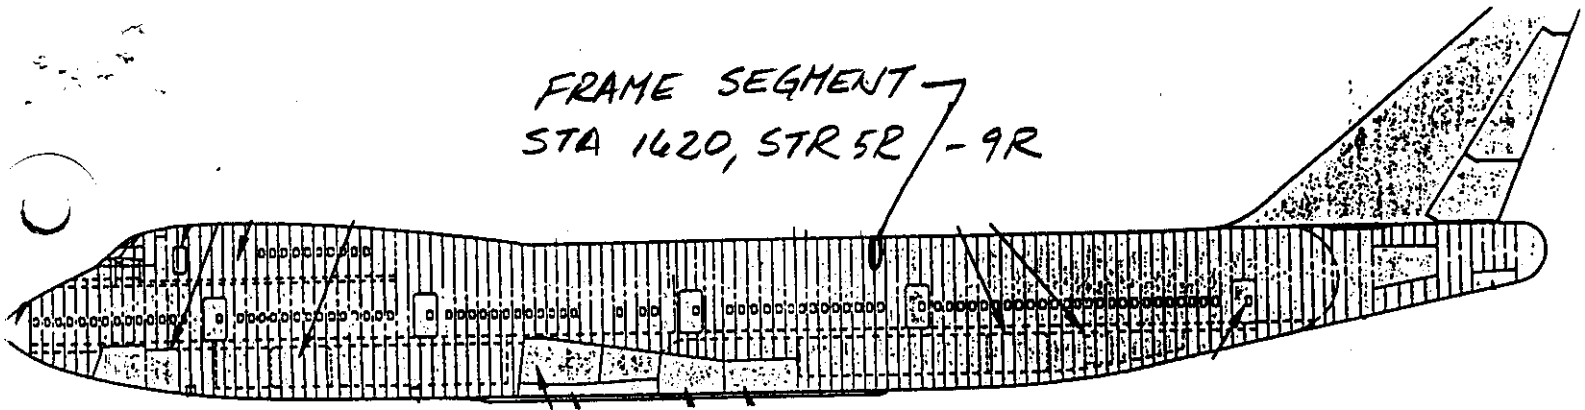
- STA 1620 FRAME SEGMENT, STR 5R-9R
- STR CLIPS SHOW SIGNS OF LATERAL DEFORMATION
- FASTENERS C/T SHEAR TIE AND SKIN PULLED THRU SHEAR TIE
- NO HEAVY SIGNS OF SOOTING, ONLY 'CLOTH ASH'

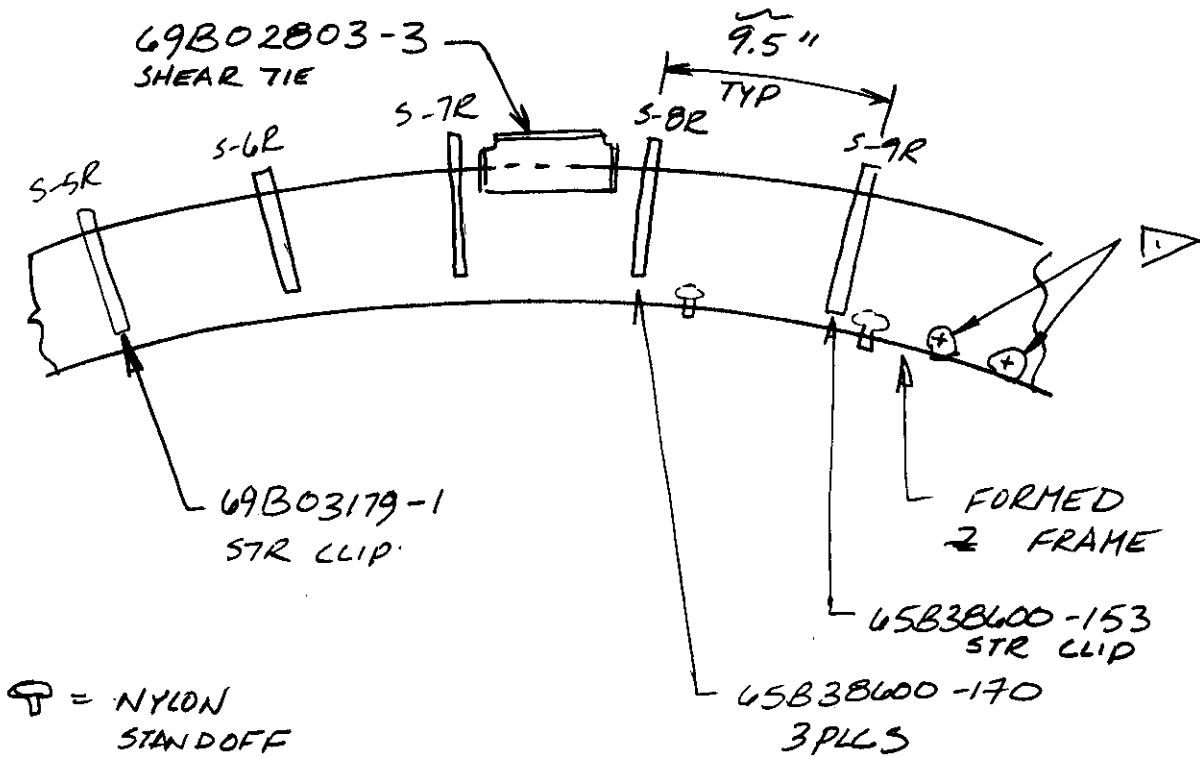
SUBJECT; STA 1620 FRAME SEGMENT, DATED 7/19/96

▷ REMNANTS OF THIN SHEET METAL PART ATTACHED HERE WITH 'FABRIC' FABRIC PART# = 65B41074-3

ACTION; PLEASE LOCATE IN TERMS OF STR'S
