LOG # RF114  
 TARGET # \_\_\_\_\_  
 COORD: LAT \_\_\_\_\_  
 LONG \_\_\_\_\_

SKIN STA 1120-1170  
 \$19- \$23

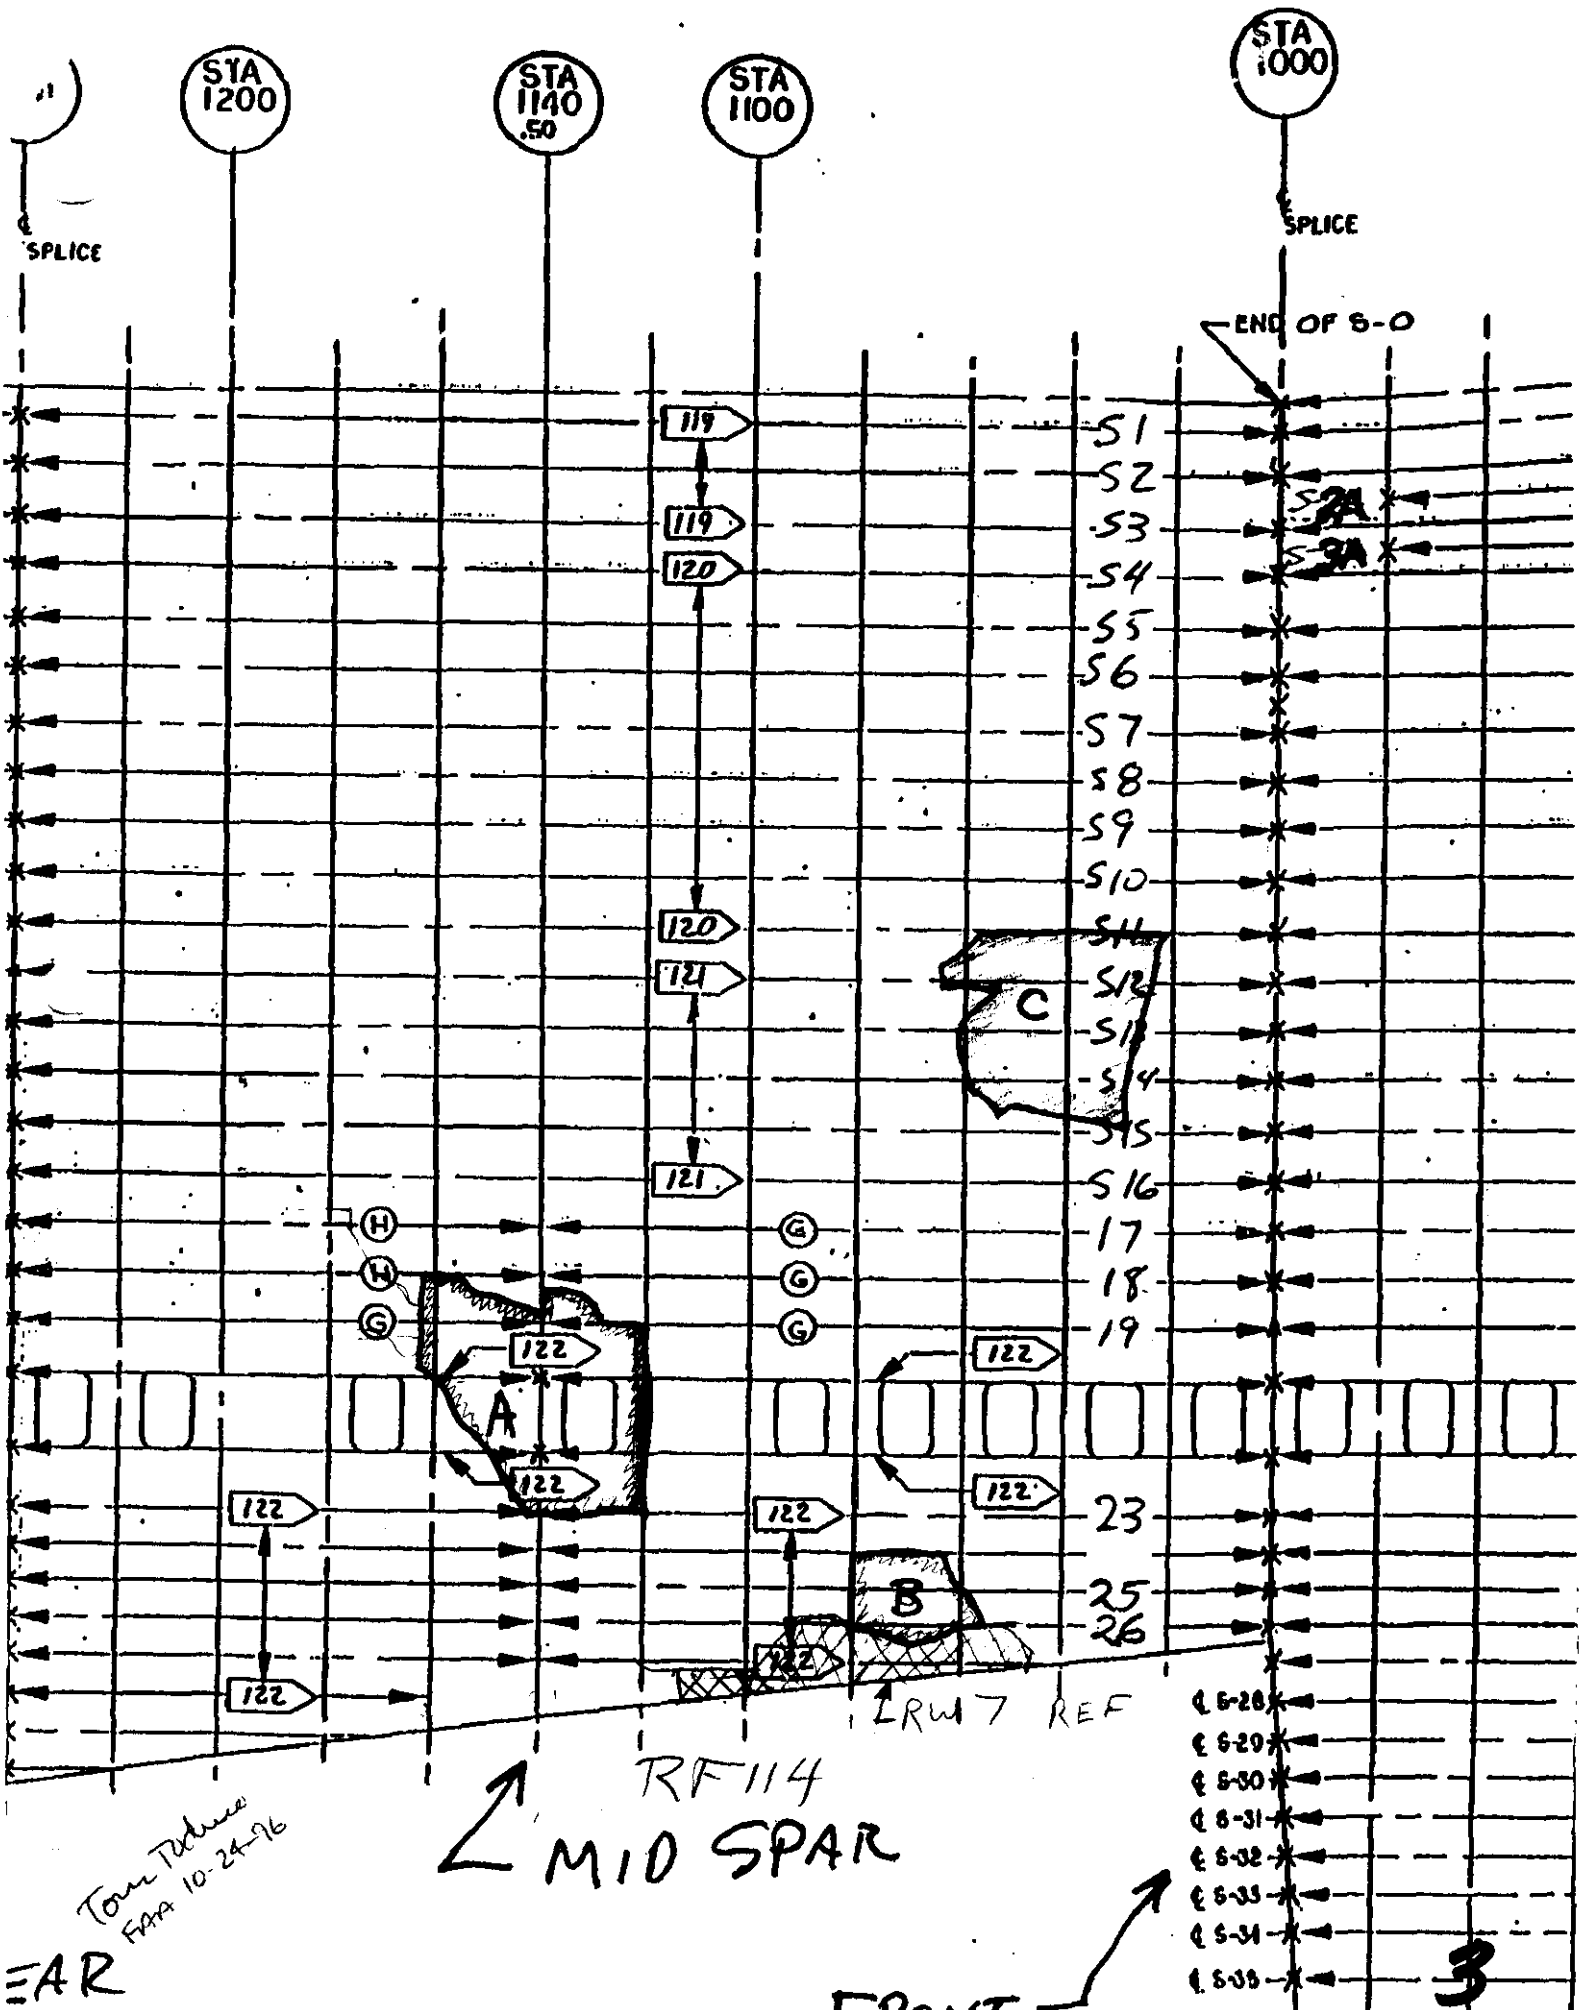
RF114A BOTTOM FWD 20"

- FWD <sup>E</sup> EDGE FRACTURE THRU FASTENERS ARE THRU NON-FASTENER AREAS. ALL OTHER FRACTURES SEPERATED. STA 1140-1160 DOUBLER

- LIGHT SMOKE ON EXTERIOR WITH DARK TAR LIKE RUN 2" WIDE STA 1120 TO 1140 ABOVE WINDOW
- SOME TARNISH ON INSIDE

RF114B TOP & AFT EDGE FRACTURE THRU FAST. E'S

- LIGHT SMOKE ON EXTERIOR
- INSIDE PRIMER IS TARNISHED (DIRT OR SMOKE)

RF114C TOP FRACTURE THRU FASTENER

- LIGHT - MODERATE SMOKE OR DIRT ON EXTERIOR
- INSIDE PRIMER IS TARNISHED (DIRT OR SMOKE)
