RF 117

Log # 11-11-96-20
Green Area dredged Part
Tag# T6019

Skin Segment STA 920 to 980
STR 0 to str -5R

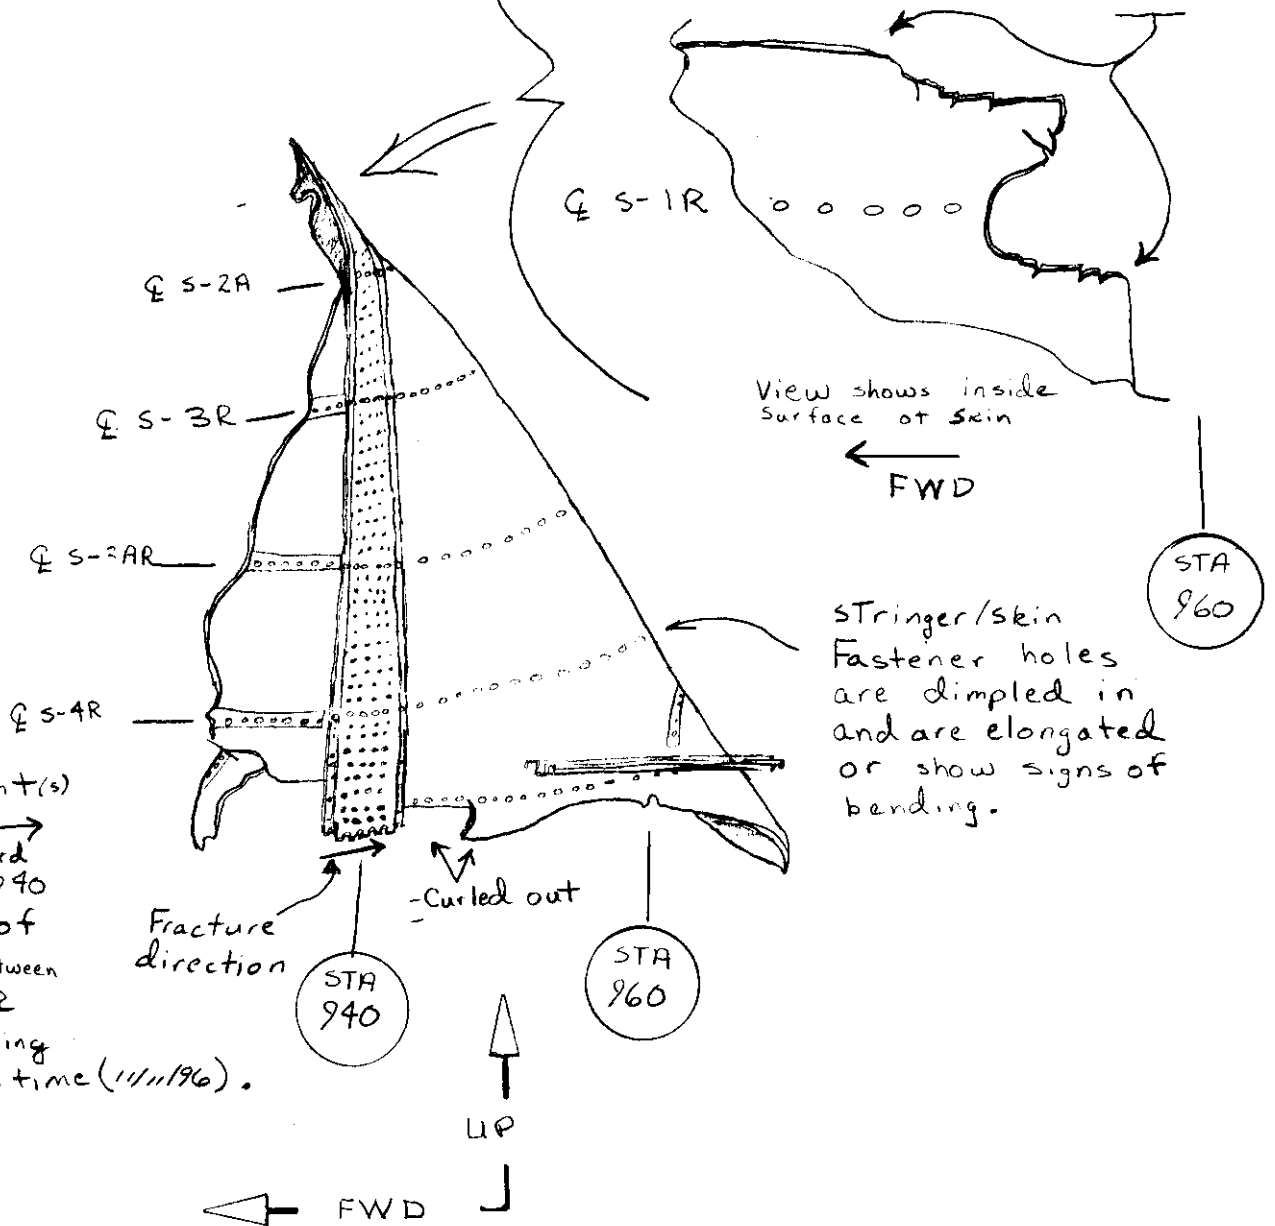
This area is jagged. Appears like large saw teeth. It does match with mating panel.

A segment(s) of skin just forward of STA 940 and aft of RF 19 between S-4R & 6R is missing at this time (11/11/96).

- Fracture surfaces on forward and Aft edge of panel are 45° fractures with a burr on the interior side of skin except in those areas smoothed by the dredging operation.

All Fractures appear to be ductile fractures
