BS 1480 Bulkhead Assembly Approximately RBL 8 to RBL 75

Log Number	RF119
Debris Field	Green
Target Number	C105
Coordinates:	
Latitude	
Longitude

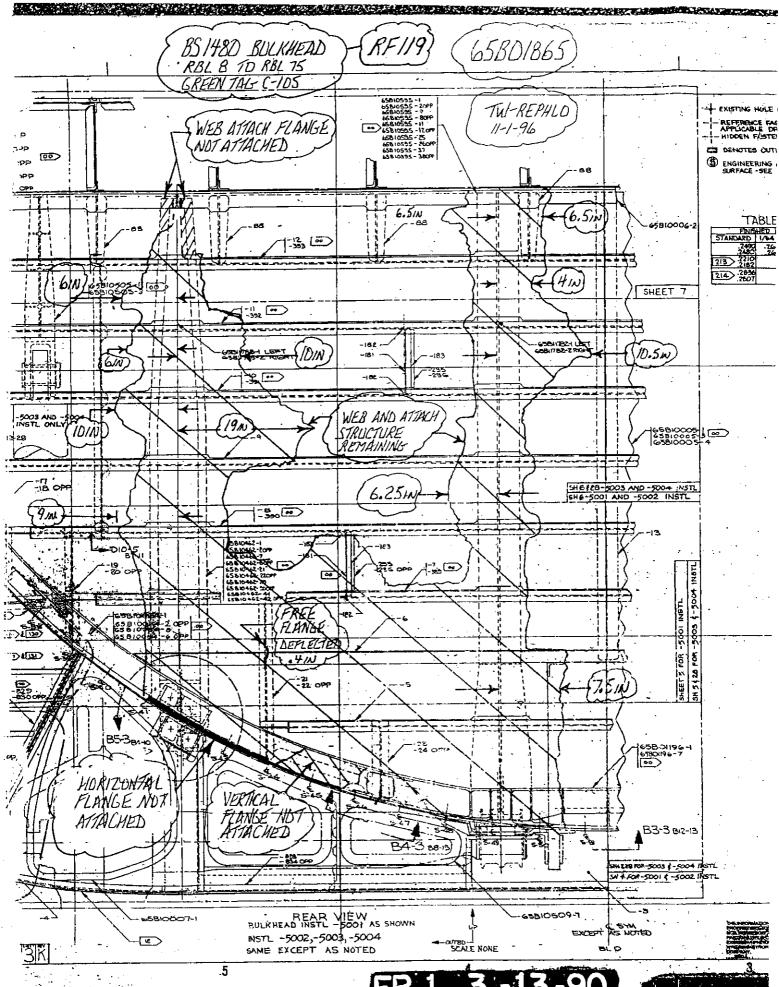
Body gear trunnion fittings 65B11782 and 65B10462 are attached to the body gear assembly, see LG4, and a portion of 65B10005 web as shown on attached illustration. Approximately ten to fourteen inches of the right side keel beam box structure is attached to the BS 1480 bulkhead assembly.

Inboard and outboard trunnion fittings have two rods located at the upper end which are attached to the trunnion fittings. The rod ends not connected to the trunnion fittings contain a small portion of structure or linkage that failed.

Horizontal stiffeners located on the aft side of web have torn away at the radius and departed. Horizontal web assembly 65B01865-6 is attached at outboard end but has cracked in the radius running inboard approximately forty-three inches where the -6 assembly has been sheared through all members in the foreaft direction. Not shown on attached illustration. See picture.

Bulkhead web chord horizontal flange is not attached from S46R to S41R. Bulkhead web chord vertical flange is not attached from S46R to S44R. See attached illustration.

Various types and lengths of wiring and conduits are attached twelve inches above S45R and S46R.

Structure has minor surface abrasions at random locations through paint layer. Primer remains. No visible indication of soot / Dig T
