LOG # RF127

TARGET # C-069

SEGMENT OF PRESSURE DECK
WEB FROM B.L. ϕ TO RBL 33.99,
STA 1404 TO STA 1458

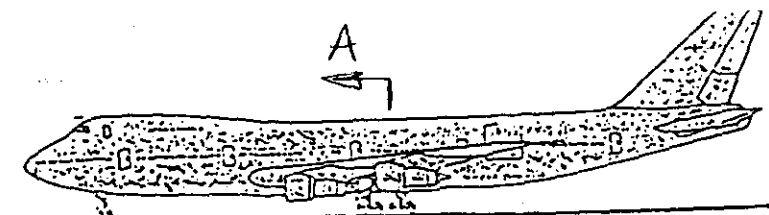
VIEW A-A

- 1) PORTION OF WEB FROM ~ STA 1410 TO 1424, B.L. ϕ TO ~ RBL 7.0 MISSING.
- 2) WEB CRACKED FROM RBL ~ 6.0 TO RBL ~ 23, AT ABOUT STA 1424,
- 3) WEB CRACKED FROM RBL ~ 5.0 TO RBL ~ 14.0 AT ABOUT STA 1414.
- 4) WEB CRACKS ORIGINATING AT ABOUT (RBL 3.0) (STA 1436) RUN DIAGONALLY TO ABOUT STA 1436, RBL 11.33 AND TO ABOUT STA 1442, RBL 11.33.
- 5) ALL EDGES OF WEB JAGGED ALONG FORWARD AND AFT EDGES, AND ALONG B.L. ϕ FROM ~ STA 1410 TO ~ STA 1424. EDGES ALSO JAGGED ALONG RBL 33.99 FROM STA ~ 1435 TO STA ~ 1458, WHERE A SLENDER REGION OF WEB IS MISSING (ABOUT 3" WIDE).

- 1) ALL STIFFENERS RUNNING TRANSVERSELY ON BOTTOM OF WEB REMAIN ATTACHED (EXCEPT FOR THE ONE AT STA 1439) BUT ARE BENT AT VARIOUS POINTS ALONG THEIR LENGTHS.

- 1) REMNANTS OF THE FLOOR BEAM ATTACHMENT CHORDS AT RBL 11.33 AND 33.99 REMAIN ATTACHED. ONLY THE HORIZONTAL FLANGES REMAIN, THE VERTICAL FLANGES HAVING DEPARTED WITH THE FLOOR BEAMS.

THE WEB APPEARS DIRTY ON TOP AND BOTTOM SURFACES BUT HAS NO APPARENT SOOTING, EXCEPT AS DESCRIBED FOLLOWING:

THE OUTBOARD FLANGE OF THE RBL 33.99 FLOORBEAM APPEARS TO BE MODERATELY SOOTED ALONG ITS LENGTH FROM STA ~1409 TO ~1438. THE INBOARD FLANGE IS NOT SOOTED.
