LOG # RF135

TARGET # DZ113

RF135 CONSISTS OF FLOOR BEAM  
ABOVE PRESSURE DECK AT STA 1396 → DEBRIS FIELD WHITE  
1425. SEAT TRACK AND FLANGE IS IN-TACT ALONG MOST  
OF THE UPPER CHORD. LOWER CHORD IS FAILED IN RADIUS.  
ALL FASTENERS ARE PRESENT. VERTICAL STIFFENER  
ON OUTBOARD SIDE IS UN-DAMAGED INBOARD STIFFENER  
IS MISSING FLANGE.

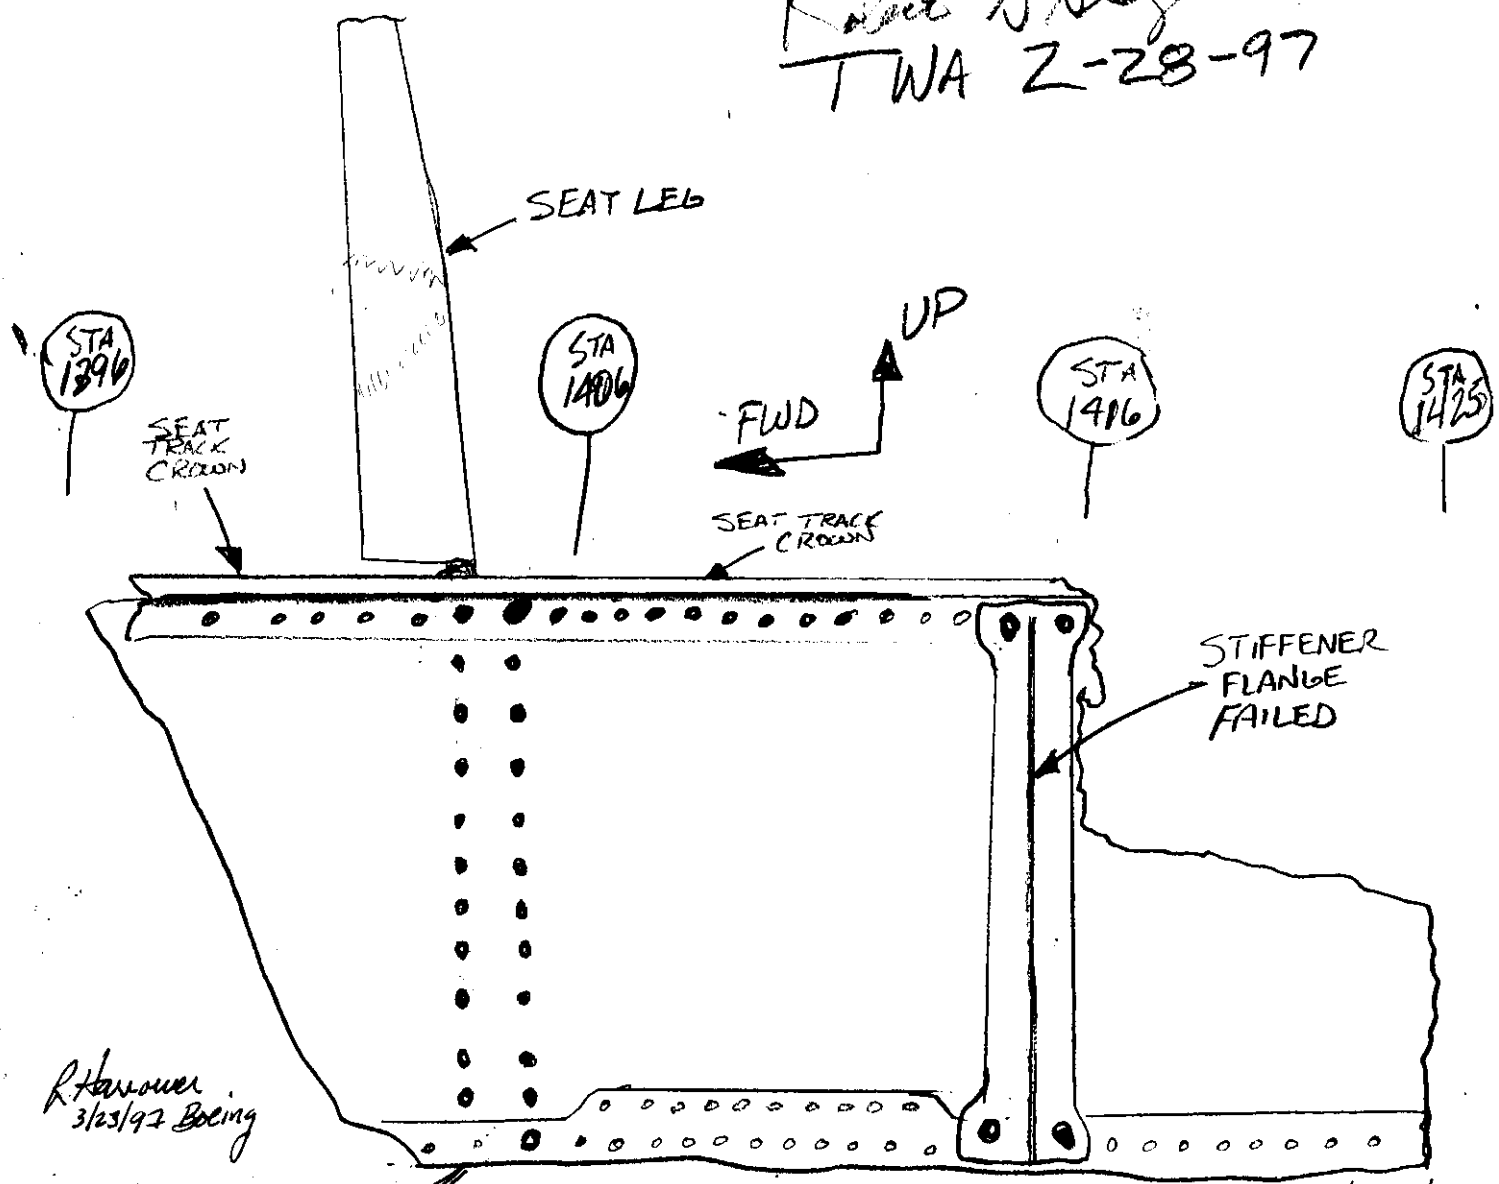
LWR CHORD  
FAILED AT RADIUS
