LOG # RF136

TARGET # D2114

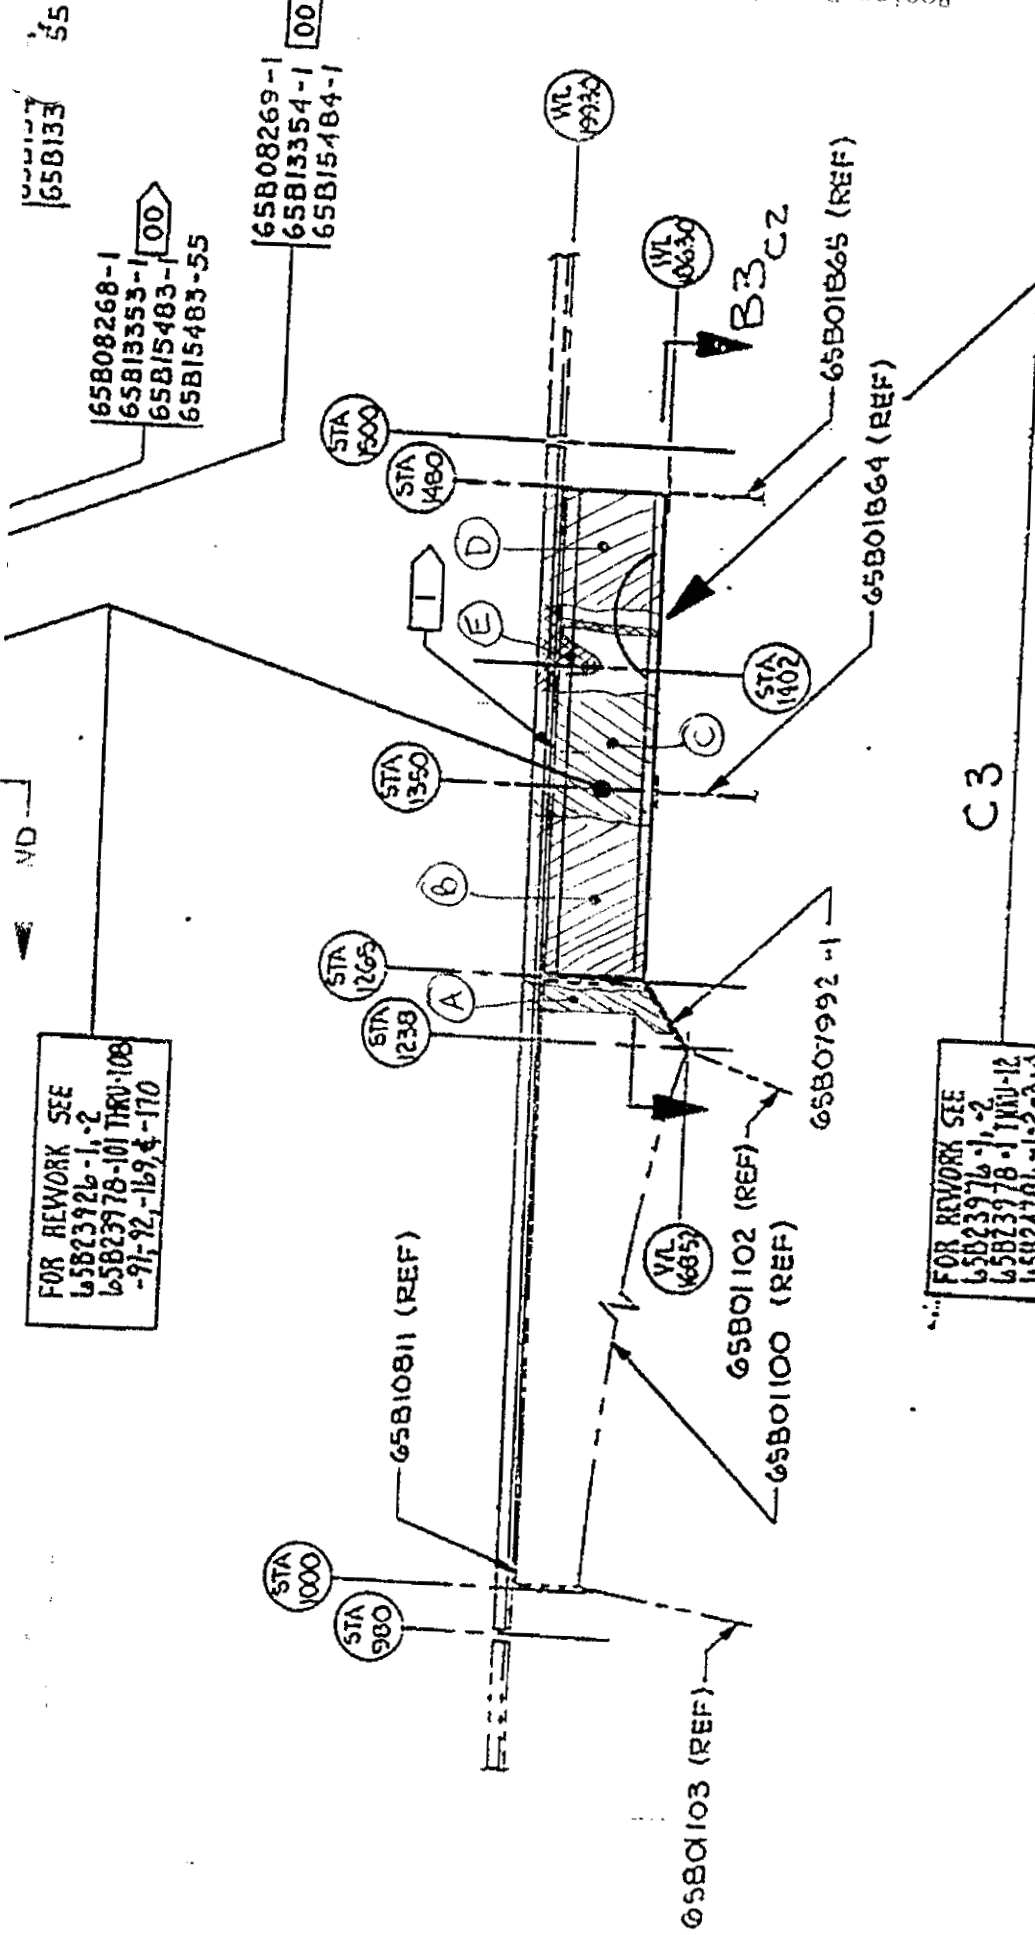
RBL 33.99  
 FLR BM

RF136 CONSISTS OF PRESSURE DECK FLOOR BEAM AT ATRBL 33.99 FROM BS 1320 TO DEBRIS FIELD WHITE

1395. FAILURE IS VERY SIMILAR TO RF135 UPPER CHORD SEAT TRACK FLANGES AND CROWN ARE LARGELY INTACT. LOWER CHORD IS FAILED

AT RADIUS. A FORE-AFT <sup>FLOOR</sup> STIFFENER IS ATTACHED WITH A LENGTH OF FLOOR PANELING TO UPPER CHORD FLANGE. THE CENTER LINE OF THE

PARALLEL STIFFENER IS APPROX. 6 INCHES INBOARD OF THE SEAT TRACK CROWN CENTER LINE. THIS FORE-AFT STIFFENER RUNS AT FLOOR LEVEL FROM BS 1327 TO 1367.

FLOOR BEAM FASTENERS AND STIFFENERS ARE LARGELY IN-TACT. STRUCTURE APPEARS TO HAVE HAD CORROSION INHIBITOR (DINOL) APPLIED WITH THE ASSOCIATED "DIRTY" FINISH.
