RF-14

GREEN DEBRIS FIELD TAG# C-157

SKIN SEGMENT SEC'N 44

STA 1120 - 1060, STR 19R - 24R

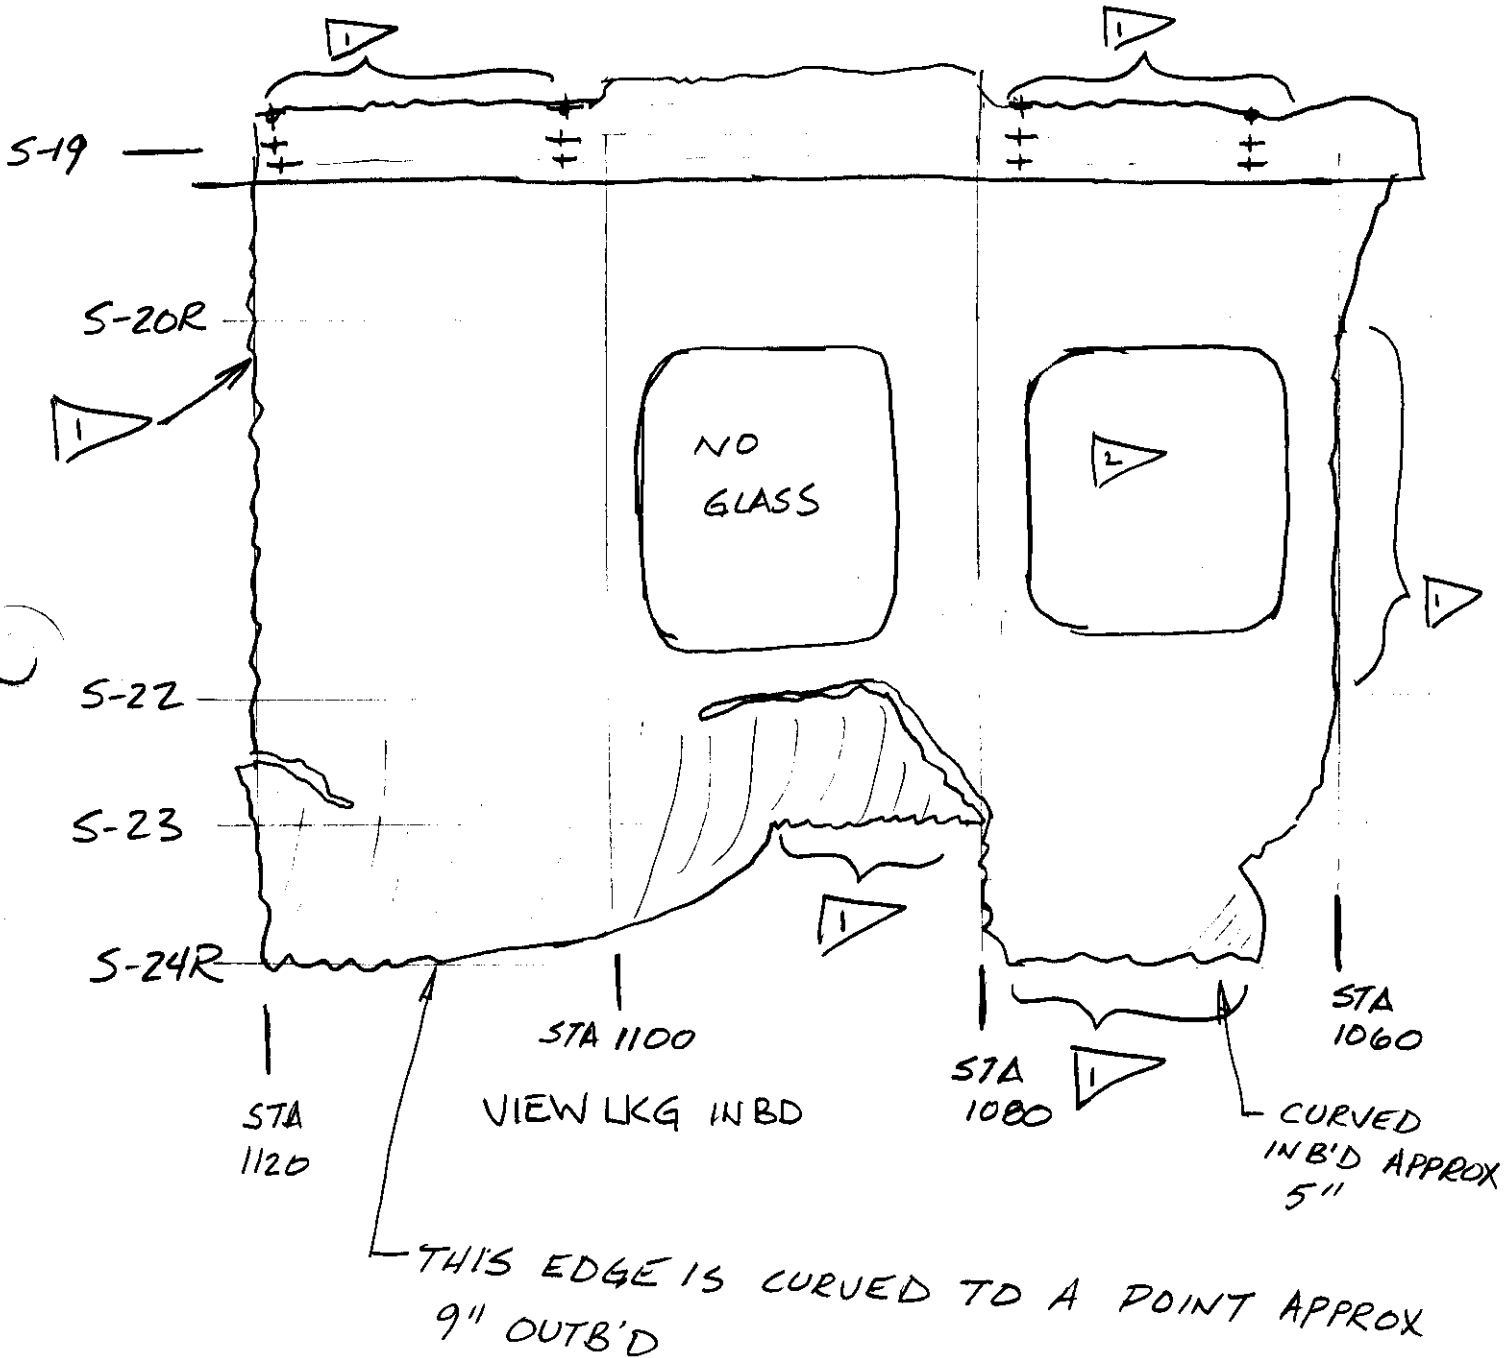
RF-14

1 NET AREA FAILURE
ALONG 'RIVET LINE'

▷ WINDOW GLASS HEAVILY DAMAGED, LOOKS LIKE ALLIGATOR SKIN / DRIED MUD / CRACKLED

TYPICAL DAMAGE THRU OUT WINDOW GROVES ARE APPROX .020 IN DEEP

HEAVY SMOKE / SOOT / DAMAGE ON FULL EXTERIOR OF PART

- INTERIOR OF PART LOOKS LESS DAMAGED THAN EXTERIOR
- FROM 5-21 & ABOVE LOOKS DIRTIER THAN SHOULD BE EXPECTED - SIGNS OF SOOT
- INTERIOR OF WINDOW w/ GLASS HAS ONLY SOOT ON IT AND NO SIGNS OF CRACKLING
- STR'S 19, 20 & 22 ARE FAIRLY INTACT
- WINDOW DOUBLER TORN BTWN STA 1080 & 1100, JUST BELOW STR 22
- ALL SHEAR TIES FAILED EXCEPT AT STR 19-20, STA 1100, 1120 FAILURE MODE WAS EITHER BENDING AROUND SKIN ATTACH FASTENERS OR NET AREA OR COMINATION
- SHEAR TIE TO FRAME FASTENERS FAILED IN SHEAR AT STR 19-20, STA 1100 & 1120
