LOG # RF-15

Green Tag #
C117

SKIN PANEL STA 2280 TO STA 2340

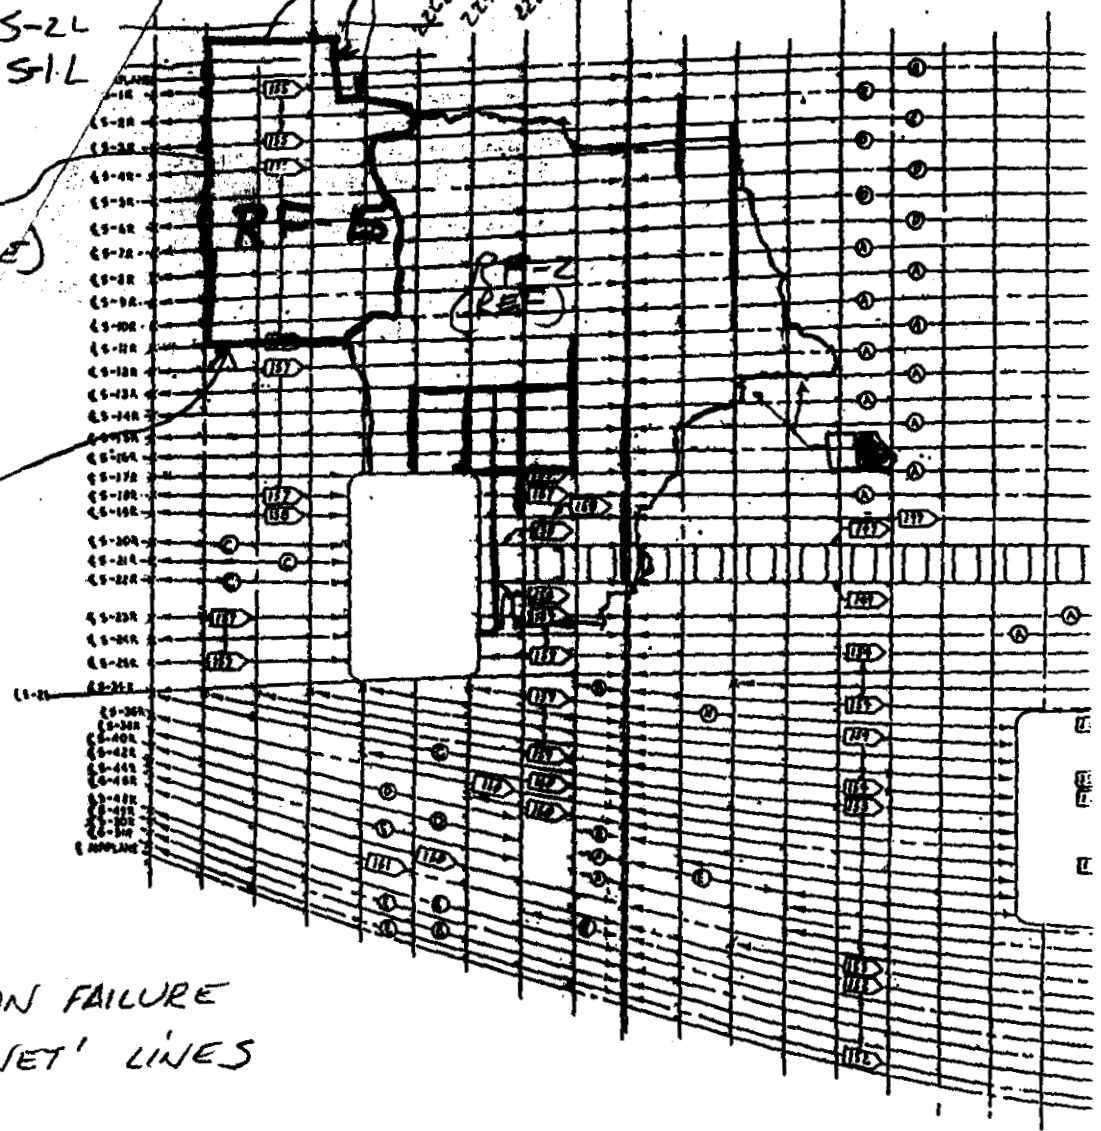
RF-15

ALMOST ALL STRINGERS HAVE SQUARE TENSION BREAKS

SAWCUT FROM RF-9A

TEAR ALONG STRAP (FWD EDGE)

NET TENSION FAILURE ALONG 'RIVET' LINES

FS. SKIN HAS A PUNCTURE HOLE. FROM THE
OUTSIDE/IN. JUST AFT OF FS STR 2280
BETWEEN STR 2R & 3R PUNCTURE HOLE IS
APPROX. 4" X 6"
