LOG # RF15Z

TARGET # C2467

1480 BULKHEAD UPPER PORTION

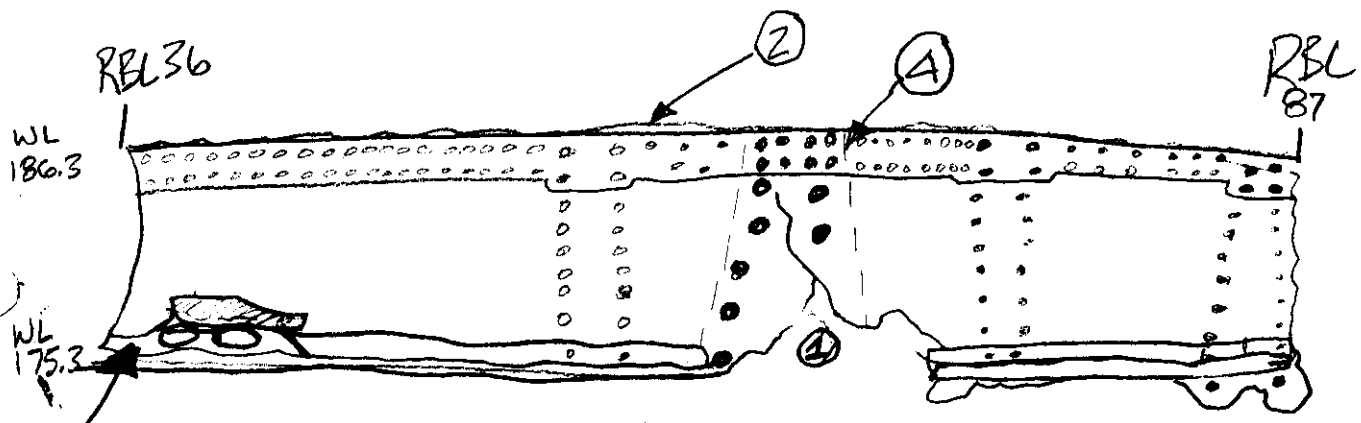
* WEB IS MOSTLY FLAT WITH A GENTLE FORE-REAR DEFORMATION

HORIZONTAL STIFFENER FRACTURED ALONG MOST OF THE LENGTH

- ① LOWER STIFFENER IS MISSING WITH A PORTION OF THE WEB WHERE TOP OF O. B. MAIN BODY LANDING GEAR TRUNNION FITTING IS ATTACHED TO WEB.
- ② UPPER CHORD IS FAILED AT FLANGE RADIUS
- ③ ~~REINFORCED ANGLE AND MOST OF WEB OF LOWER STIFFENER STILL ATTACHED~~ SOME AT Boeing TWA 3/24/97
- ④ SMALL PORTION OF O. B. MLG TRUNNION AFT UPPER FLANGE IS ATTACHED TO RF15Z WEB.

* MINOR SCOTING AND/OR SOILING IS PRESENT ON FORWARD SIDE
