LOG # RF162

PRESSURE DECK WEB DEBRIS FIELD UNKNOWN

STA 1324 - 1346

RBL 75.92 - 98.58

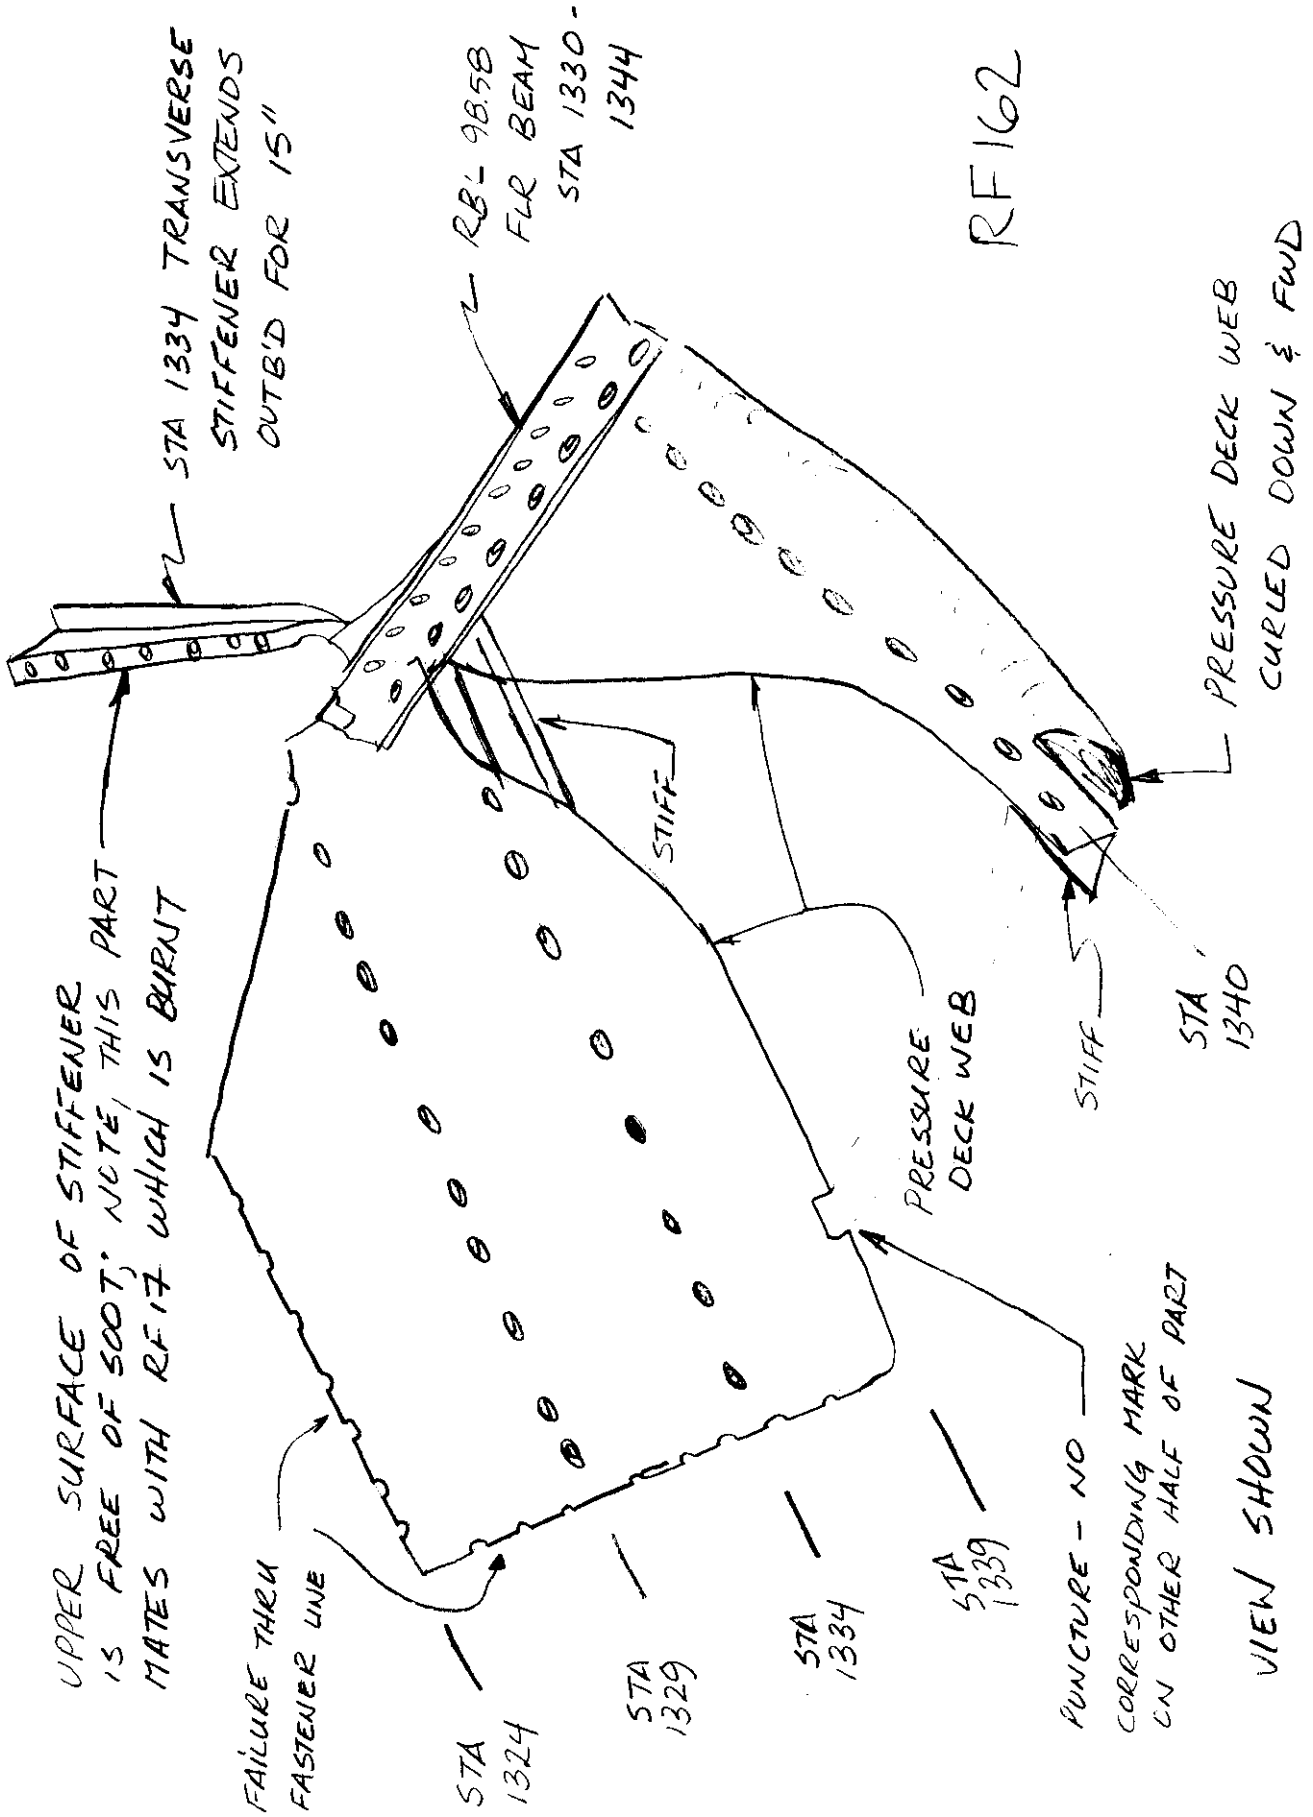
RF162

- UPPER SURFACE OF PART IS CLEAN
- ALL FRACTURE SURFACES AND DISBONDED SURFACES ARE FREE OF SOOT
- LOWER SURFACE OF PART IS DIRTY WITH THE AFT SURFACES OF THE STA 1329 & 1334 STIFFENERS BLACKENED

UPPER SURFACE OF STIFFENER IS FREE OF SOOT; NOTE, THIS PART MATES WITH RF17 WHICH IS BURNED

STA 1334 TRANSVERSE STIFFENER EXTENDS OUTBD FOR 15"

PRESSURE DECK WEB CURLED DOWN & FWD

FAILURE THRU FASTENER LINE

PUNCTURE - NO CORRESPONDING MARK ON OTHER HALF OF PART
