LOG # RF-17 {CW-1001}

TARGET # 89-1 89-96

LOG RF 17 ADDITIONAL COMMENTS

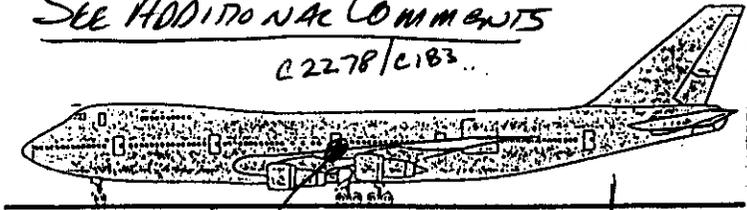
R/4 BODY SECTION INTERIOR
 VISUAL INDICATIONS OF BURNING ABOVE
 WING CENTER SECTION - VIRTUALLY NONE
 IN CENTER SECTION OF EXPOSED INTRACT AREAS

- 1) LOWER PICKLEFORK PRONGS ARE ATTACHED TO REMNANTS OF THE REAR SPAR WEB & BACKUP STRUCTURE (TERMINAL FITTING). REMNANTS OF THE UPPER & LOWER WING BOX SPAR CHORDS REMAIN ATTACHED AS WELL.)
- 2) ALL FORE/AFT ORIENTED FLANGES OF THE PICKLEFORK PRONGS ARE BUCKLED FROM COMPRESSION LOADING.
- 3) THE REAR SPAR WEB AND LOWER PORTIONS OF THE PICKLEFORK PRONGS ARE DEFORMED AFTWARD. THE SPAR WEB IS THEREFORE OUT-OF-PLANE WITH ~~OTHER SPAR WEB REMNANTS~~ ITS ORIGINAL ORIENTATION.
- 4) THE OUTER PRONG OUTER FLANGE, ALONG WITH THE ATTACHED OUTBOARD FAIL SAFE STRAP, ARE FRACTURED AT THE PEAK POINT OF THE OUTER FLANGE BUCKLE.
