LOG # RF-2 FIS 11.6
SD

TARGET # GREEN TAG C004

DEBRIS FIELD #1

FUSELAGE

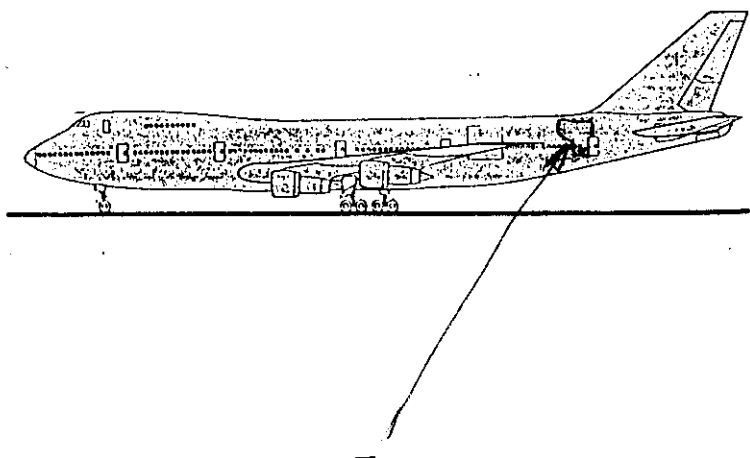
SKIN & STRINGERS

STA 2100 - 2280

STRS 23R - 2R

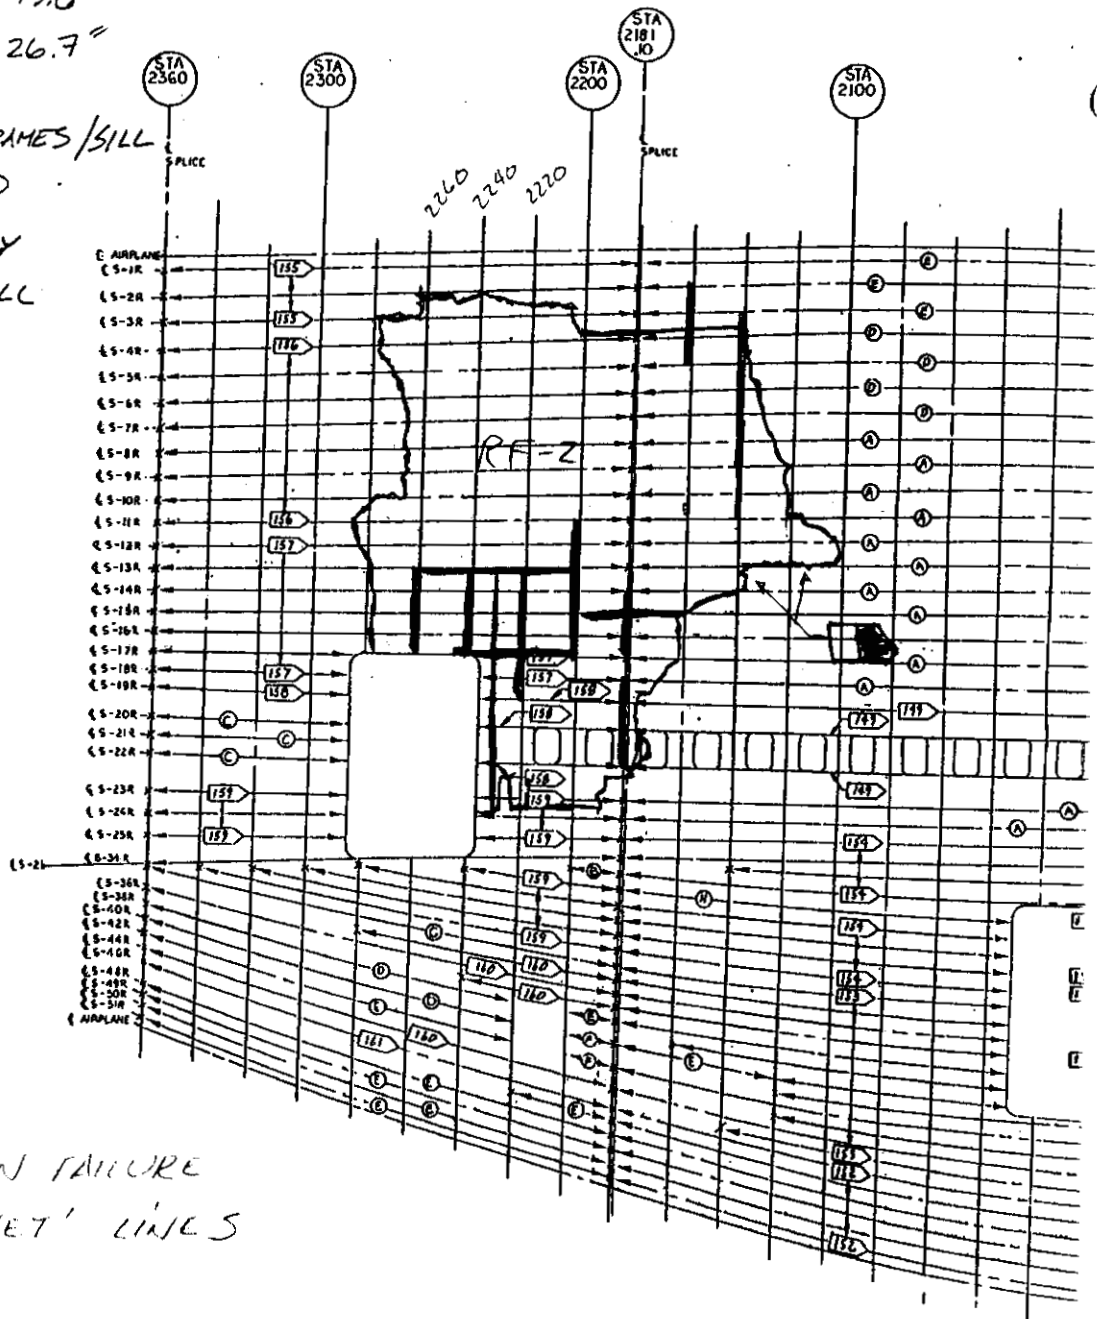
SK-FAN

HEAVY LINE = FRAMES/SILL
STILL ATTACHED
NOT NECESSARILY
FASTENED AT ALL
LOC'S

NLT TENSION FAILURE
ALONG 'RINET' LINES
