LOG # RF-22

RF-22

4½ WINDOW SEGMENT AFT OF STA 1480
STA 1480 - 1580, STR 19R - 26R

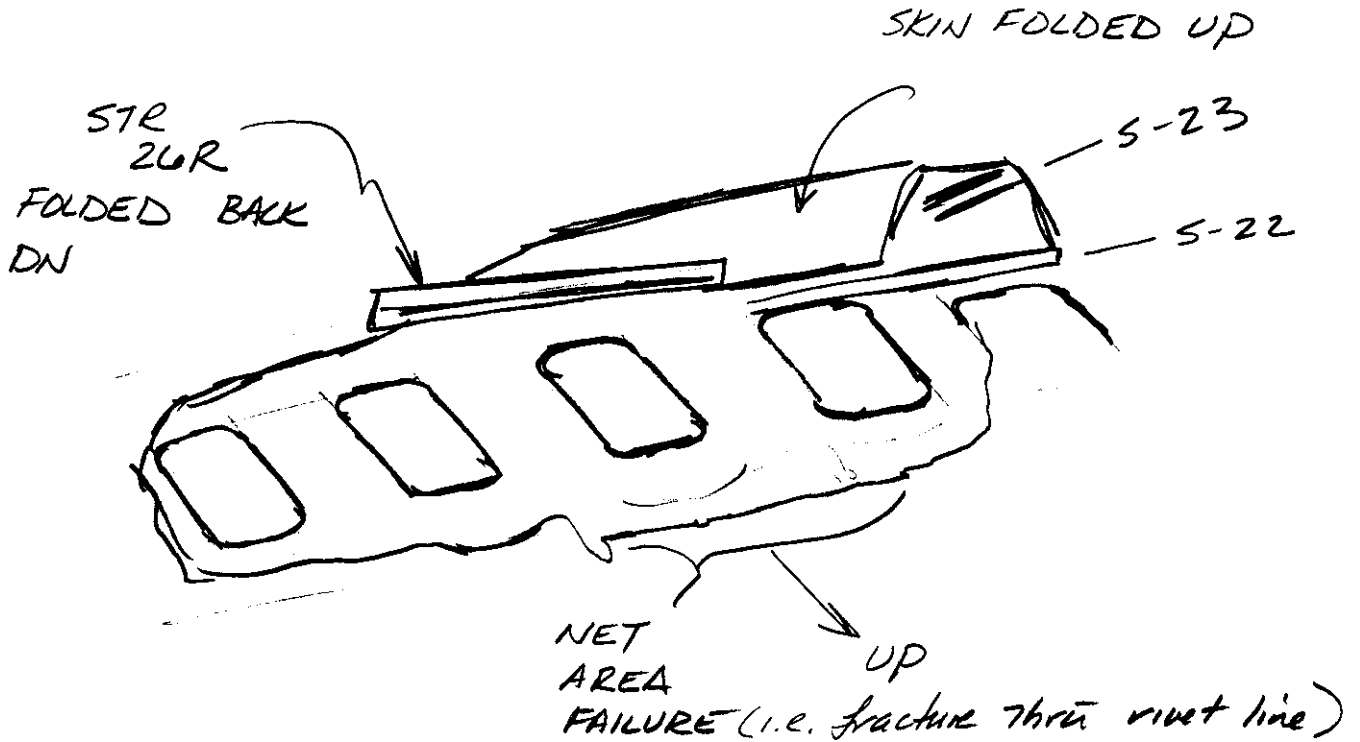
REFER FIRE AND EXPLOSION GROUP NOTES FOR FIRE DAMAGE

- MOST FRACTURE SURFACES ARE 'ANGLED' (BUT LIGHT SOOT ON THE OUTSIDE)
- NO SIGN OF HEAT DAMAGE, WHITE PAINT ON EXTERIOR IS NOW LIGHT GREY. ½ OF RED PAINT BELOW WINDOWS HAS PEELED OFF
