LOG # RF 23

145A-309

STA 1020 TO STA 1240, S11 TO S19; SKIN STRINGER AND FRAMES.

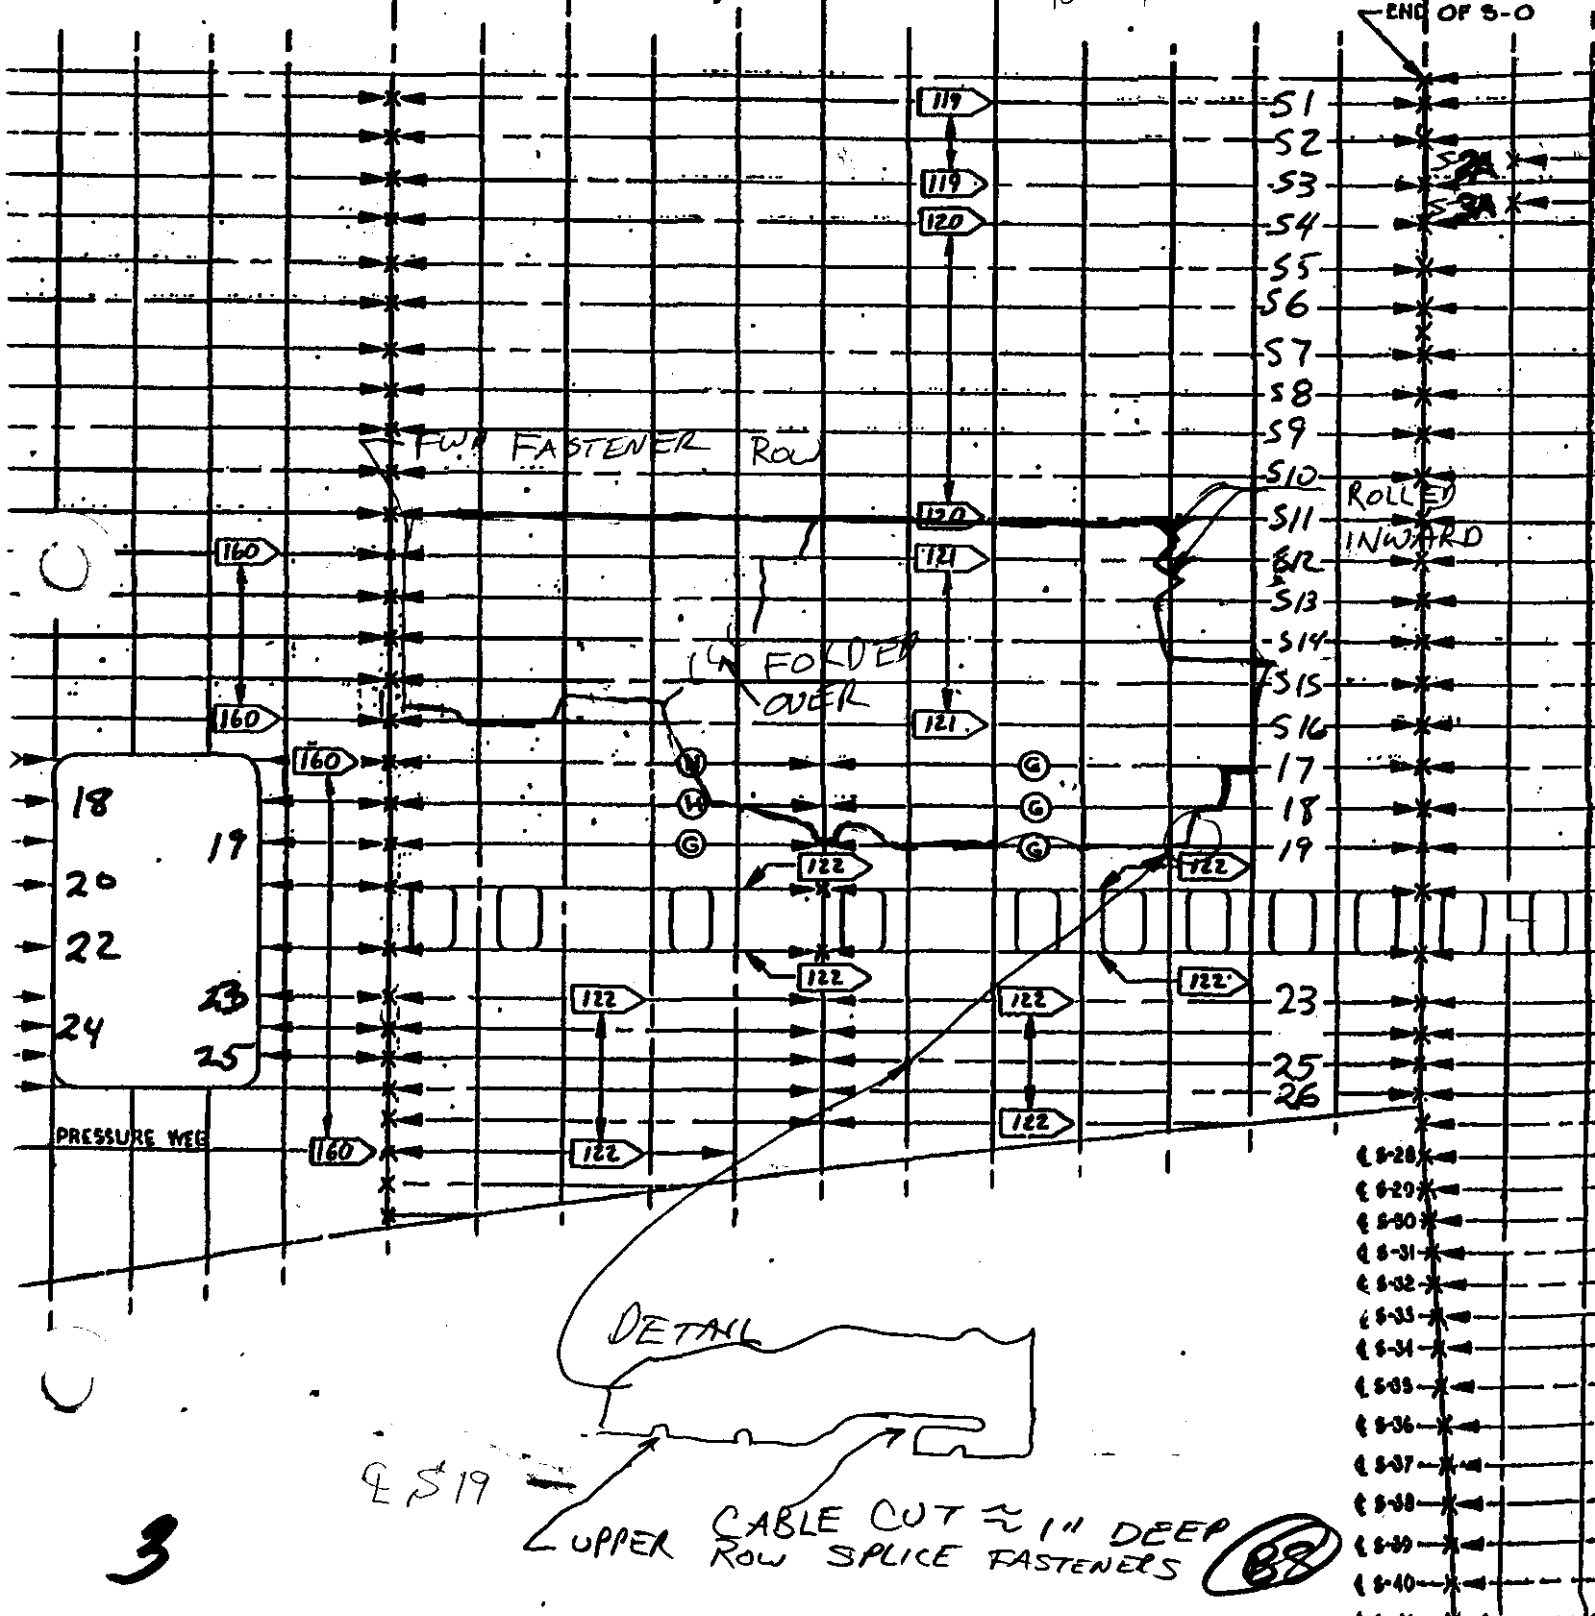
PG 2/2  
RF-23

- 1140 BULKHEAD ATTACHED S-9 TO S-17.5 (SPICE) FRACTURE @ LOWER WEB SEGMENT UPPER ROW
- 1120 FRAME ATTACHED S-11 TO S 17
- 1100 FRAME ATTACHED S 11 TO S 18
- ALL STRINGERS ATTACHED TO FWD & AFT EDGES OF PANEL

ALL STRINGERS BROKE AT STA 1145 - 1150 RANGE

S-15	PEELED OFF SKIN	STA 1145 TO 1200	} FOLLOWED BEND TANGENT
S 14	" " OFF " "	STA 1145 TO 1190	
S 13	" " " "	STA 1147 TO 1175

- STA 1241 SKIN SPICE IS FAILED THROUGH FWD ROW OF FASTENERS OF SKIN
- FWD END DIDN'T FOLLOW ANY FASTENER LINES
- S 11 FAILED THROUGH FASTENER OF 100% OF PANEL
- S 19 & S 16 FAILED THROUGH FASTENERS LESS THAN 50%
