LOG # RF26 U.S. 1 RS 9-30-96 AEB
 TARGET # _____
 COORD: LAT _____
 LONG _____

DEBRIS FIELD #1 Green
 (Far)

RHS aft Body skin between Door 5 and STA 2360, S-11R → 24R, and area below the Door.

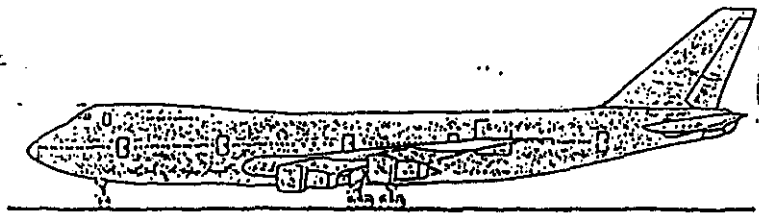
Panel A Green Tag # C274

Lwr portion of skin is crumpled upward and inboard. Panel is torn in several places. Y ring is attached from S-13R to S-22R and portion of Blkhd web attached to Y ring as shown in detail on LF26.

This panel aligns with Panel A at S-21 (failure through skin, straps and edge frame). Lwr portion of door cutout is distorted with fwd cnr obtuse and aft cnr acute.

There is light scuffing on exterior surface only (both segments).

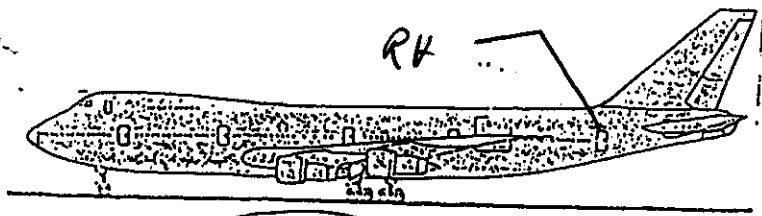
RF 26A

DOOR 5 UPPER AFT CORNER CUTOUT

STA 2360 TO STA 2280, S 11R TO S 23R

- NO SMOKE INSIDE
- LIGHT GREY SMOKE OUTSIDE
- TEAR ALONG S-11 @ FASTENER &
- S 12 LAP PERL BETWEEN 2315 - 2340 OUTWARD
- LOWER END OF PANEL CRUMPLED AND TORN
- DOOR FRAME SEVERED @ S-21
- SILL BROKE AT 2280 (NEAR TANGENT OF RADIUS
- 2280 FRAME, S 13 TO SILL
- 2285 S-21 TO AUX SILL (S-13)
- 2300 S 18 TO AUX SILL (S-13)
- 2320 S 18 TO S-12
- 2360 BLKH FWD BREAK RING, 48 SEC BREAK RING, EXTRUSION @ FROM PRESSURE DOME S 13 TO S-22 EXCLUSIVE OF BOTH ENDS TENSION TIES
- AFT TENSION TIES FAILED (48 SEC) @ EXTRUSION ROOT AND 48 SECTION BREAK RING FRACTURED ALMOST EXCESSIVELY @ TENSION BOLTS &
