LOG # RF 28 RTS 9-30-96

TAG C 217

Field # 1

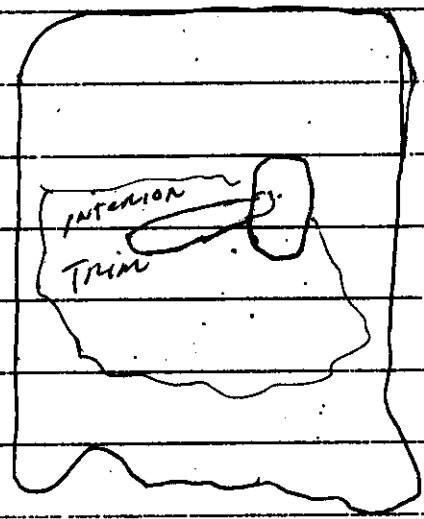
R3 MED Interior side of Door Blacked &  
 Chandel - Door Handle still attached to Door outer window  
 pane intact.  
 Interior Trim Melted & Distorted

Lower Portion of Door Fwd to Aft Severely damaged  
 Above Lower Flap seal door crushed & curved out ward

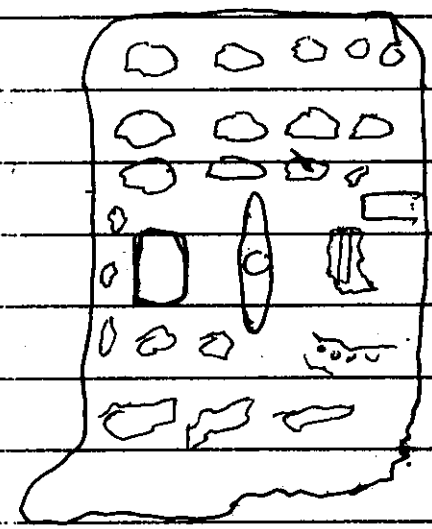
Extention side of Door MANY Holes HANDLE in stowed position  
 Outer Window PANE Melted

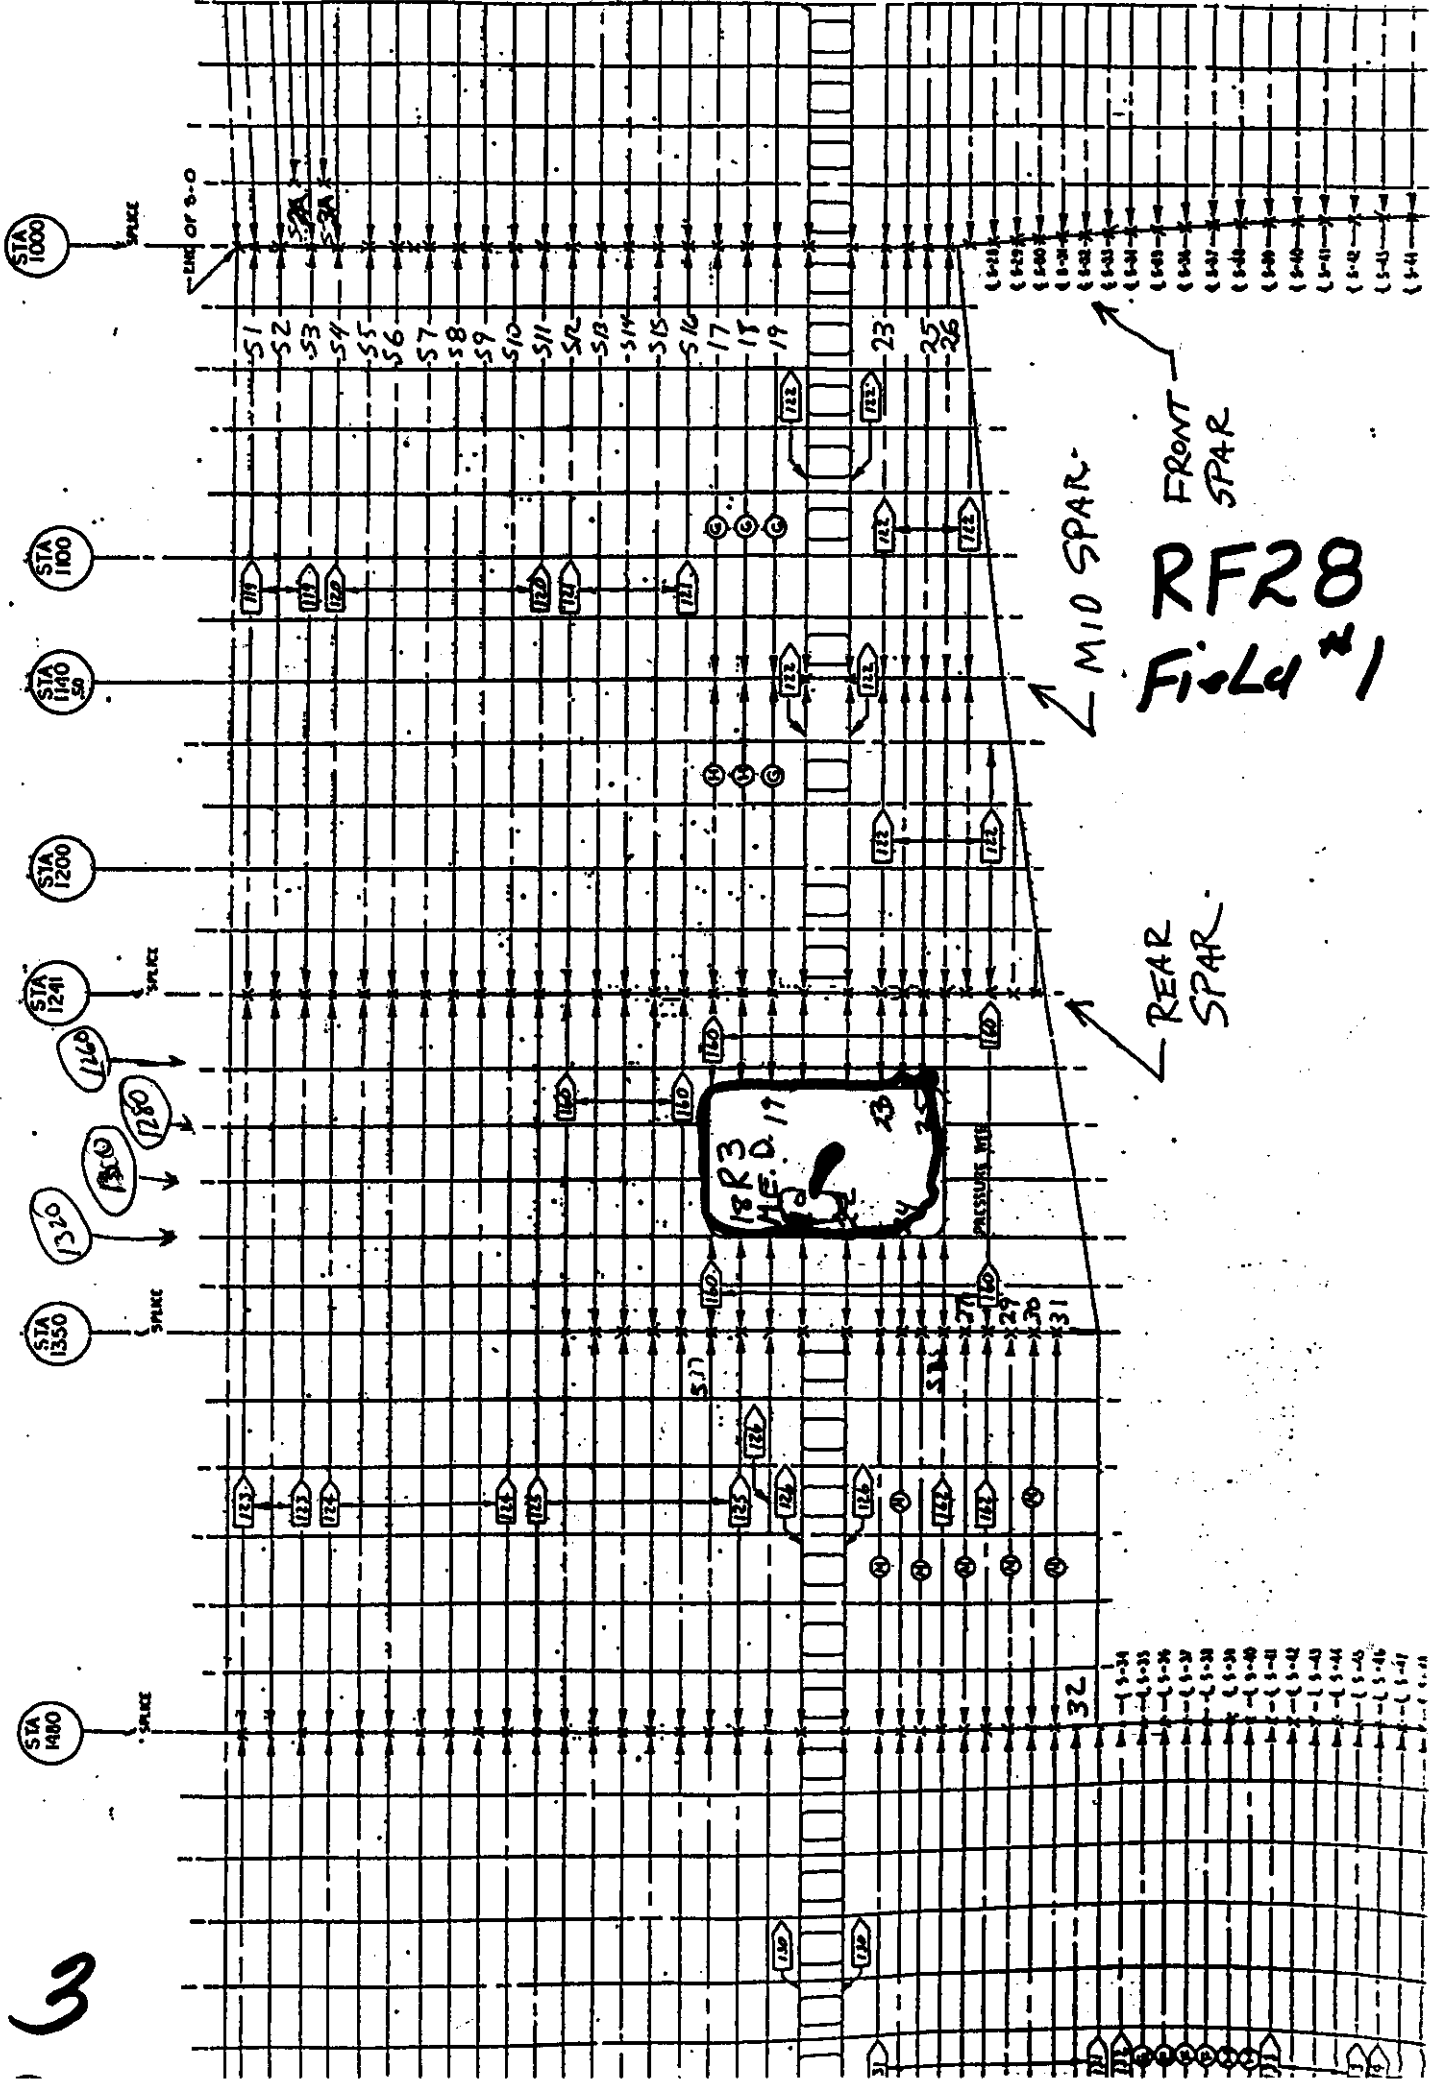
RF28  
Field #1

RIGHT HAND SIDE
