LOG # RF3 ^{SDG} ^{D. J.} ^{AS} ^{-A-F-96} ⁴⁻³⁰⁻⁹⁶

TARGET RF3 CONTAINS APPROX 20% OF THE MAIN CARGO DOOR STRUCTURE AND SKIN. ALL DOOR FRAMES ARE FRACTURED AND BENT APT. DOOR IS CUT THRU BETWEEN REMAINING PORTIONS AT STA 64.5 AND 652.9 SKIN MATERIAL JAGGERED AND CRUSHED. NO EVIDENCE OF FIRE OR SMOKE DAMAGE.

RF3 FORWARD CARGO DOOR

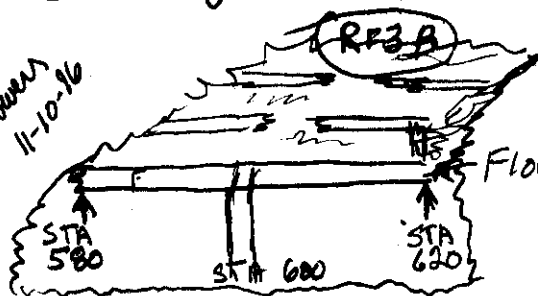
TARGET RF3A REMAINS ATTACHED TO DOOR STRUCTURE ^(RF3) BY MEANS OF THE LOWER DOOR LOCKS STILL ENGAGED TO DOOR SILL. THIS STRUCTURE IS SEVERELY CRUSHED, AND MANY FRAMES MISSING, AND STRINGERS MISSING AND FRACTURED. THIS TARGET COVERS STA 600 THRU 780 AND STRINGERS S23R THRU S44R NO FIRE DAMAGE

TARGET RF3B CONTAINS THE UPPER TOP DOOR OPENING STRUCTURE FROM STA 600 THRU 640 AND STRINGERS S26R, S25R ALSO ATTACHED IS PORTION OF FLOOR BEAM TO FUSELAGE. STRINGERS FRACTURED AND SKIN CRUSHED AND JAGGERED NO EVIDENCE OF FIRE/SMOKE DAMAGE

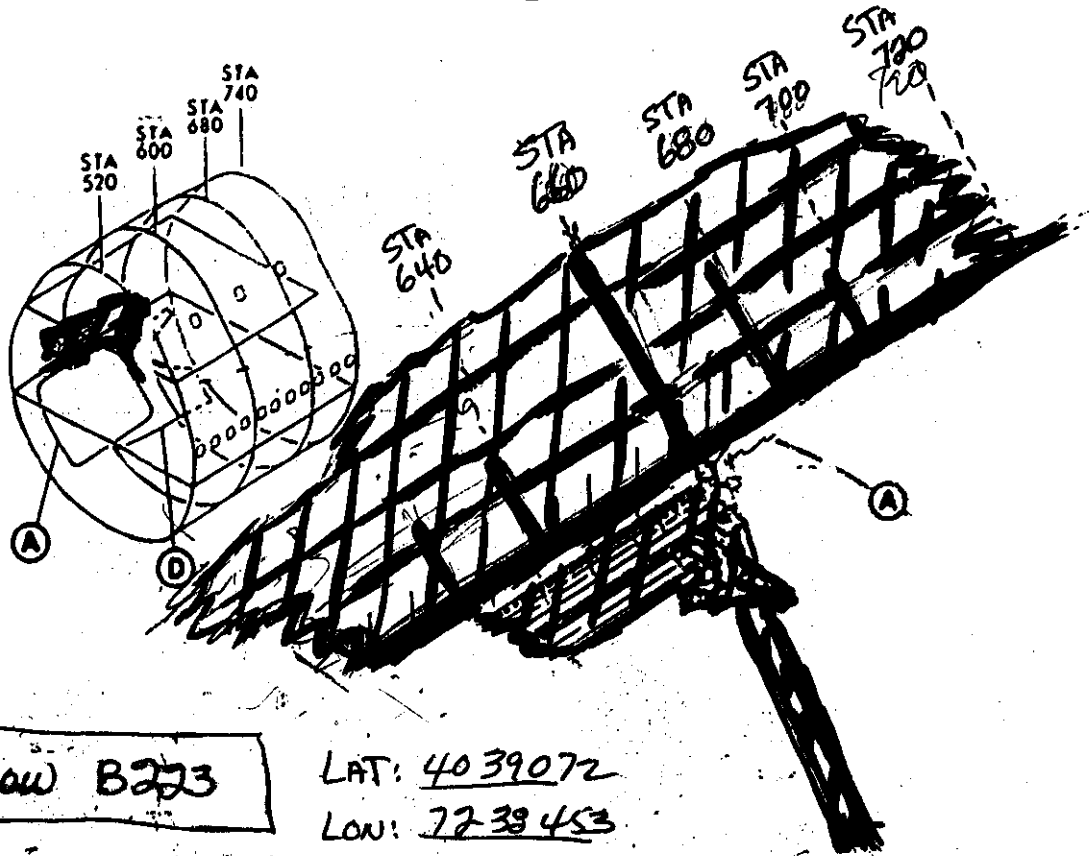
RF3C

THIS SECTION CONTAINS FUSELAGE SKIN AND REAR TOP PORTION OF FWD CARGO DOOR FRAME, AFT PORTION OF DOOR FRAME, AND AFT ~~ACTUATING~~ MECHANISM, (STILL ATTACHED VIA DOOR HINGE.) THIS SECTION MEASURES APPROX 8 1/2' X 3 1/2' AND ENCOMPASSES FRAME STATIONS 600 THRU STA 720, AND STRINGERS S 24, S 25, + S 26. ALL STRINGERS ARE FRACTURED, MANY FRAMES MISSING, AND PORTIONS REMAINING AT VARIOUS STATIONS ARE FRACTURED AND BENT AFT. FUSELAGE SKIN IS CRUSH SHEARED AND JAGGERED.

NO EVIDENCE OF FIRE OR SMOKE DAMAGE

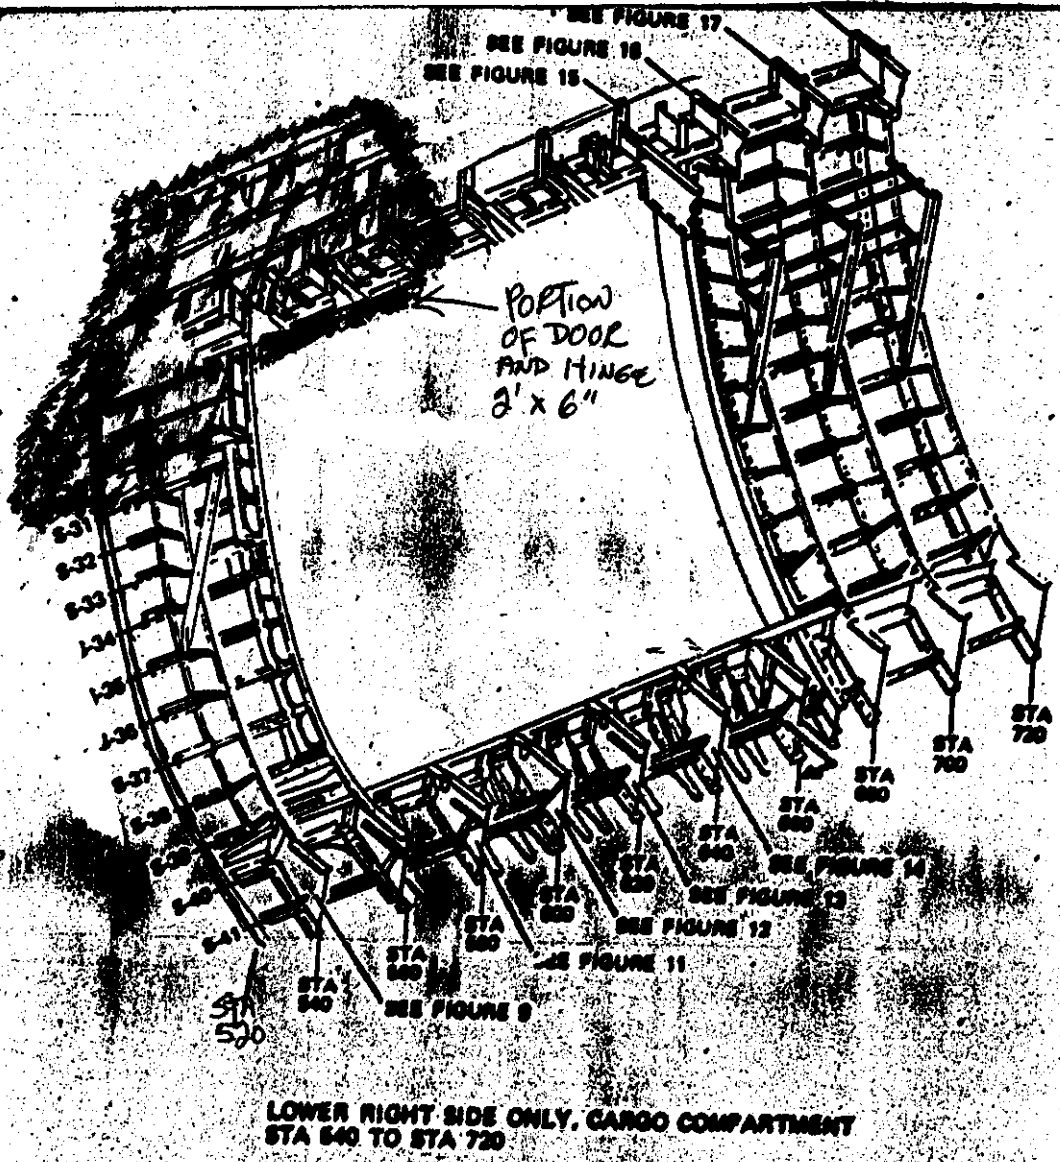
RF3(D)

This piece of fuselage skin and structure measures approx 4 1/2' x 4' and encompasses frames 540 thru 580, and stringers S24R thru S30R. Also attached (by hinge) is small fwd upper section of door.
 Original stringers and frames fractured and missing. Fuselage skin is jagged, crushed and rolled over fwd of STA 540.
 No evidence of fire or smoke damage

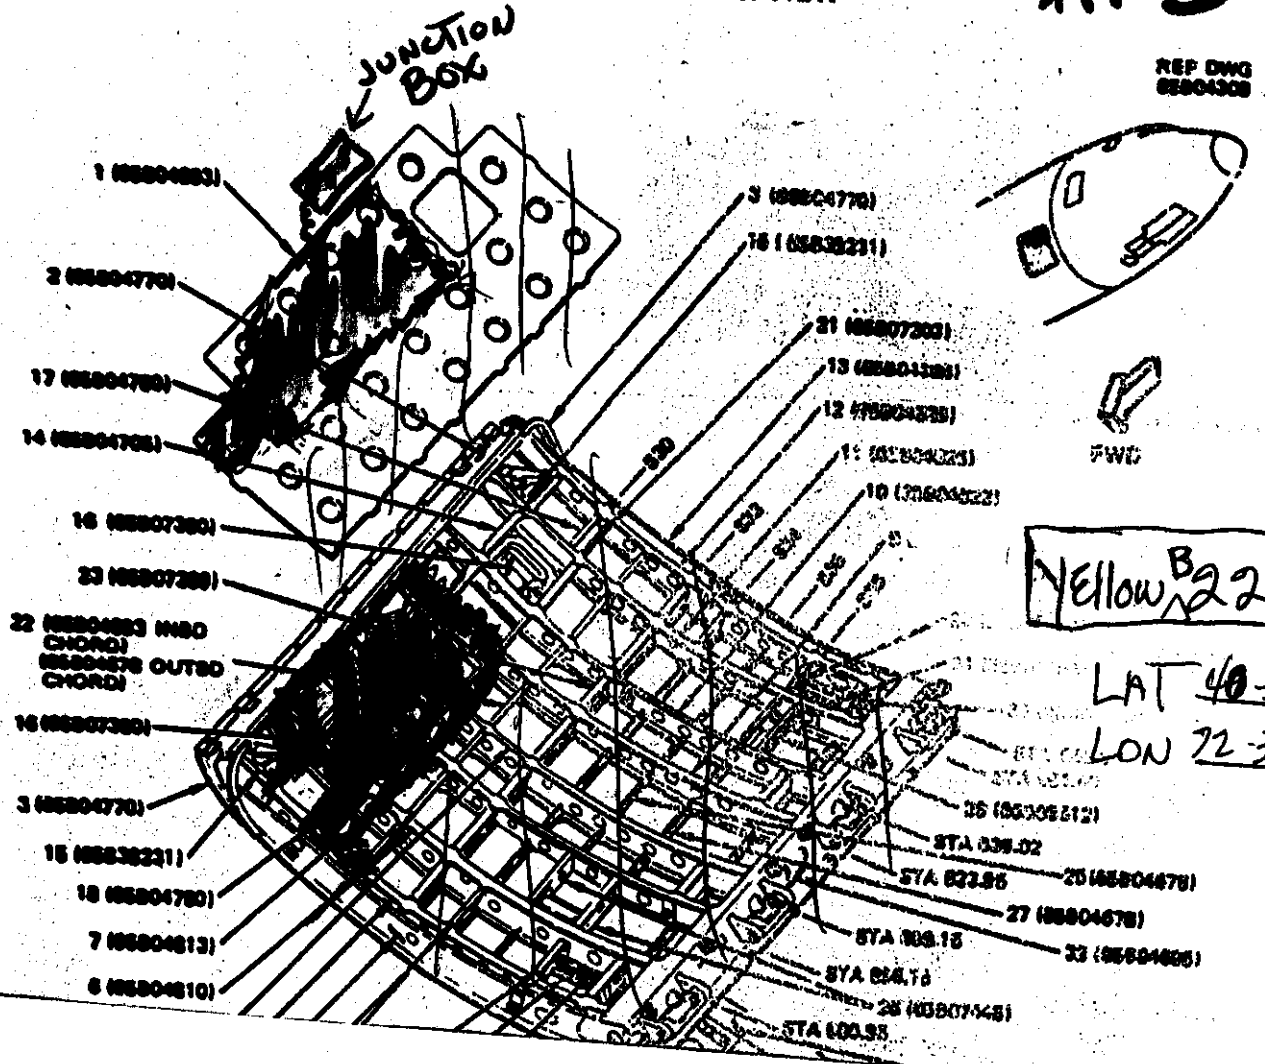
RF3 E

This portion contains small section of upper cargo door (with portion of fwd pressure door opening). Electrical junction box not secured to structure, but is attached to portion of door by electrical wires. Section measures approx 4' x 4 1/2'. All door skin jagged and crushed. No evidence of fire or smoke damage.

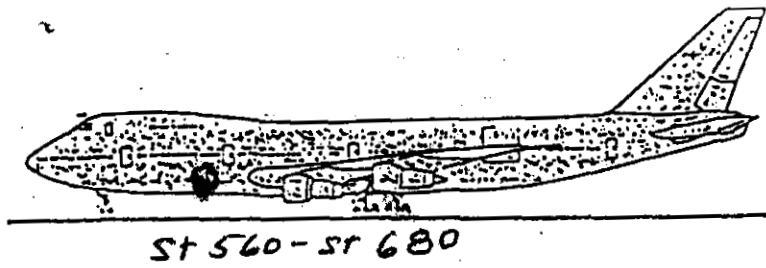
LOG # RF3G & RF3H
TARGET # B007-RF3G
COORD: LAT _____
LONG _____

Piece of Fwd Door mid section lower portion contains #3 Lower Latch Mechanism in the Locked Position & Attached to a lower portion of the Door Sill with two rollers at the opening edge.

Section measures approximately 40" x 48" Piece severely mutilated with cracks & fractured & jagged edges, punctures in skin inward.

Piece of Fwd CGO Door Fwd Section lower portion contains #1 & #2 Lower Latch Mechanism in the Locked Position & a section of lower Door Sill (1) one roller at opening

Piece HAS many fractures & rips & Bent in & outward SHARP jagged edges complete deformation of

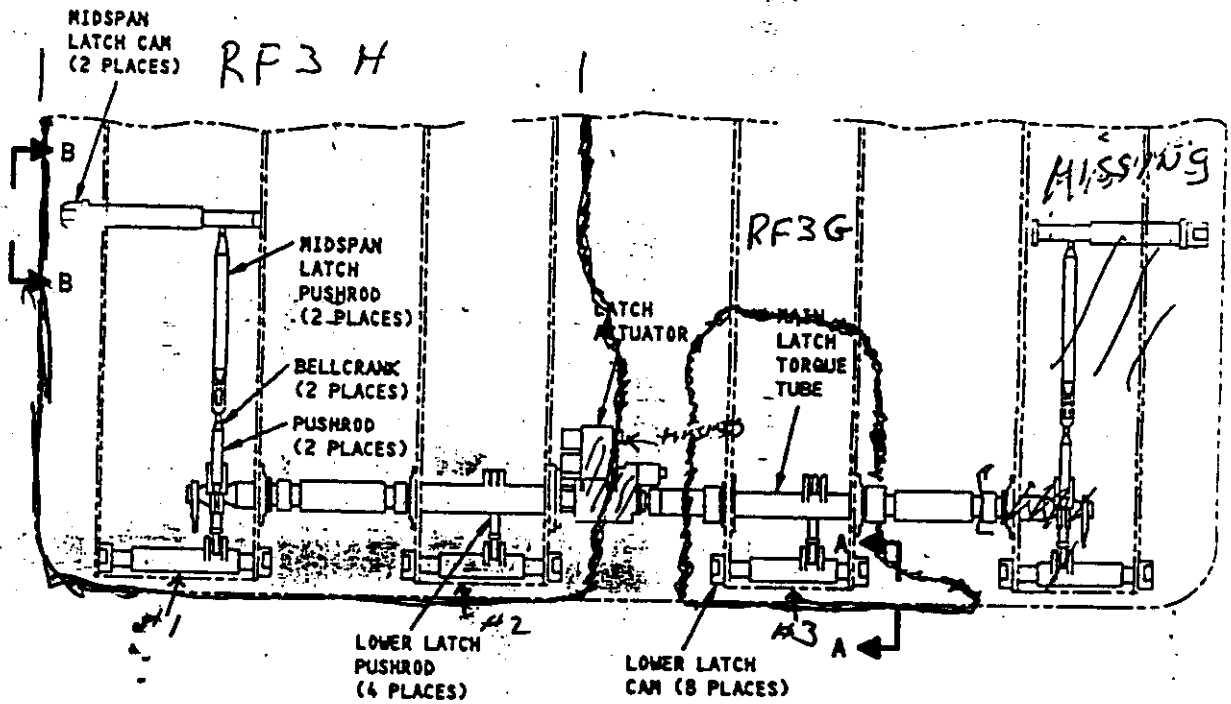
Latch Mechanism
Figure 503 (Sheet 2)

- 1) All ~~RF3~~ CARAO Door AND Surrounding SKIN OF RF3 COMPONENTS EXHIBIT SIGNS OF INWARD BENDING OF OUTER FUSELAGE SKIN AT NON REINFORCED AREA'S. WITH MULTIPLE INWARD PUNCTURES AND TEARS. THESE CONDITIONS EXIST ON THE FOLLOWING PARTS RF3A, B, G, H, F, ~~A~~ E, D.
- 2) BLUE TRANSFER MARK EXISTS AT STATION 600 APPROXIMATELY 1 FOOT ABOVE DOOR HINGE ON INSIDE.

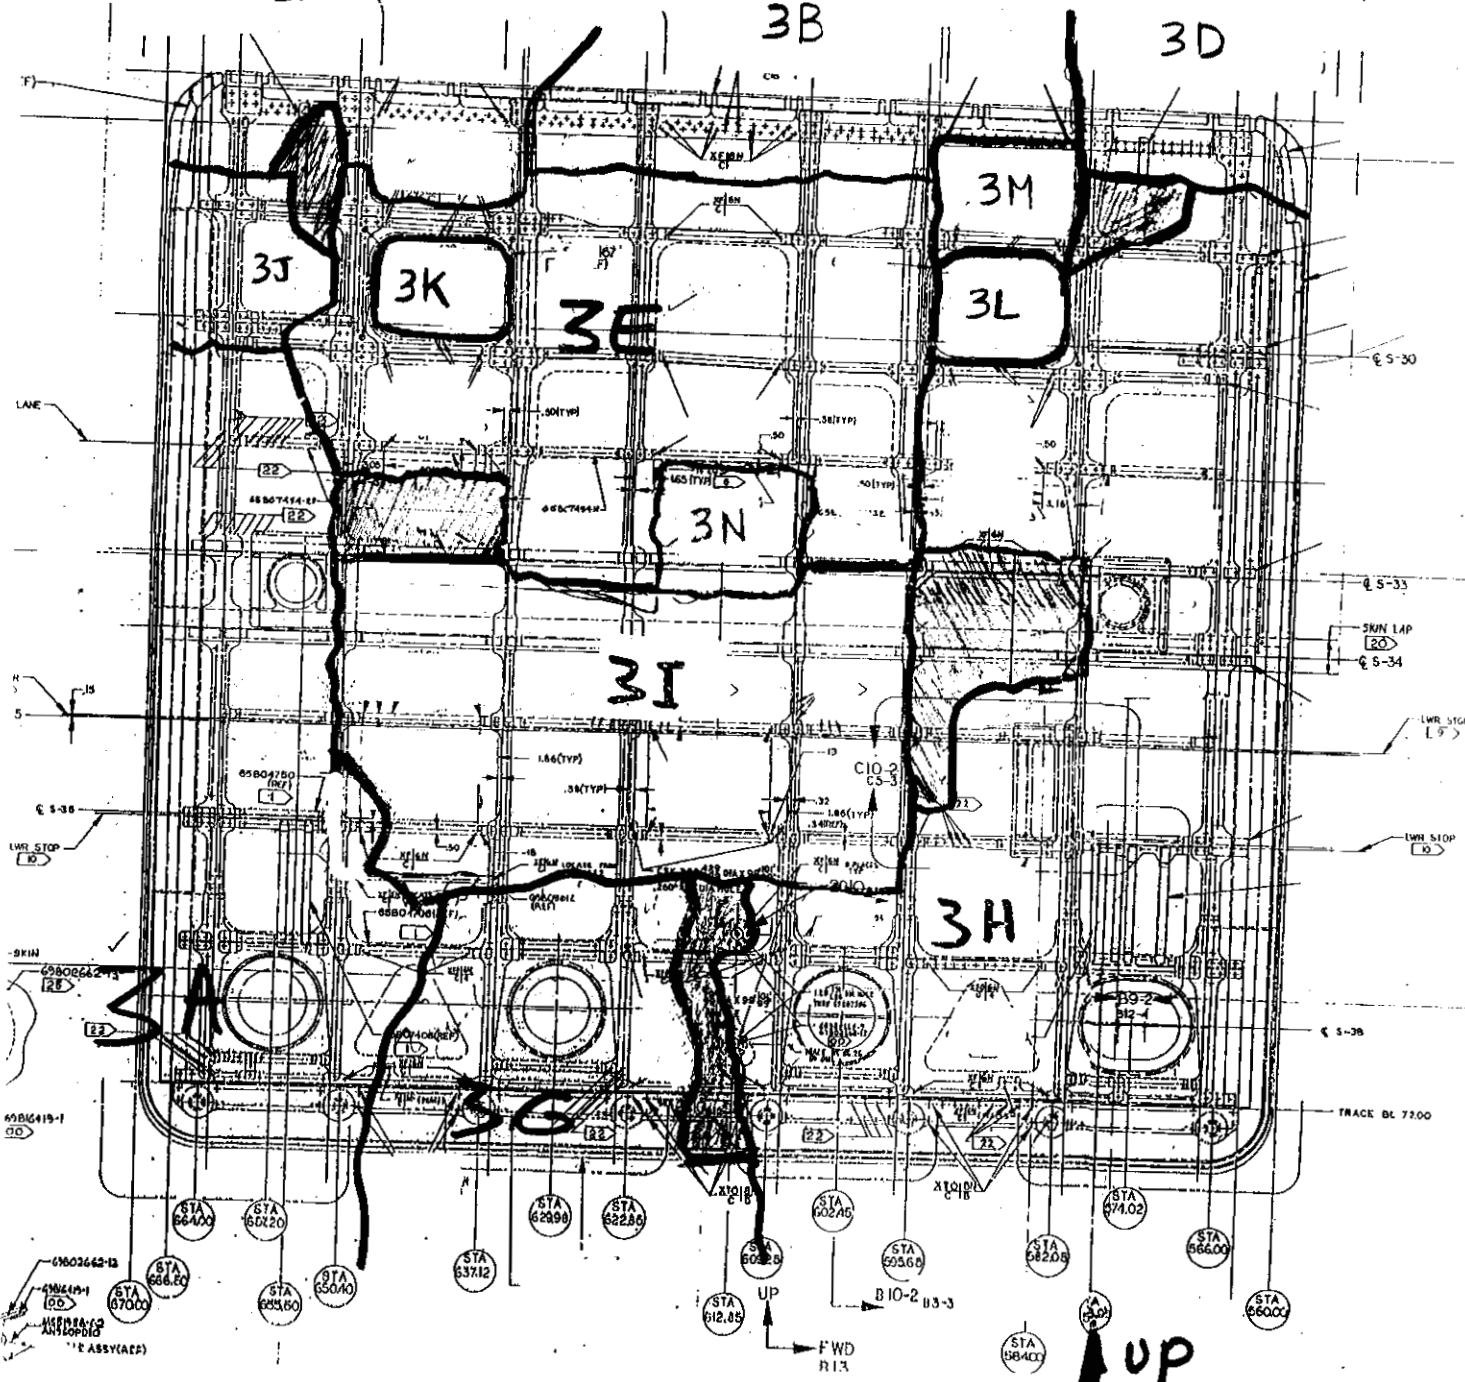
*REVISED MAP OF FORWARD CARGO DOOR; FOR PARTS A, B, C, D, F, G & H SEE ORIGINAL MAP ALSO.

SHADDED AREAS ARE MISSING
