LOG # RF-30 RTB 4/2/96
PMS

SKIN ABOVE
CARGO DOOR
ON RHS

RF-30

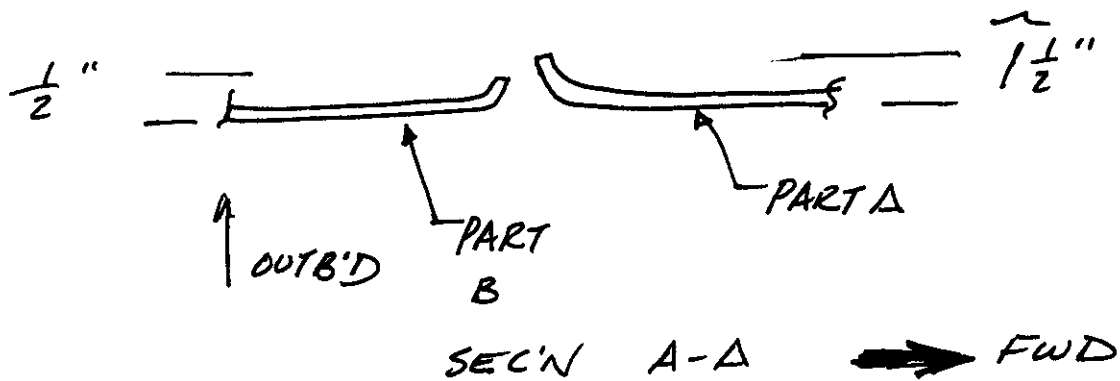
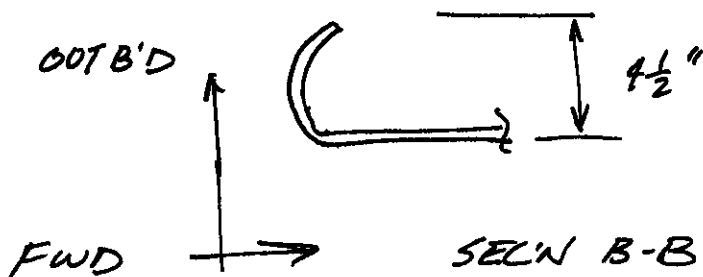
- ALL FRACTURE FACES FREE OF SOOT/BLACKENING
- EXTERIOR SKIN IS FREE OF BLACKENING, 20% OF PAINT (RED) HAS PEELED
- 90% OF STRINGERS INTACT, SEVERED AT STA 1840
- FRAMES AT STA'S 1840, 1860, 1880 & 1940 ARE MISSING
- UPR MAIN SILL INTACT FOR LENGTH OF PARTS A & B EXCEPT IT HAS BEEN JAMMED UPWARDS / ROTATED OVER 90° BTWN STA'S 1860 & 1900 FROM INBD TO OUTBD DIRECTION. SILL WEB & INNER CHORD MISSING FROM STA 1920 AFT

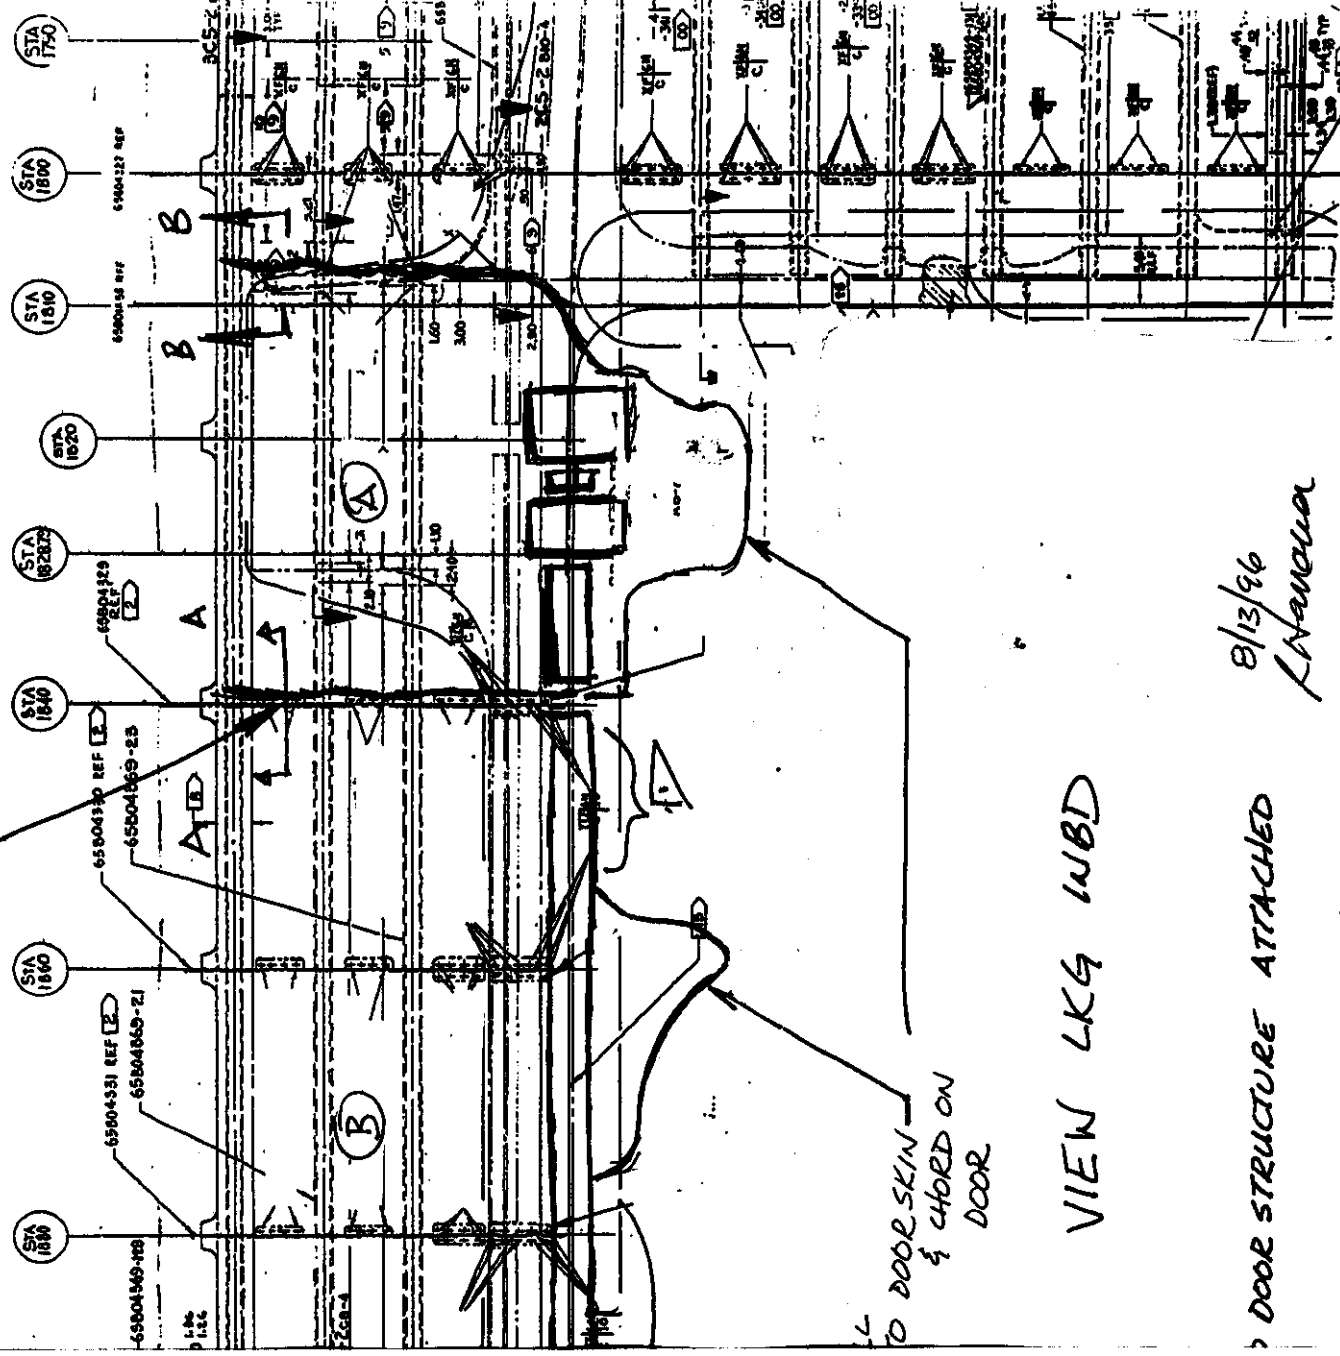
RF-30 C

FAILURE THRU FASTENER LINE

DOOR STRUCTURE ATTACHED

TO DOOR SKIN
& CHORD ON
DOOR
