LOG # RF-32

TAG A 605

SKIN PANEL, STRINGERS AND FRAME ASSY STA 800 TO STA 940, S-37R TO S44R

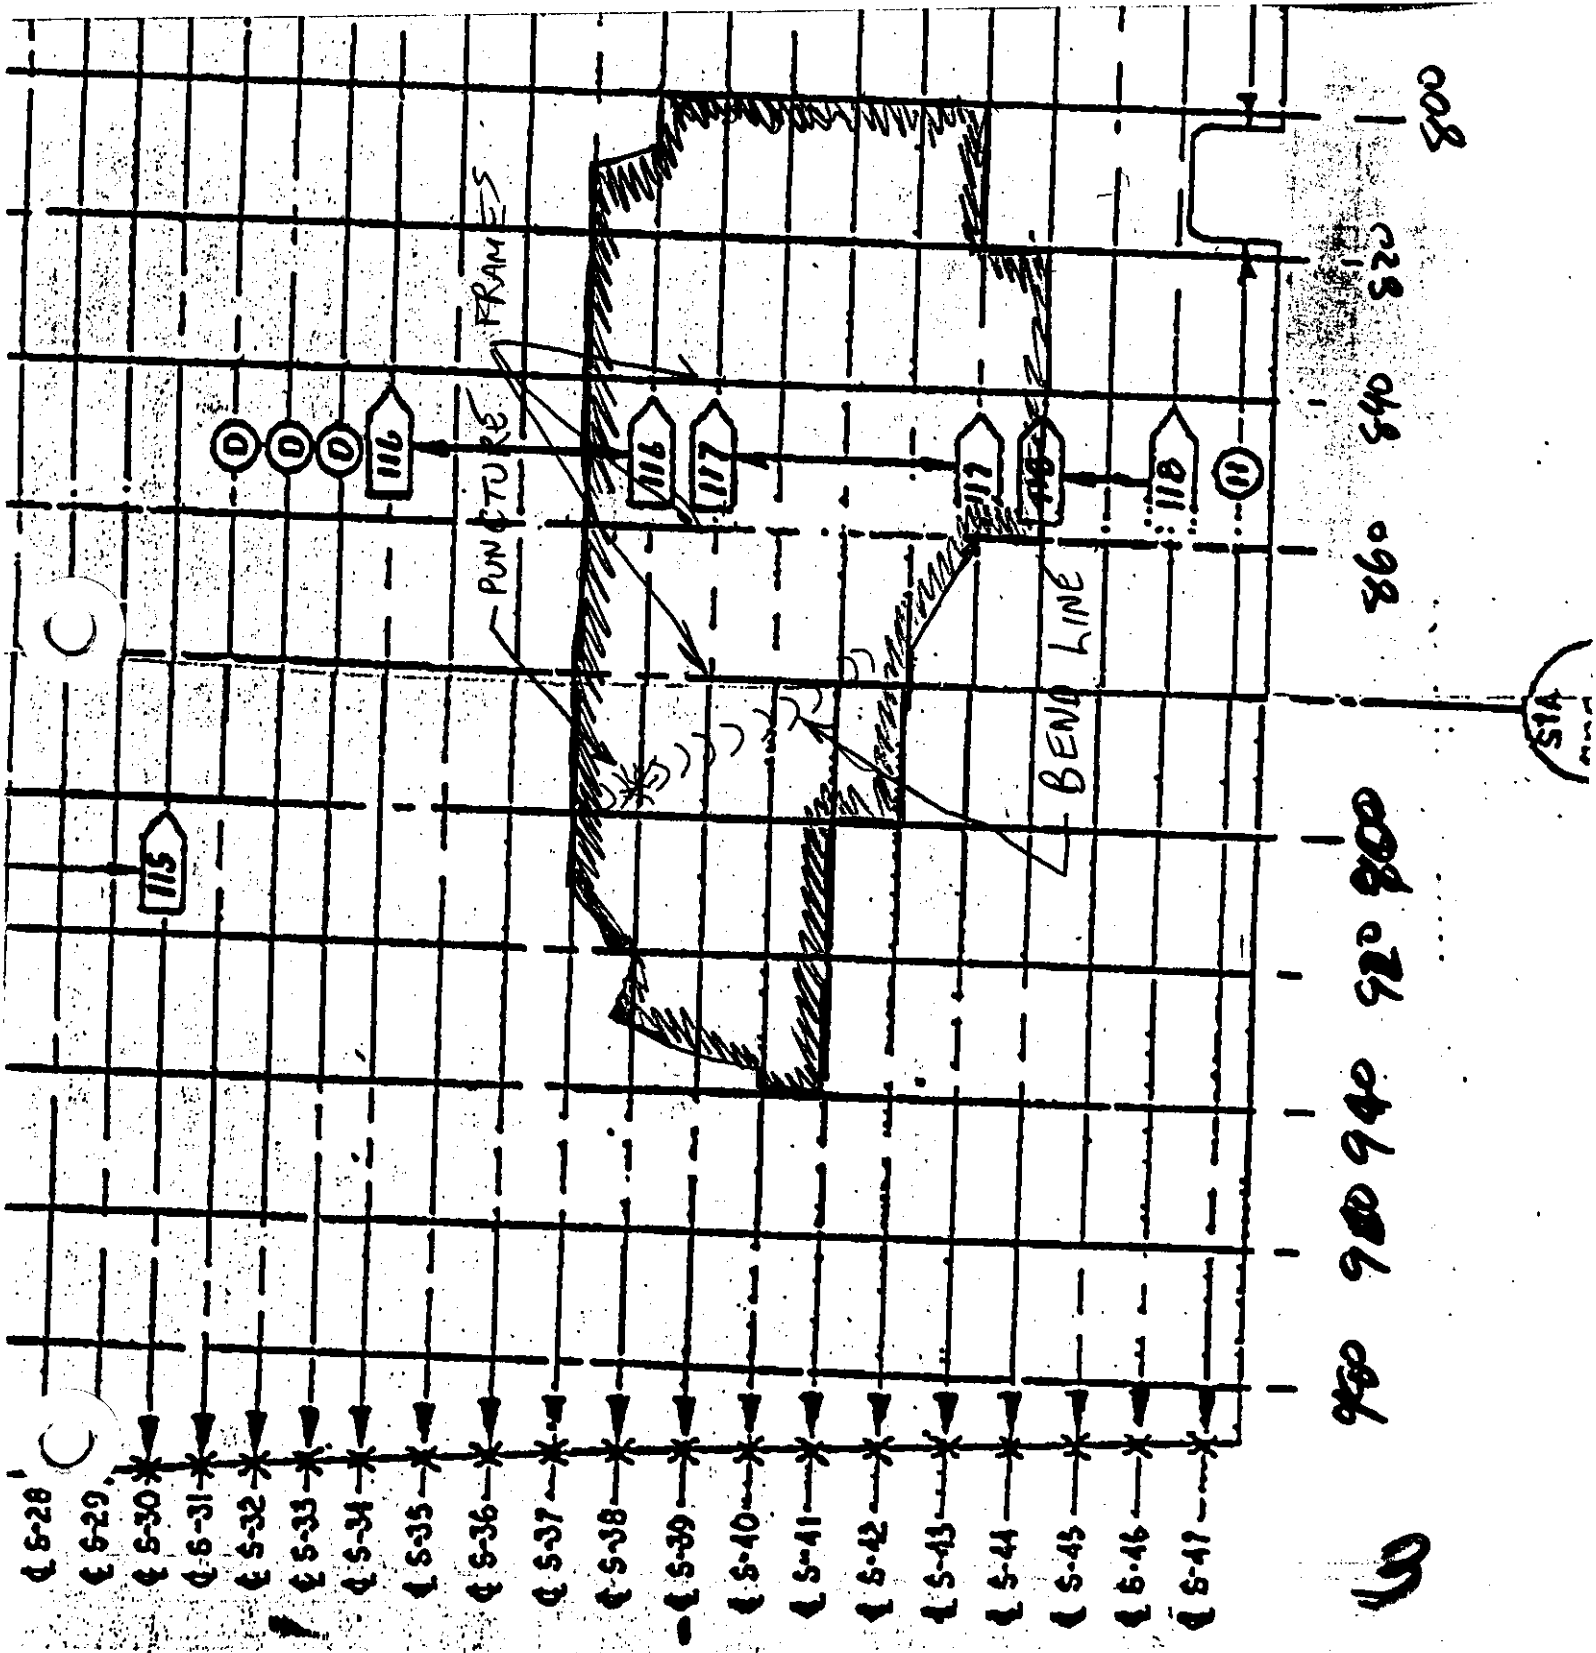
- STA 800 FRACTURE THRU SHEAR TIE FASTENER & EXCEPT S41-S42 WHERE FAIRING BRACKET REMAINED FIXED.

- LOWER END FRACTURE ON STRINGER & FASTENERS

- AFT END TYPICALLY FRACTURED BETWEEN FRAMES
- UPPER END FRACTURE BASICALLY ALONG STRINGER &

FRACTURE FACE $\approx 45^\circ$ RANDOM INWARD AND OUTWARD SLOPE

- STA 840, 860 & 880 FRAMES SQUARE FRACTURE @ S37.5. LINING SUPPORT, CARGO SIDE RAIL, ROLLER TRAY & CARGO TRACK STILL INTACT.

- STA 840 FRAME FRACTURE @ S47 @ SKIN & \approx S45 @ CARGO FLOOR

- STA 860 FRAME FRACTURE @ S44 @ SKIN & \approx S47 @ CARGO FLOOR

- STA 880 FRAME FRACTURE @ S44 @ SKIN & \approx S45 @ CARGO FLOOR

SKIN ROLLED FWD ^{UP} @ STA 880 WITH SKIN ^{OUTWARD} PUNCTURE AT S39 & STA 895

- STRINGERS @ 800 SQUARE FRACTURE, S39-S43
