LOG # **RF33X**

RF 33 A c2237

LOG # RF33J P950F12

LOG # RF33K Pg 7 of 8

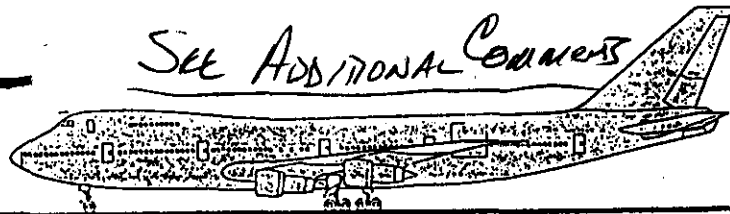
This section of fuselage skin measures approx 2' x 4' and encompasses frame stations 1760 thru 1780 and stringer locations S41R thru S35R. All frame members missing, also S36R is missing. Fuselage skin is irregular in shape and all edges jagged, remaining stringers are fractured and crushed. ~~NO EVIDENCE FIRE OR SMOKE DAMAGE~~ (SOOTING ON OUTSIDE SURFACE)

This section measures approx 3' x 1' and encompasses frame stations 1720 thru 1760 (NO FRAMES ARE ATTACHED), AND STRINGERS S40R AND S41R. STRINGER S41R AND FUSELAGE SKIN ARE CUT THRU (MIDWAY) TO S40R. FUSELAGE SKIN IS ROLLED OVER ON TO ITSELF. ALL EDGES ARE JAGGED. NO EVIDENCE FIRE OR SMOKE DAMAGE IN INSIDE BUT LIGHT SOOTING ON OUTSIDE.

This section of fuselage measures approx 1 1/2' x 2' and encompasses frame stations 1740 AND 1760 (NO FRAMES ATTACHED) AND STRINGERS S42R, S43R + S44R. (WHICH ARE FRACTURED AND CRUSHED). FUSELAGE SKIN IS TORN FROM S42R TO EDGE. SKIN IS IRREGULAR IN SHAPE, AND ALL EDGES JAGGED. NO EVIDENCE FIRE OR SMOKE DAMAGE INSIDE BUT SOOTING ON OUTSIDE

THIS SECTION OF FUSELAGE MEASURES APPROX 3 1/2' X 3 1/2' AND ENCOMPASSES FRAME STATIONS 1680 THRU 1720 (NO FRAMES ATTACHED) AND STRINGERS S36R T S41R. FUSELAGE SKIN AND STRINGER 37R MISSING FROM STA. 1700 & 1720. PORTIONS OF FUSELAGE SKIN AND STRINGER S41R MISSING 6" FORE AND 6" AFT OF STA 1700 (DOWN TO S40R). REMAINING STRINGERS AND FUSELAGE SKIN FRACTURED, JAGGERED, AND BEAT, NO EVIDENCE FIRE OR SMOKE DAMAGE ON INSIDE BUT SOOTING ON OUTSIDE

THIS SECTION MEASURES APPROX 5' X 4' (IRREGULAR IN SHAPE) AND ENCOMPASSES STATION LOCATION 1620 THRU 1680, AND STRINGERS S36R THRU S42R. FUSELAGE SKIN IS TORN, AND STRINGERS:

NO EVIDENCE OF FIRE OR SMOKE DAMAGE

THIS SECTION MEASURES APPROX 4' X 2', IS IRREGULAR IN SHAPE, AND FUSELAGE SKIN IS SHEARED, BEAT, AND ALL EDGES JAGGERED. SECTION ENCOMPASSES FRAME LOCATIONS 1660-1700 AND STRINGERS S40R THRU S43R.

NO EVIDENCE FIRE OR SMOKE DAMAGE, ON INSIDE BUT SIGHT SOOTING ON OUTSIDE.

This SECTION OF FUSELAGE MEASURES APPROX 5' x 6 1/2' AND ENCOMPASSES FRAME STATION 1640 THRU 1740, AND STRINGERS S43R THRU S51R ON THRU  $\text{\textcircled{C}}$  AND ON TO LEFT SIDE FUSELAGE (WHICH INCLUDES S51L, S50L, + S49L). FUSELAGE SKIN IS TORN IN MANY PLACES, ALL EDGES ARE JAGGERED, AND IS IRREGULAR IN SHAPE.

FUSELAGE SKIN ROLLED OVER AT STATION 1700, NO EVIDENCE FIRE OR SMOKE DAMAGE ON INSIDE BUT SOOTING ON OUTSIDE.

THIS SECTION OF FUSELAGE MEASURES APPROXIMATELY 5' x 4' AND TRANSITIONS FROM LOWER LEFT SIDE OF SIDE AIRCRAFT THRU & AND UP RIGHT SIDE TO MATCH SECTION RF 33 G. THIS SECTION ENCOMPASSES STATION LOCATIONS 1620 THRU 1680, AND STRINGERS S51R THRU & THRU FROM S51L THRU S45L. NO FRAMES SECURED TO THIS SECTION. STRINGERS S51L, + S45L MISSING COMPLETELY

ENTIRE LENGTH OF REMAINING FUSELAGE SKIN CURLED INTO "U" SHAPE AT STATION 1660. ALL EDGES ARE TORN + JAGGED. NO EVIDENCE OF FIRE OR SMOKE DAMAGE ~~OR A HOLE, BUT LIGHT SOOTING ON OUTSIDE.~~

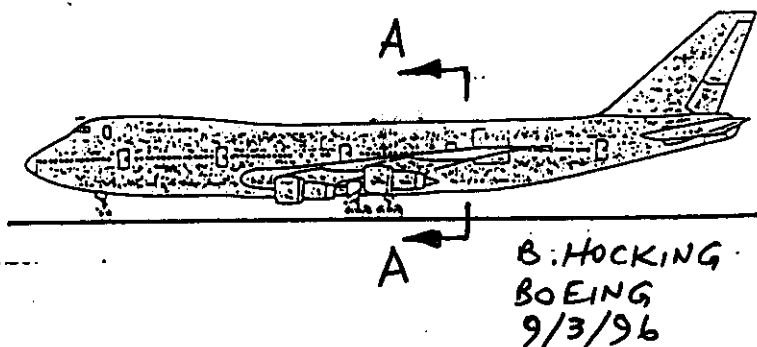
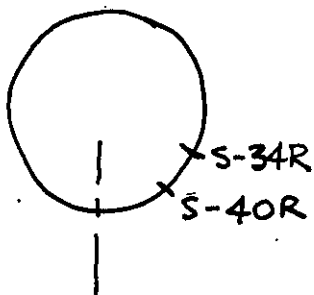
SKIN SEGMENT, STA 1780 TO STA 1800,  
STRINGER 34R TO 40R.

- 1) BETWEEN STRINGERS, PANEL EXHIBITS INWARD DEFORMATIONS DUE TO AN EXTERNALLY APPLIED PRESSURE.
- 2) ~~THE LONGITUDINAL SKIN SPLICE AT S-40R HAS THE WIDTH OF PANEL SUPPORT~~
- 2) THE LOWER EDGE OF THE PANEL (ABOUT 1 1/2"; THE PORTION NORMALLY ATTACHED BY THE LOWER TWO ROWS OF SPLICE FASTENERS) IS BENT OUTBOARD AND UP ALONG THE UPPER ROW OF FASTENERS. THE BOTTOM TWO FASTENER ROWS WERE EVIDENTLY PULLED THRU THEIR HOLES AS EVIDENCED BY HOLE DIMPLING.

- 1) STG'S 35R THROUGH 39R REMAIN ATTACHED TO THE PANEL.
- 2) STG 38R EXHIBITS INBOARD BENDING OF THE CENTER WITH RESPECT TO ITS ENDS. THE OTHER FOUR STRINGERS HAVE DAMAGED ENDS (FLATTENED, TORN, BENT ~~IN~~ OUTBOARD)

- 1) REMNANTS OF FRAME-TO-SKIN SHEAR TIES CAN BE FOUND AT THE FOLLOWING LOCATIONS: STA 1780, S-39R TO S-38R, S-38R TO S-37R, S-37R TO S-36R, S-35R TO S-34R. ALSO AT STA 1800, S-40R TO S-39R, S-38R TO S-37R,
- 2) THE MAIN CARGO DOOR CONTROL BOX IS STILL ATTACHED BETWEEN S-36R & S-35R. THE CONTROL SWITCHES ARE PRESENT BUT DAMAGED. THE ~~FRONT~~ BOX INBOARD SURFACE IS DEFORMED OUTBOARD AS THOUGH AN OUTBOARD-ACTING PRESSURE ~~WAS~~ HAD BEEN APPLIED TO IT. WIRES RANGING IN LENGTH BETWEEN 6 INCHES TO 6 FEET REMAIN ATTACHED.

- 3) LIGHT SOOTING EXISTS ON THE OUTBOARD SURFACE MAINLY IN THE REGION FROM S-40R TO S-39R.
- 4) FRACTURE SURFACES APPEAR TO BE DUCTILE FAILURE.

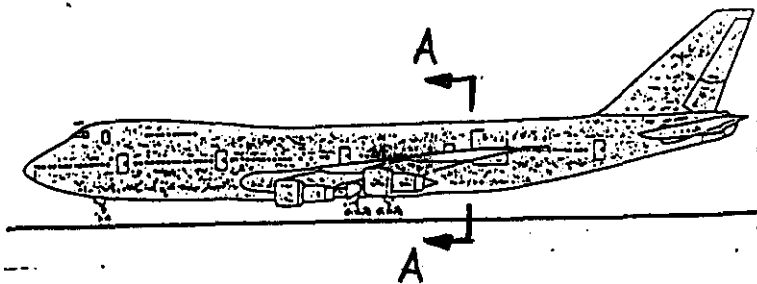
SKIN PANEL SEGMENT, STA 1680 TO STA 1700, STG 42R TO 44 1/2 R.

SKIN: THE PORTION OF THE PANEL BETWEEN STG 43R AND 44R HAS AN INWARD BULGE WHICH WOULD APPEAR TO INDICATE THAT AN EXTERIOR PRESSURE ACTING INWARD WAS EXERTED ON THE PANEL, THE SKIN GAGE IN THIS REGION APPEARS TO BE ABOUT 0.10 INCH THICK,

- 1) STRINGERS 43R AND 44R REMAIN ATTACHED TO THE PANEL
- 2) THE STRINGER ENDS AT STA 1680 AND 1700 ARE TORN. WITH PIECES EXTENDING AS FAR FORWARD AS STA 1673 AND AS FAR AFT AS 1717.

- 1) THE PANEL POSSESSES THREE NUTPLATES ATTACHED TO THE SKIN INNER SURFACE WHICH ARE USED FOR OUTSIDE FAIRING PANEL INSTALLATION. THEY ARE LOCATED AT STA 1690, STG 42 1/2 R; STA 1688, STG 43R (IN OPEN CENTER OF STRINGER) AND AT STA 1684, STG 43 1/2 R.
- 2) A FRAME-TO-SKIN SHEAR TIE SEGMENT IS ATTACHED TO THE PANEL AT STA 1700, STG 44R TO 45R.
- 3) A PIECE OF A STRINGER CLIP REMAINS ATTACHED TO THE STG 44R SIDE WALL AT STA 1700.
- 4) A SMALL (1 1/2" X 6") PIECE OF FAIRING PANEL REMAINS ATTACHED ON THE OUTER SURFACE.
- 5) THE PANEL HAS MODERATE SOOTING OF THE OUTER SURFACE OVER THAT REGION ~~NOT ONE~~ THAT WAS NOT ORIGINALLY COVERED BY FAIRING PANEL. THE INNER SURFACE HAS LIGHT SOOTING.
- 6) THE FRACTURE SURFACES APPEAR TO HAVE LIGHT SOOTING AND APPEAR TO BE DUCTILE FAILURE.
