LOG # RF35

RED TAG # A421

### SECTION 42 upper Aft RHS skin Panel

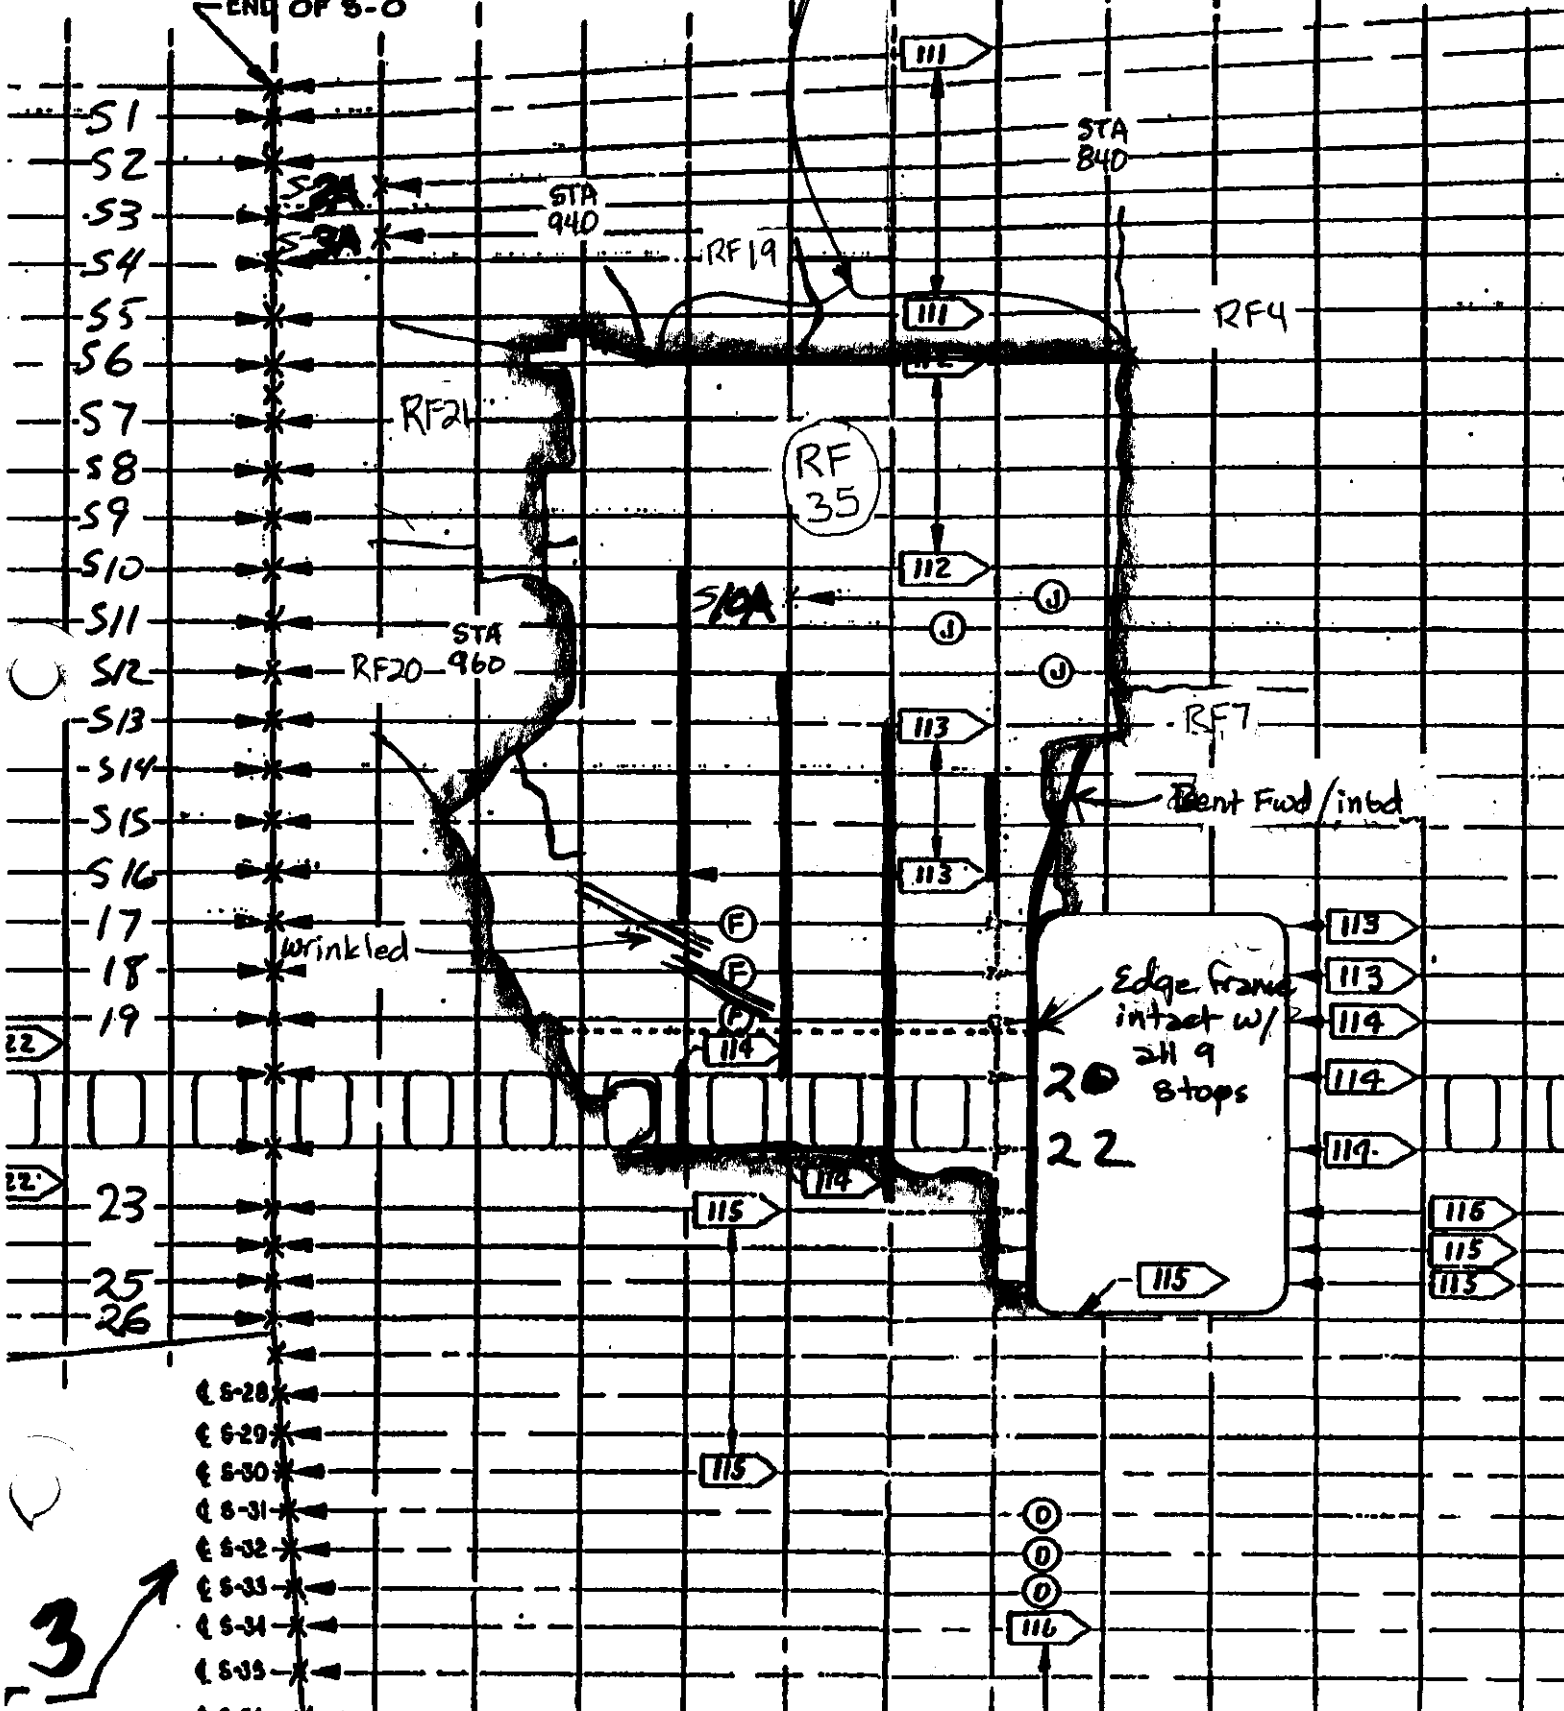
RF35

This panel does not exhibit the curling like RF1. Most stringers remain attached. The STA 940

frame is entirely gone. Other remaining frame segments are highlighted on next sheet. Missing segments appear to have detached from skin with rivet tension (either open holes in skin or driven heads pulled through shear ties).

At STA 940 (and several other locations), the shear tie flange remains, failed at the band radius. There is no evidence of fire damage or sootmg.

Static failure through lap splice upper row in upper skin.
